Helping you fix it right the *first* time - every time

## Rewriting the ODO Data to a New Gauge Control Module

## Fix That Pesky Glove Box Light Leak

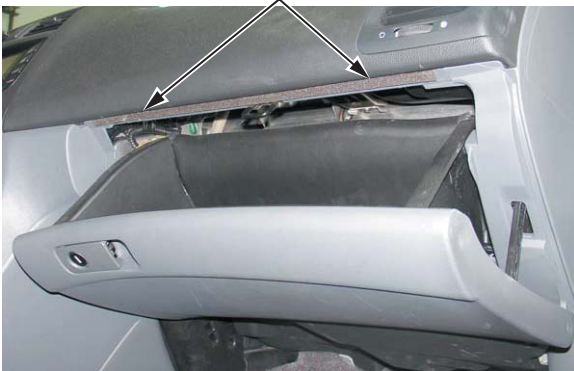
Sometimes the glove box door in a '03–07 Accord may not meet up just right with the dashboard when you close it. If this is the case and you turn on the parking lights or the headlights, you wind up with a pesky light leak from the glove box.

Replace this strip of EPT foam.

1. Cut a piece of EPT foam (P/N 06992-SA5-000, H/C 2086668) that's **10 mm x 450 mm**. Make sure you use a straight edge and a sharp blade to do this. **Don't** use a pair of scissors; the edges must look straight and clean.
2. Remove the old factory-installed foam strip (if it's still there) from the dashboard.

3. Peel off the paper backing from the foam strip and, starting from left to right, press the strip to the dashboard in the same place where the old strip was. Make sure the strip doesn't show when you close the glove box door.
4. Make sure the glove box door closes without too much resistance. Over time, the foam strip will conform much like window and door weatherstrips do. The glove box door will then close easier.

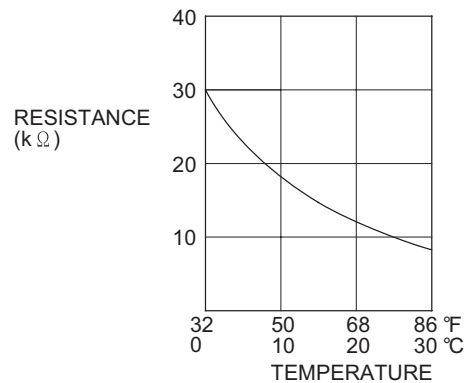
'07 4-door model

You need to do a bit of tweaking to step 4 of the Evaporator Temperature Sensor Test on page 21-76 of the '06–07 Civic S/M Volume 2. The evaporator temperature sensor for '07 Civic Coupes has changed and, along with it, its specified resistance values.

4. Compare the resistance readings with the specifications shown in the graph; the resistance should be within the specifications.
