### Product Update: DC-DC Converter (Supersedes 00-093, dated November 21, 2000)

### Product Update: Insight Charging System

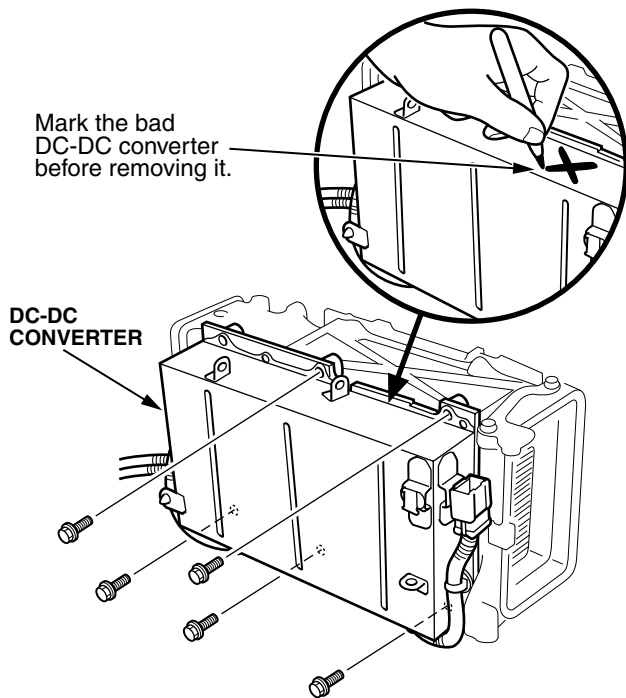
In certain DC-DC converters, the internal temperature monitors are defective, causing the converter to shut down when there is no overheating.

- Remove the DC-DC converter mounting bolts. Remove the converter from the PCU.

- Install the new DC-DC converter.
- Remove the air intake from the side of the PCU and reinstall it on the air duct in the vehicle.
- Install the PCU into the vehicle in the reverse order of removal. Make sure the air intake duct is aligned properly with the PCU.
- Reinstall the remaining parts. Make sure you turn on the battery module switch.
- Reconnect the negative cable to the 12V battery.
- Remove the EPS fuse from the under-hood fuse/relay box.
