## Product Update: IMA Controller Modification

### BACKGROUND

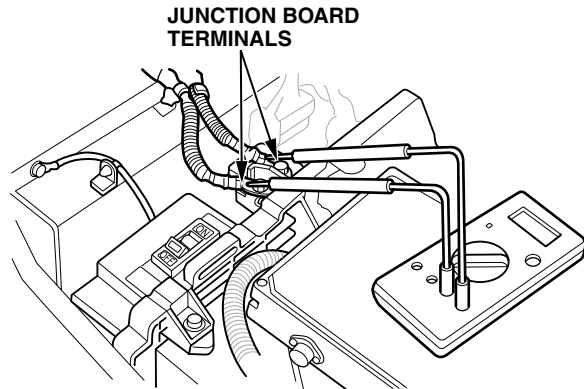
10. Measure the voltage between the junction board terminals. There should be 10 V or less.

- If you have more than 10 V, there's a problem in the IMA system. Look for and troubleshoot any DTCs before continuing.
- If you have 10 V or less, continue to step 11.
