Product Update: Premature IMA Battery Module Failure

(Supersedes 06-026, dated May 13, 2006, to update the information marked by the black bars)

Product Update and Warranty Extension: Integrated Motor Assist Battery System

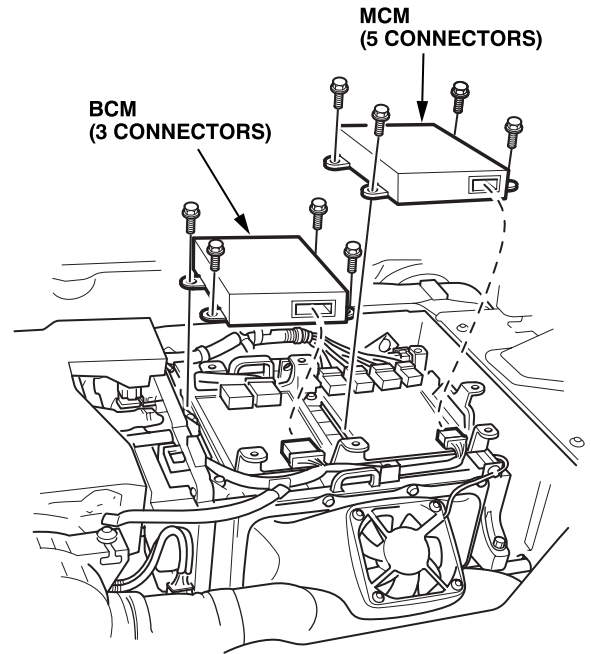
The IMA battery control module(s) allows the battery to overcharge. Occasional overcharging is a desirable function, but too many frequently repeated cycles of overcharge can damage the IMA battery. This damage is the result of excessive current and heat build up. Unique local topographical and ambient conditions in affected states, combined with a driving cycle that typically keeps the IMA battery fully charged, create this potential problem.

11. Replace the BCM (2002–04 Insights) or the BCM and the MCM (2000–01 Insights):

- Remove the mounting bolts.
- Disconnect the connectors: The BCM has three; the MCM has five.
- Remove the module(s).
- Install the new module(s) in the reverse order of removal, and torque the mounting bolts to **9.8 N·m (7.2 lb-ft)**.
