# Safety Recall: Combination Light Switch

(Supersedes 04-015, dated March 26, 2004)

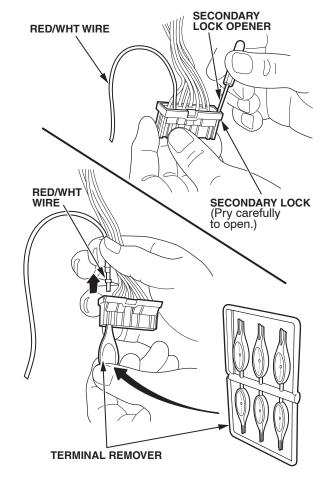
- 11. Inspect the 16P connector for heat damage or discoloration.
  - If the connector is OK, go to step 12.
  - If the connector is damaged or discolored, go to step 14.
- 12. Using the Secondary Lock Opener from the Terminal Maintenance Set (T/N 070AZ-S5A0100), carefully pry open the secondary lock on the RED/WHT wire side of the 16P connector.
