Transmission Flush Systems: Just Say “No”

H HONDA ServiceNews

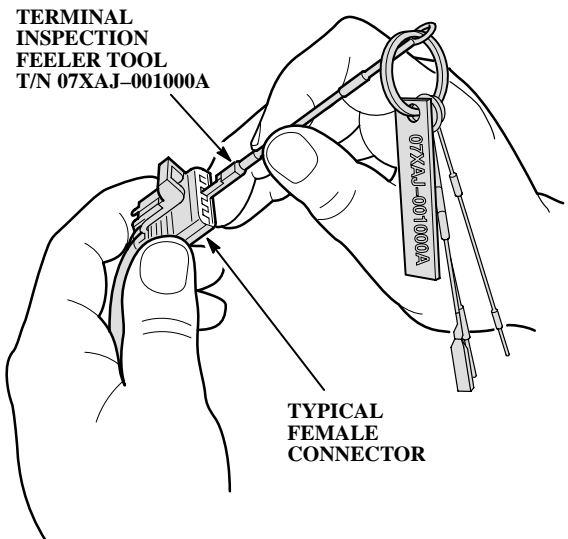
1. Find the terminal tool that best matches the male terminal in the mating connector. Make sure you don't select a terminal tool larger than the mating female terminal; it will spread the female terminal and cause a loose terminal fit.
2. Insert the terminal tool into the female terminal, then remove it.

3. Compare the drag to the other terminals in the connector; if there's less drag, remove the female terminal, and tighten the contacts to increase the tension, or replace the terminal with a new one from the appropriate terminal repair kit (see Service Bulletin 95-023, *Terminal Replacement Instructions*, filed under Special Tools).

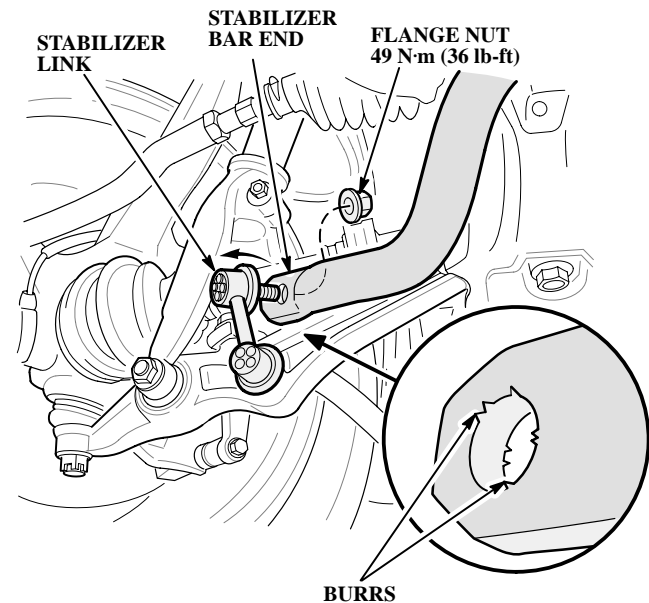
Clunking on Turns or Bumps: '99–00 Accord

On '99–00 Accords, if your customer complains that the vehicle clunks when turning or going over bumps, check if the flange nuts on the front stabilizer links are loose. If they are, disconnect the stabilizer links from the stabilizer bar ends, pivot the links out of the way, and check the holes in the bar ends for burrs. A nut that's tightened against a burr can loosen as the burr flattens or changes shape. To keep this from happening again, remove any burrs with a file, and reconnect the stabilizer links to the bar ends. Torque the flange nuts to 49 N·m (36 lb-ft).
