A/C Warning Light On: '88–91 Prelude

**HONDA ServiceNews**

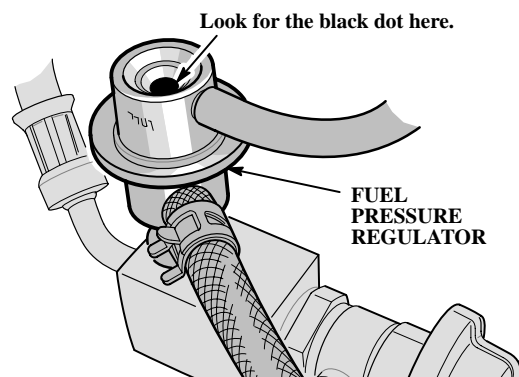
Before you replace a fuel pressure regulator or PCM on a '00 Accord V6, first look at the regulator to determine which replacement parts to order.

- If there's a black dot on the regulator, it's the updated type. Replace it or the PCM with these parts: fuel pressure regulator, P/N 16740-PGK-A01, H/C 6435093 or PCM, P/N 37820-P8C-A54, H/C 6432710.
- If there's *no* black dot on the regulator, it's the original type. Replace it or the PCM with the parts listed in the parts catalog.

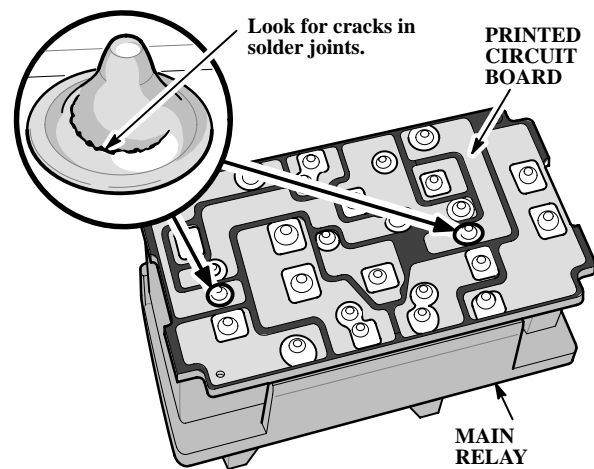
If the complaint matches this scenario, remove the main relay, and use an 8X magnifier to look at the two solder joints on the relay's printed circuit board. If the solder is cracked, replace the main relay.
