## Uneven Glove Box Fit: '01 Civic

HONDA ServiceNews

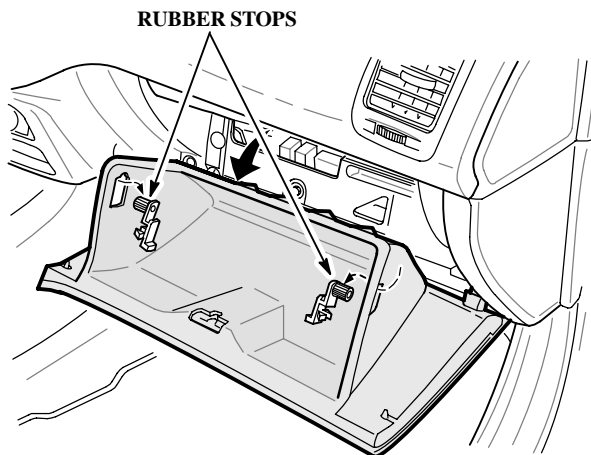
On '01 Civics, the glove box may not fit evenly. To fix this problem, here's what you do:

1. Look at the glove box face, and note where the gaps appear uneven.
2. Remove the rubber stops inside the glove box, and lower it to access the frame bracket.

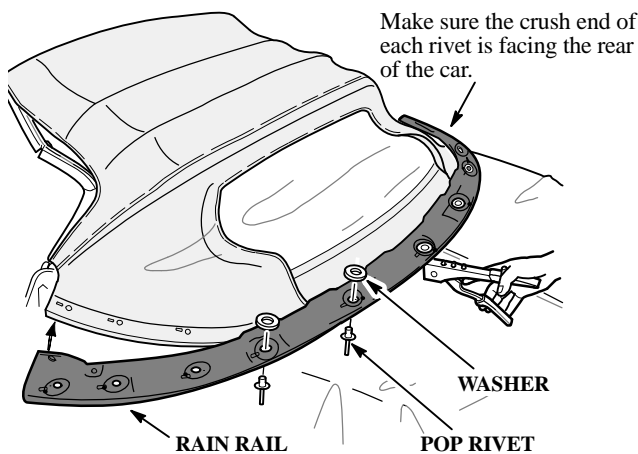
What's **not** in the kit is the mounting hardware needed to attach the roof and the rear window to the rain rail. So, you'll need to purchase these items from a local hardware store:

You **must** install the pop rivets from inside the vehicle with the washer and the crush end of the rivet facing the rear of the vehicle. If the rivet's too long, the crush end will interfere with the body where the rain rail mounts. For complete installation instructions, see S/B 00-048, *Service Manual Update: Rear Window Replacement*, filed under Body.
