**HONDA ServiceNews**

ASN 22789 (0107)

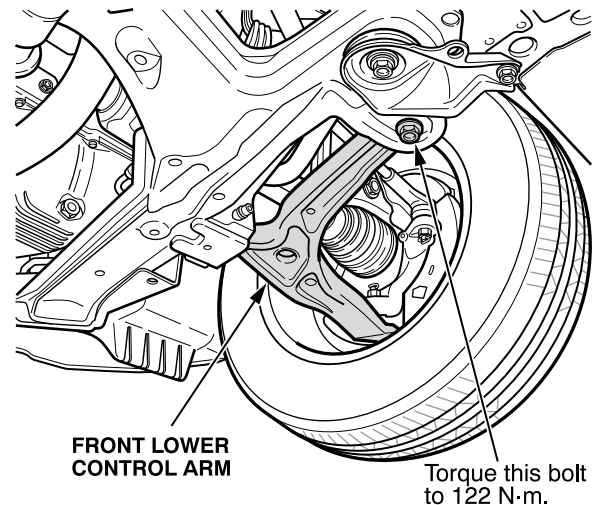
On all '99-00 Odysseys, and '01 Odysseys thru VIN 2HKRL18651H555625, insufficient clamping of the rear mounting bolt on the front suspension lower control arm can cause a clunk or thump from the front floor when you brake or accelerate briskly. Insufficient clamping happens if the thread friction is too high while the mounting bolt is tightened.

To fix the problem, loosen then torque the rear mounting bolt on each lower control arm to **122 N·m (90 lb-ft)**. Test-drive the vehicle to make sure the noise is gone. If the noise is gone, return the vehicle to your customer. If the noise is still there, hook up a ChassisEAR diagnostic tool (T/N JSP-SM06600), and continue with normal troubleshooting. For info on using the ChassisEAR, refer to S/B 00-063, *Steelman ChassisEAR Diagnostic Tool*, filed under Tools.

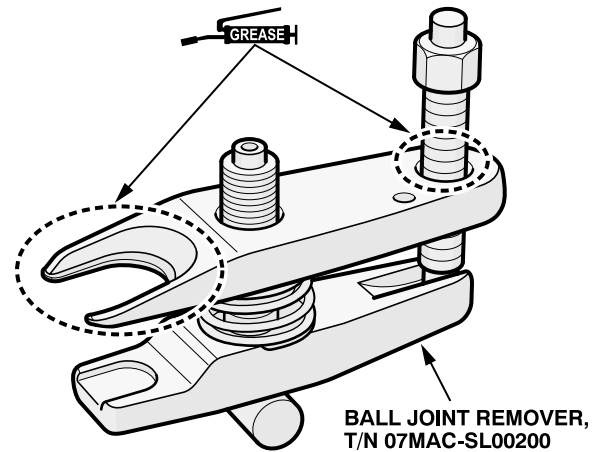
On '01 Civics, if you're doing a repair that calls for separating lower control arm ball joints, follow these tips for best results:

- Make sure you use the 28 mm ball joint remover, T/N 07MAC-SL00200.

- Apply molybdenum grease to the tool on the areas shown before each use.
- Apply pressure to the ball joint by tightening the tool with the pressure bolt.
- If the ball joint *won't* pop loose from the control arm, *don't* try to release it by hitting the tool, the knuckle, or the control arm with a hammer or other object; you could damage the tool or the components and require their replacement. Just keep tightening the tool with the pressure bolt until the ball joint releases.

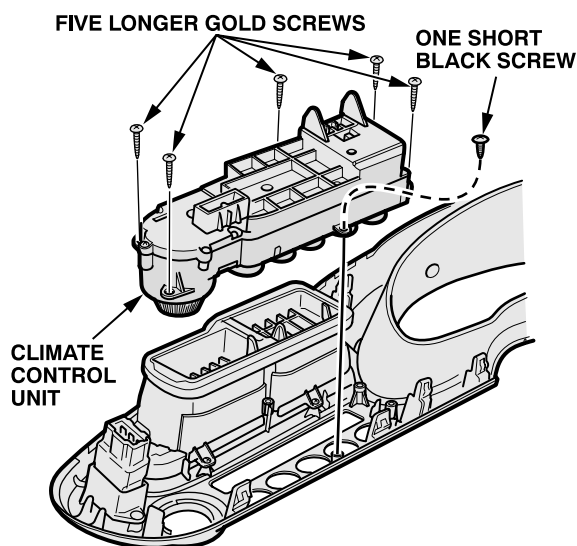
Here's a tip that came to us from **Terry Banta** of Honda of Tempe, Tempe, AZ. On '00-01 Insights, when you're installing an A/C system or working on the climate control unit, refer to the illustration on page 21-80 of the '00 Insight Service Manual before you reinstall the unit to the instrument panel. The illustration shows you the location of the short, black self-tapping screw. If you install one of the longer, gold self-tapping screws in the hole for the short screw, the point of the screw will dimple the instrument panel outward and require replacement of the panel. Thanks, Terry, for this valuable tip.
