## PGM Tester Software SN211: Capabilities and Limitations

**HONDA ServiceNews**

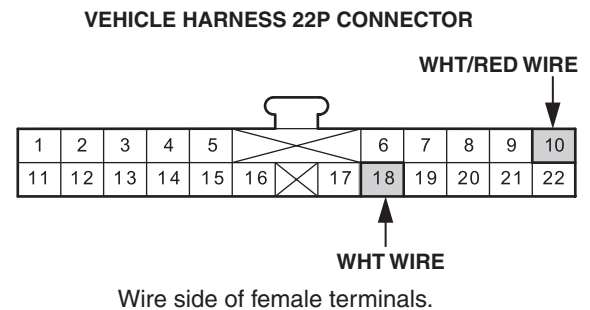
If you've used AII 23086, *Security System*, to install the accessory security system in an '02 CR-V, you might have noticed the illustration in step 16 for the vehicle harness 22P connector is a little tough to follow. The actual connector has more cavities than what's shown in the illustration, so it's hard to tell just where to insert the WHT and WHT/RED wires. Here's a connector diagram that will make it clear:

The WHT/RED wire goes to the security unit, and it is hot at all times. The WHT wire goes to the security system LED. If these wires are inserted in the wrong cavities, the LED or possibly the entire security system may not work.

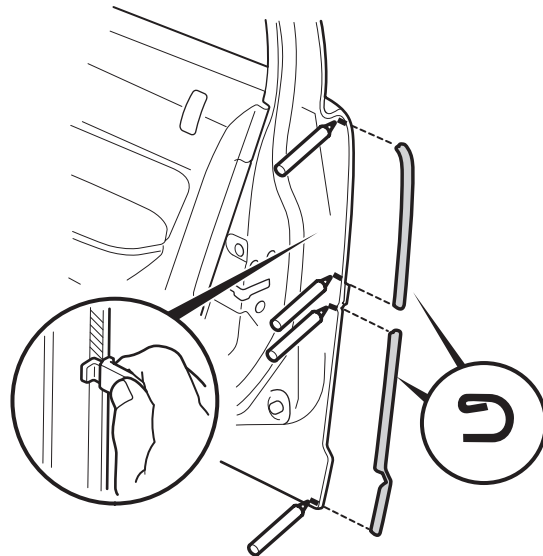
When installing accessory door edge guards on a '01–02 Civic, make sure you follow step 4 of the appropriate installation instruction *to the letter*. Trim the sealer from the door with the hem sealant cutting tool. If you *don't* trim the sealer, the door edge guard *doesn't* fully seat when you install it. Over time, it could detach itself from the door and fall off.
