PGM Tester Software SN211: Some More Things to Know

**HONDA ServiceNews**

ASN 23767 (0204)

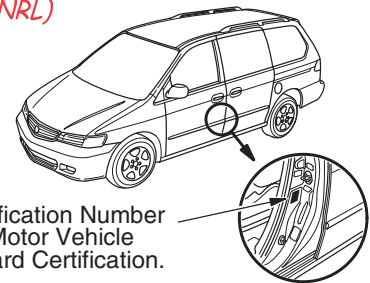
Now that Odysseys are being produced in Alabama, the VIN decoder info on page 1-5 of the 1999–02 Odyssey Service Manual needs updating. Mark up your copies of the S/M to look like this:

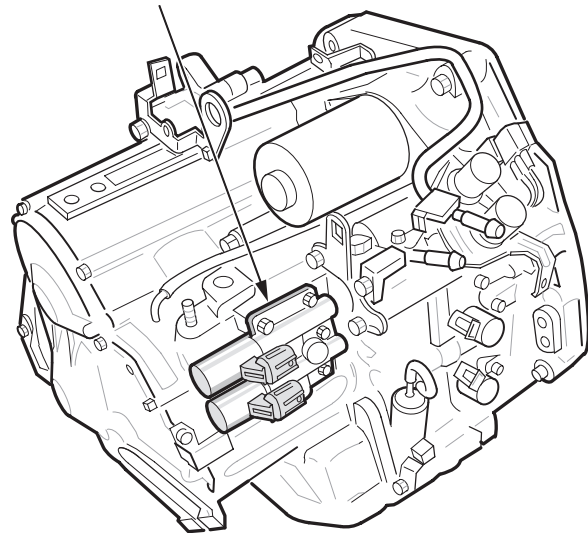
A/T CLUTCH PRESSURE CONTROL SOLENOID A/B ASSEMBLY

If your customer complains of slippage, flare, or hard upshifting, the problem may be a faulty A/T clutch pressure control solenoid A/B assembly. These solenoids control fluid pressure to the clutches for smooth shifting.

To fix this problem, first make sure the ATF is clean and at the proper level. Refill with Honda ATF-Z1 as needed. Then install a known-good solenoid assembly, and test-drive the vehicle. If shifting gets better, order a new solenoid assembly. If there's no improvement, continue with normal troubleshooting.
