## DTC P1381: '98-01 Accord L4, '96-00 Civic

**HONDA ServiceNews**

ASN 22397 (0101)

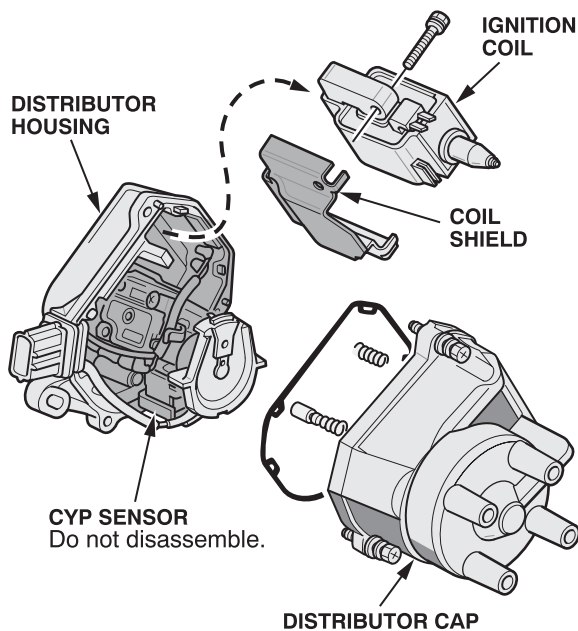
On '98-01 Accord L4s, and '96-00 Civics, a DTC P1381, cylinder position (CYP) sensor intermittent interruption, can set if the coil shield is missing or incorrectly installed, or if the ignition coil is faulty. To diagnose this problem, remove the distributor cap, and make sure the coil shield is installed as shown. If the coil shield is installed properly, continue with normal troubleshooting.

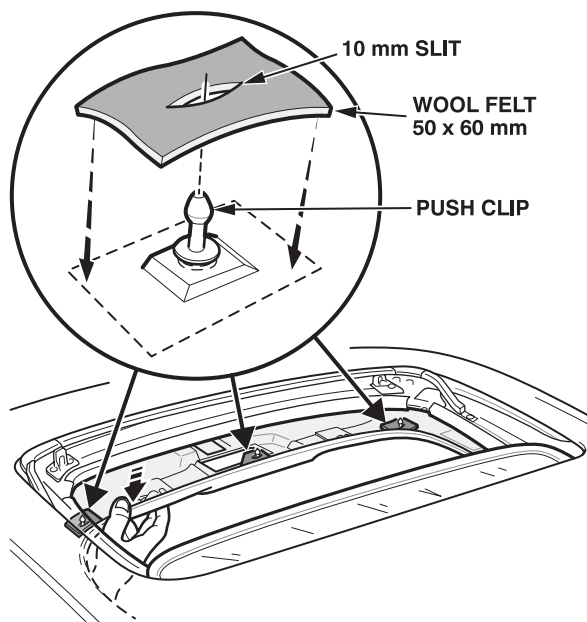
On '01 Ohio-built Civic EXs, loose front push clips can allow the headliner to hit against the frame while driving, causing a rattling noise. To fix this problem, apply wool felt to the middle push clip and to the push clip on the side where the noise is. Here's how:

1. Remove both A-pillar trim pieces (see page 20-56 of the 2001 Civic Service Manual).
2. Remove both sunvisors and holders (see page 20-59).
3. Remove the rearview mirror (see page 20-28).
4. Remove the ceiling light (see page 22-95).
5. Remove the passenger's grab handle (see page 20-59).
6. Open the moonroof all the way.
7. Release the three front headliner clips by applying slow downward pressure along the front edge of the moonroof opening in the headliner.
8. Cut a 50 x 60 mm piece of wool felt (P/N 06993-SA5-000, H/C 2086676), then cut a 10 mm slit in the center. Install the wool felt over the middle push clip. Do the same for the push clip on the affected side.
