**HONDA ServiceNews**

ASN 21860 (0007)

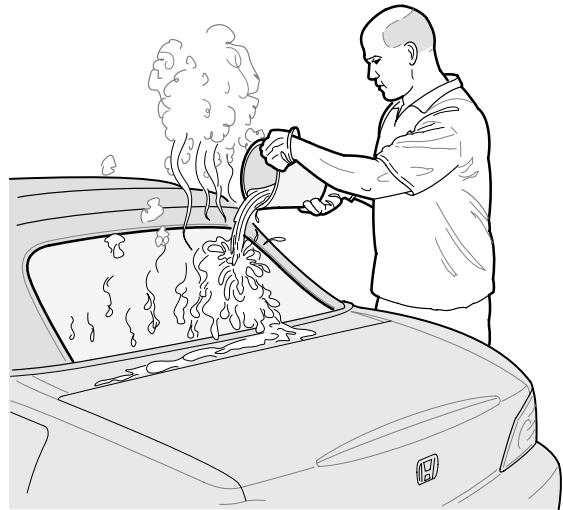
On '00 S2000s, creases or wrinkles in the vinyl rear window can distort rearward vision. To minimize them, follow these steps:

1. Heat about 2 quarts of water to 170°F (77°C).
2. Slowly pour the hot water over the rear window, in a side-to-side motion. The hot water softens the vinyl, flattening out the creases and wrinkles.

NOTE: Make sure you wear shoes that can withstand high temperatures; the hot water will run out of the body drains near your feet.

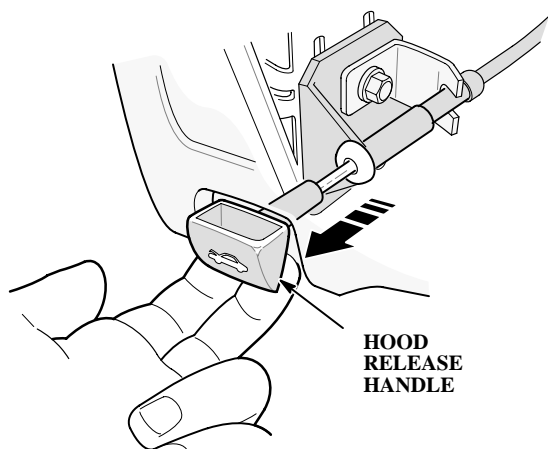
On '00 Insights, the hood release handle, bracket, and hood opener cable are one part. The handle is attached to a square metal rod that passes through the bracket and attaches to the cable. If you try to open the hood by pulling up on the hood release handle, you'll bend the rod, causing it to stick as it passes through the bracket. The hood opener cable will *not* return when released. To avoid this, make sure you always pull the hood release handle *straight out*, and advise your customers to do the same.

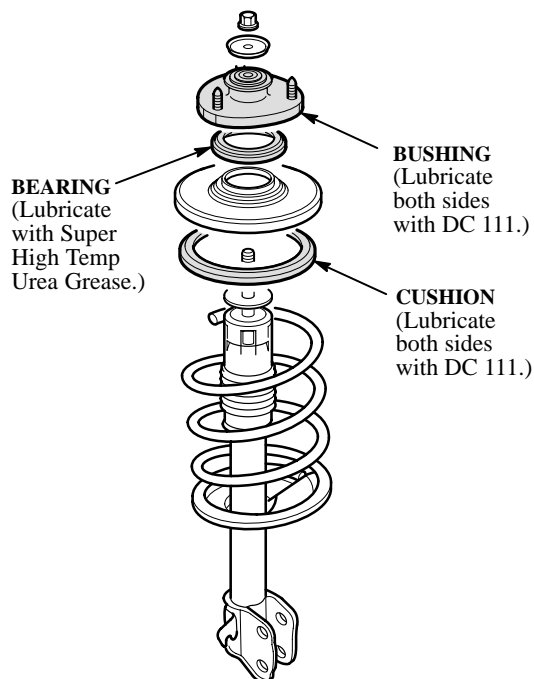
On '99-00 Odysseys, dry bushings and bearings in the front damper can cause a grunt or groan when you turn the steering wheel slowly.

1. Remove the affected front damper, then remove the spring. Refer to the Suspension section of the 1999-00 Odyssey Service Manual for details.

2. Lubricate both sides of the bushing and the cushion with DC 111 Silicone Paste (available from Dow Corning; call them at 800-248-2481 for the distributor nearest you).
3. Lubricate both sides of the bearing with Super High Temp Urea Grease (P/N 08798-9002, H/C 3720984).
4. Reassemble and reinstall the damper.
