Are You Using 5W-30 Engine Oil?

**HONDA ServiceNews**

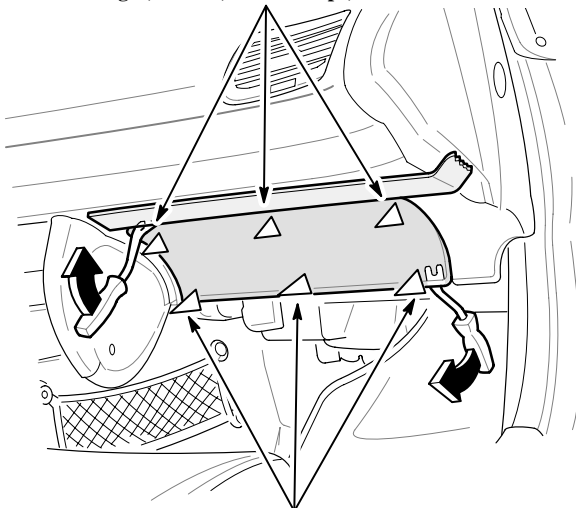
On the '00 S2000, it's hard to remove the passenger's dashboard lower cover without damaging it or the dashboard. But if you follow this procedure, you shouldn't have too much trouble. You'll need a trim pad remover and duct tape.

1. Sand or file off any burrs that may be on the end of the trim pad remover.
2. Stick some duct tape across the dash above the upper edge of the cover opening.
3. Remove the cover:

- ② Insert the remover forward, and pry out the right, middle, and left clips, in that order.

- ① Insert the remover backward, and pry out the right, middle, and left clips, in that order.
