HONDA ServiceNews

ASN 21673 (0004)

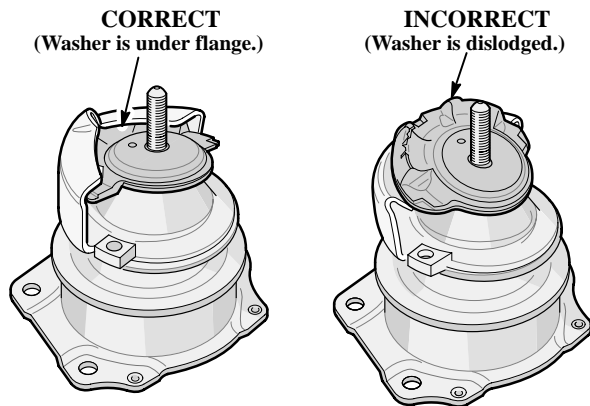
Idle Vibration or Grinding Noise: Accord L4 w/A/T

On '98–00 Accord L4s with A/T, symptoms like idle vibration, grinding during acceleration, or wheel-bearing-type noises may be caused by the rear engine mount. To spot a failed mount, check the rubber-coated washer on top of it. The washer should be *under* the flange around the mount's upper edge. If the washer is dislodged, replace the mount.

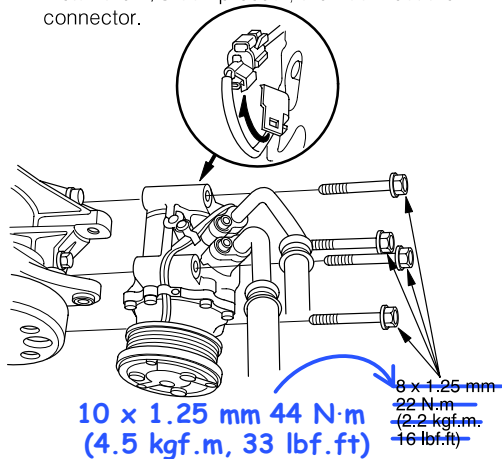
S/M Fix: A/C Compressor Mounting Bolt Torque

On page 13-71 of the '00 S2000 S/M, the size and torque spec for the A/C compressor mounting bolts is wrong. Correct the page like this:

27. Install the A/C compressor, then connect the 1P connector.

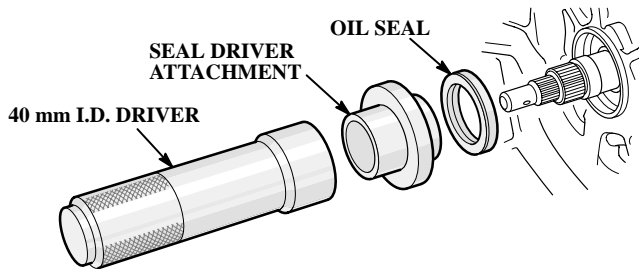
An ATF leak that usually shows up between 8,000 and 15,000 miles may be caused by the wrong torque converter oil seal (see the 11/99 S/N for more seal info).

If you find that the wrong seal was installed (the small arrow on its face should point clockwise on V6 models and counterclockwise on L4s), you can replace it without disassembling the trans. Just refer to S/B 00-022, *Torque Converter Oil Seal Installation Tool*, filed under Tools, and install the correct seal with the new seal driver attachment and your 40 mm I.D. driver.

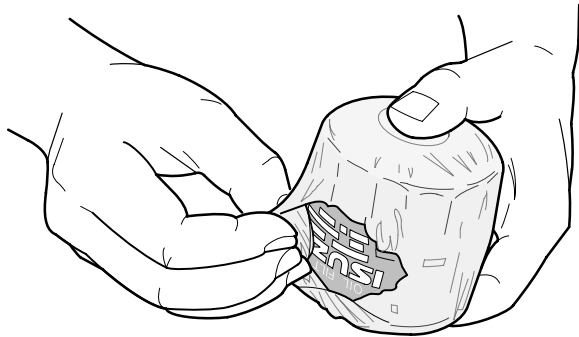
When you grab an oil filter and remove it from its box, be careful how you unwrap the plastic from it. If you do what comes naturally, that is, poke a hole in the plastic through the center of the filter, a small piece of the plastic may fall into the filter. Then when you install the filter, the plastic could be pumped through the engine and clog an oil passage, causing oil starvation and possible internal damage.

To prevent this problem, hold the filter with its gasket end down, and tear off the plastic from the side.

Tear off plastic from the side.

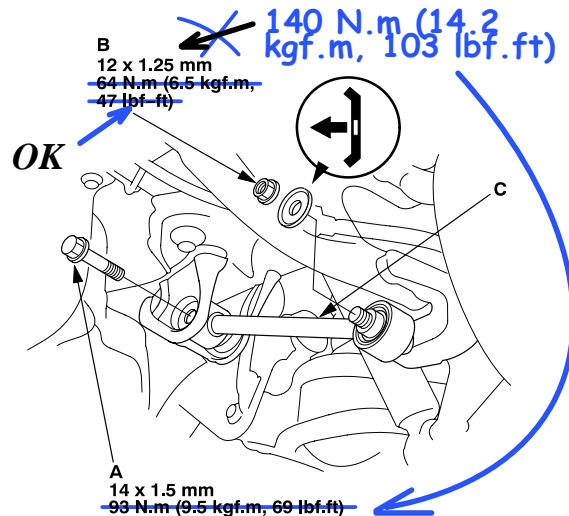
'99–00 Odyssey S/M, page 18-25:

In the February '00 S/N, the torque correction we gave you for the Odyssey lower arm A was wrong. It should have been for the mounting bolt, not the nut. Here's how the corrected correction should look:
