## Lower Condenser Pipe O-Ring Leakage: '03 Accord

**HONDA ServiceNews**

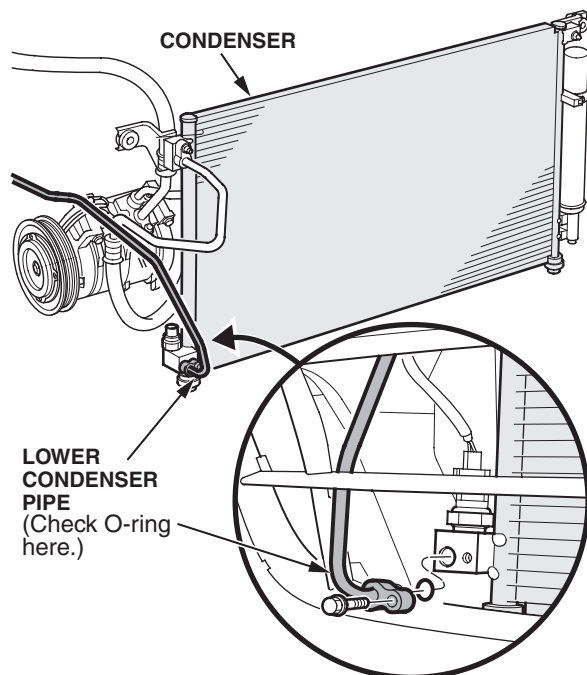
If you're looking for a refrigerant leak on a '03 Accord, first check for a faulty 8 mm O-ring on the lower condenser pipe before you start checking the entire A/C system. If the O-ring is faulty, replace it with P/N 80873-ST7-000, H/C 4256129.

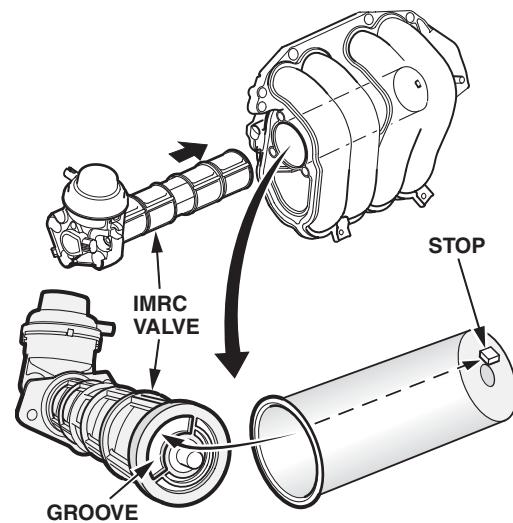
## Install IMRC Valve Correctly: '02 CR-V

If you've got a '02 CR-V with DTC P1077 [intake manifold runner control (IMRC) system malfunction (low rpm)] set, there's a good chance the IMRC valve (IMRC actuator assembly) wasn't installed correctly during a repair. For a correct installation, make sure the stop in the intake manifold fits into the groove on the end of the actuator assembly.

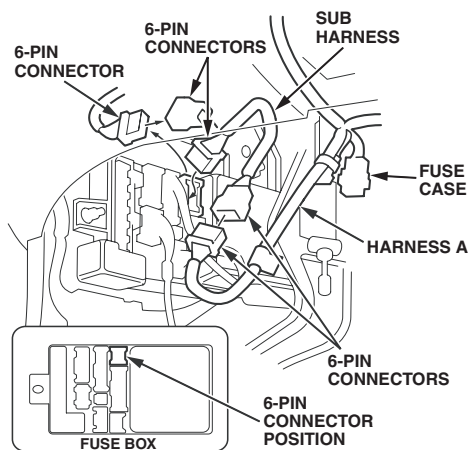
35. *With heated seats:* Plug the 6-pin connector of harness A into the 6-pin connector of the driver's side fuse box. Attach the 2A fuse label to the fuse case.
  - When the 6-pin connector of another harness is already connected fuse box, disconnect the 6-pin connector from the fuse box and install sub harness P/N 08V31-S0X-100A between as shown.
