HONDA ServiceNews

ASN 22447-40074 (0808)

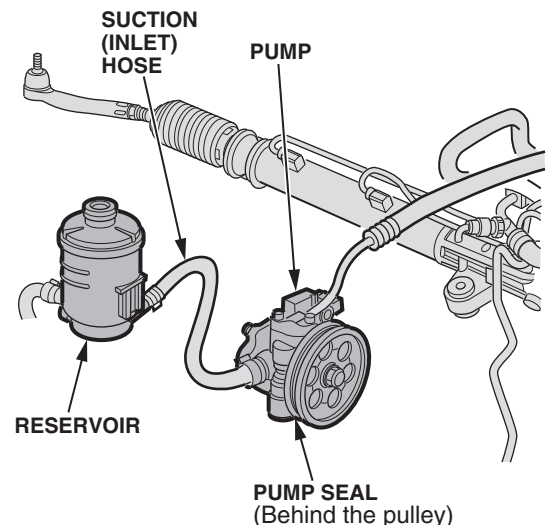
On all Hondas with power steering, a pin hole leak between the reservoir and the suction (inlet) side of the pump can cause the power steering fluid in the reservoir to foam and overflow. When air is sucked into the system, it mixes with the fluid and causes it to foam. This foaming can also cause the pump to growl. Pin hole leaks are hard to diagnose because they let air in but they don't leak fluid out. So, if you suspect a pin hole leak, try this:

1. Start the engine, and let it warm up to operating temperature.
2. Adapt a hand pump to fit into the reservoir opening. (If you're using a Mighty-Vac pump, it comes with adapters to do this.)
3. With the engine idling, connect the hand pump to the reservoir, and pressurize the reservoir to a maximum of 8 psi.
4. Look for a leak in the suction (inlet) hose or at the pump seal. Repair the power steering system as needed.

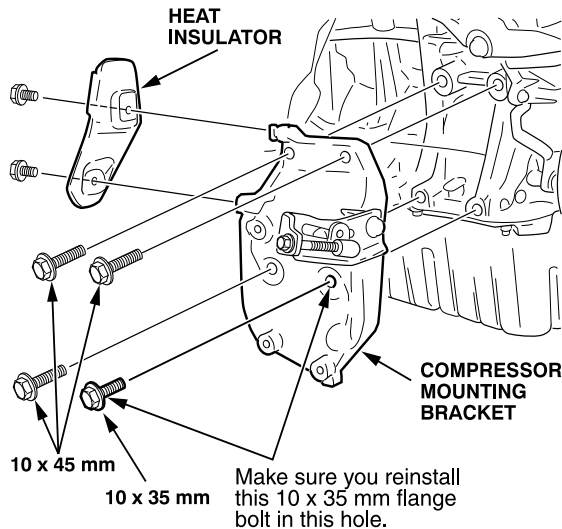
In step 17 of the '01 Civic A/C installation instruction (AII 21888-22262), you must remove the A/C compressor bracket to install the heat insulator. Three of the A/C compressor bolts are 10 x 45 mm and one is 10 x 35 mm. When you reinstall the compressor bracket, make sure you reinstall the 10 x 35 mm bolt in the *lower right* bolt hole in the bracket. If you install one of the longer 10 x 45 mm bolts in that hole, the bolt head will damage the compressor.

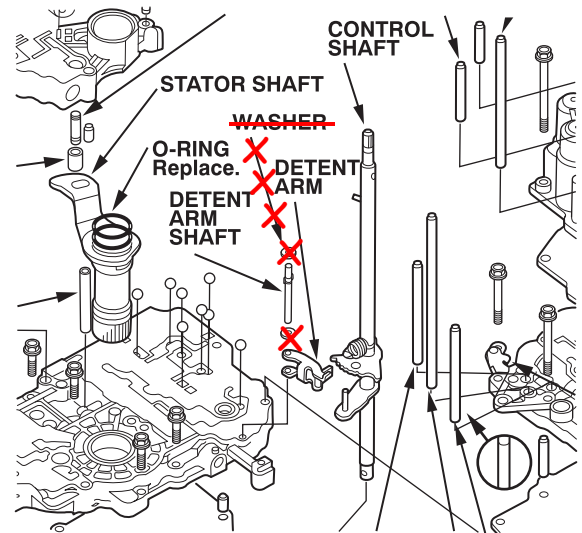
Pages 14-144 and 14-174: Change the Exploded Views to look like this:

The Automatic Transmission section of the '01 Civic S/M calls out washers for the detent arm shaft. There are *no* washers used for the detent arm shaft in '01 Civics. Make these changes in your copies of the S/M:

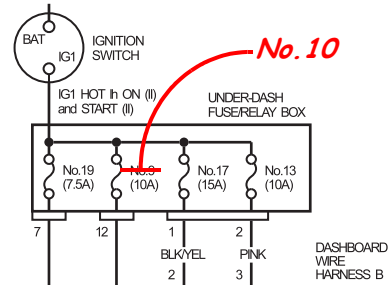
Page 23-32: Change the circuit diagram to look like this:

The Restraints section of the '01 Civic S/M has the wrong fuse number called out in the driver's under-dash fuse/relay box. The No. 19 (7.5 A) fuse should be No. 10 (7.5 A). Make sure you include these changes in your copies of the S/M:
