**HONDA ServiceNews**

ASN 24266 (0209)

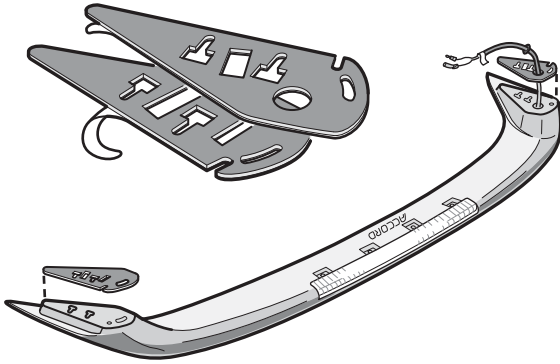
Did you know that if the black spoiler pads are poking out of the base of the trunk spoiler on a '98–02 Accord 4-door, you can replace just the pads without having to replace the entire spoiler? Honda parts stock has a base packing kit that contains two adhesive-backed black spoiler pads. Order P/N 08F13-S84-100R, H/C 5810999.

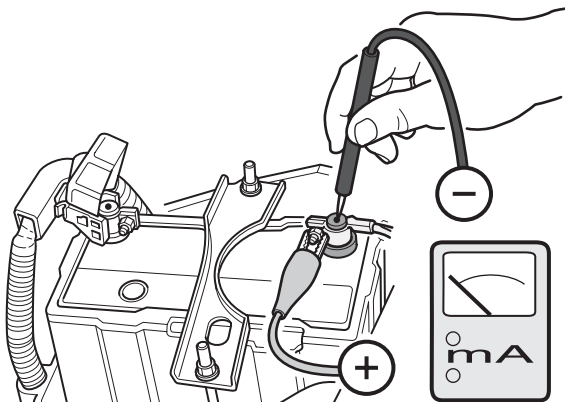
1. Make sure all switches are turned off, then remove the ignition key. Wait at least **5 minutes** for all current reduction timers to turn off (sleep mode).
2. Loosen (but don't remove) the negative battery cable.
3. Set your ammeter to the **10A** scale if it doesn't have an auto-range capability.
4. Use an alligator clip to connect your ammeter's positive lead to the negative battery terminal.

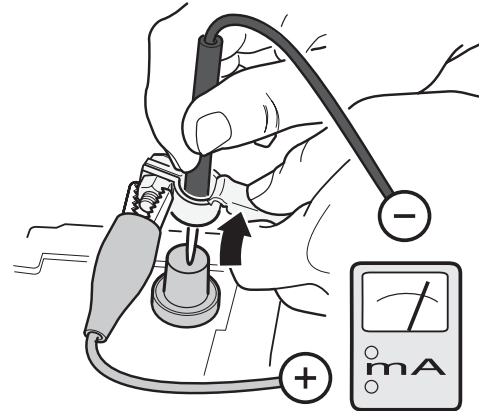
6. Slide the negative battery terminal over your ammeter's negative lead, and read the current draw. If your ammeter's range is too high to accurately read milliamps, lower the range so you can.

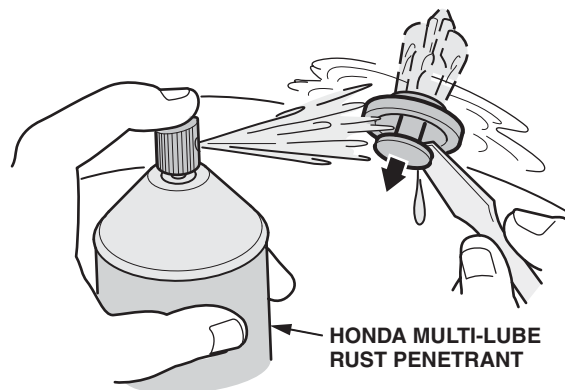
On '98-02 Accords, '96-02 Civics, '99-03 Odysseys, and '03 Pilots, plastic body clips covered with dirt or road grime are a real bear to remove and can break easily because of it. Before you try removing body clips for the bumper and other underbody components, spray a shot of Honda Multi-Lube Rust Penetrant (P/N 08732-0003, H/C 2962629) onto the top of the clip. The spray lubricates the plastic so the clip pops out more easily with less chance of breaking.
