**HONDA ServiceNews**

ASN 21521 (0003)

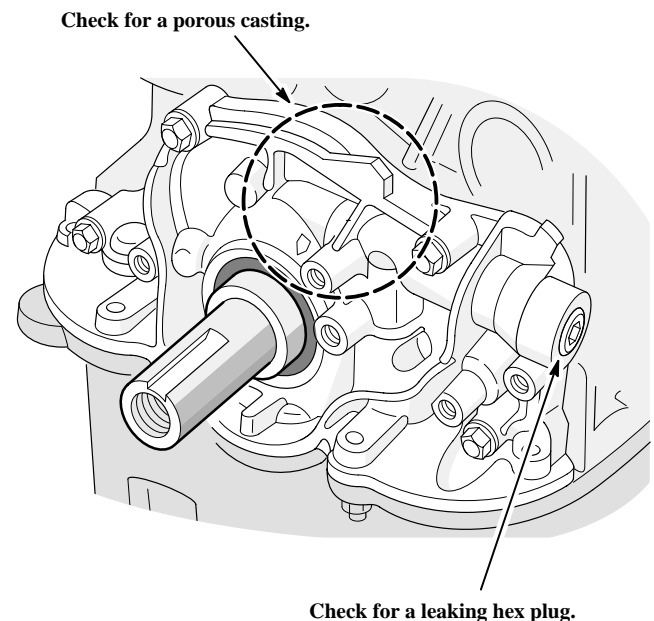
Engine Oil Leak: '96-99 Civic

A '96-99 Civic with oil coming from behind the lower timing belt cover may be leaking from the oil pump housing (porous casting) or from the hex plug on the pump.

- If the leak is from the hex plug, remove the plug, clean its threads with brake cleaner, apply Hondabond HT Silicone Liquid Gasket to the threads (P/N 08718-0001, H/C 2963817), and torque the plug to 39 N·m (28 lb-ft).
- If the leak is from the oil pump housing, replace the pump.

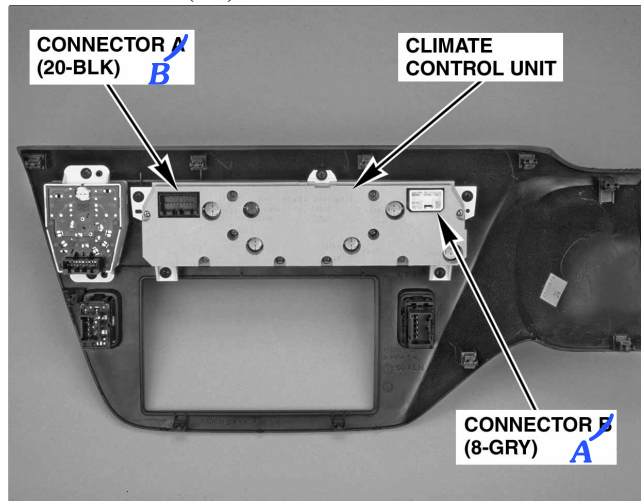
62. Center Panel (EX)

ETM Fix: Climate Control Connectors Reversed

On page 201-10 of the '99-00 Odyssey ETM, photo 62 has the connector names for the climate control unit reversed. (The gray, 8P should be connector A, and the black, 20P should be connector B.) Here's how to mark up your manual.

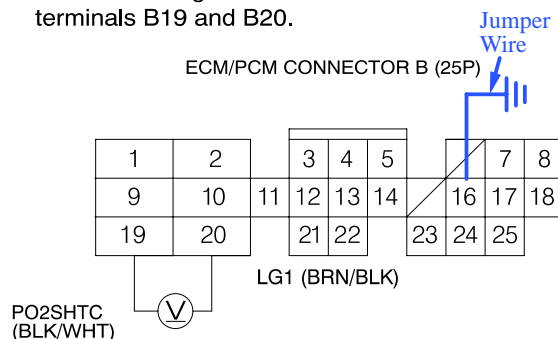
S/M Fix: DTC P1166: '98-00 Accord

On page 11-73 of the '98-00 Accord S/M, troubleshooting for DTC P1166 (Electrical Problem in Primary HO2S [Sensor 1] Heater Circuit) needs info added to the text and illustration in step 8. Here's what to add:

Connect ECM/PCM connector terminal B16 to body ground with a jumper wire, then

8. Measure voltage between ECM/PCM connector terminals B19 and B20.

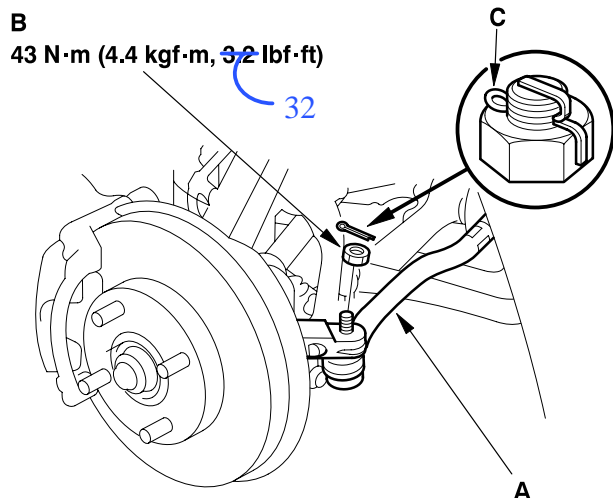
S/M Fix: Accord Tie Rod Nut Torque

On page 17-49 of the '98–00 Accord S/M, step 14 of steering gearbox installation lists an incorrect torque for the tie rod nut. The torque should be 43 N·m (4.4 kgf·m, 32 lbf·ft). Mark up your S/M like this:
