## Adapters for Fuel Pressure Gauge Set

**HONDA ServiceNews**

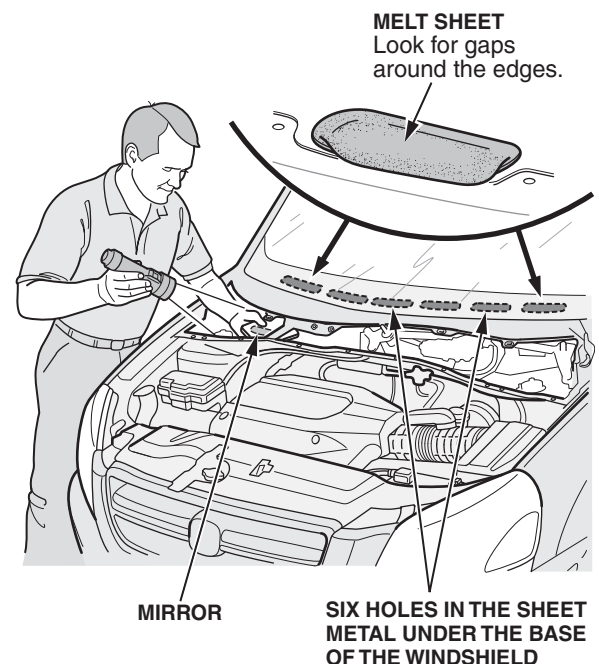
On '03 Pilots, partially sealed holes between the outside and the passenger's compartment can cause a noticeable whistling from the dashboard area or windshield while driving. This noise changes when you switch the climate control from Fresh Air to Recirculation mode.

1. Remove the cowl.
2. Use a mirror and a flashlight to look up at the bottom of the windshield support.

3. Look for gaps in the melt sheets covering the six holes in the sheet metal. Use your finger to push on the melt sheet.
4. Use windshield sealant to seal any gaps.
5. Reinstall the cowl.
6. Test-drive the vehicle to make sure the noise is gone.

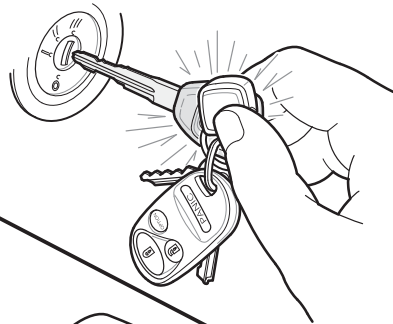
### INCORRECT:

If you're getting complaints from owners of immobilizer-equipped vehicles that the engine doesn't crank (Preludes only) or it cranks but doesn't start, find out the key ring setup (number of keys, key ring size, key fob material) before you plow ahead with extensive diagnostics. Too much metal near the transponder in the ignition key, coupled with a quick turn of the ignition switch, can interfere with the transponder's code signal and prevent the engine from starting.

Holding metal near the key.

You can check if this is the problem by starting the engine with only the ignition key (that's no key ring, no other keys, and no key fob). If the engine fires up, advise your customer to keep the ignition key on a separate key ring and—if a favorite fob has got to dangle from it—to make sure the fob is made from either plastic or leather.

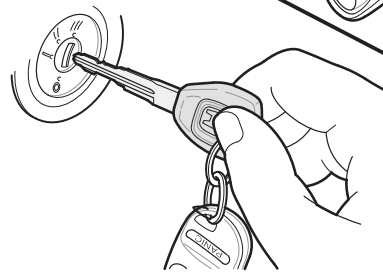
### CORRECT:

No metal near the key.

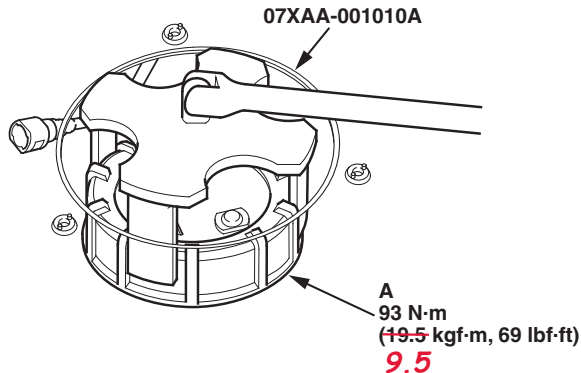
The illustration for step 7 on page 11-229 of the 2003 Accord S/M shows the wrong torque spec for the fuel pump/sender assembly locknut (A). Mark up your copies of the S/M to look like this:

7. Using the special tool, loosen the fuel pump/sender assembly locknut (A).

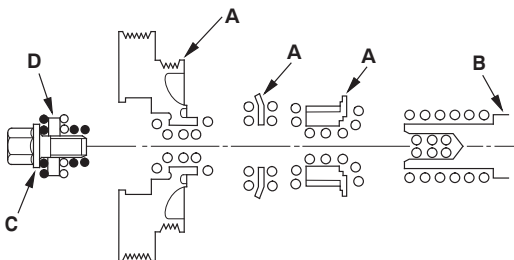
The legend for the step 1 illustration on page 6-12 of the 2003 Accord V6 Supplement S/M is wrong. Mark up your copies of the S/M to look like this:

1. Remove any oil from the pulleys (A), crankshaft (B), bolt (C), and washer (D). Clean and lubricate the points shown below.

- ~~×~~ : Clean  
● ~~×~~ : Lubricate
