ASN 25117 (0304)

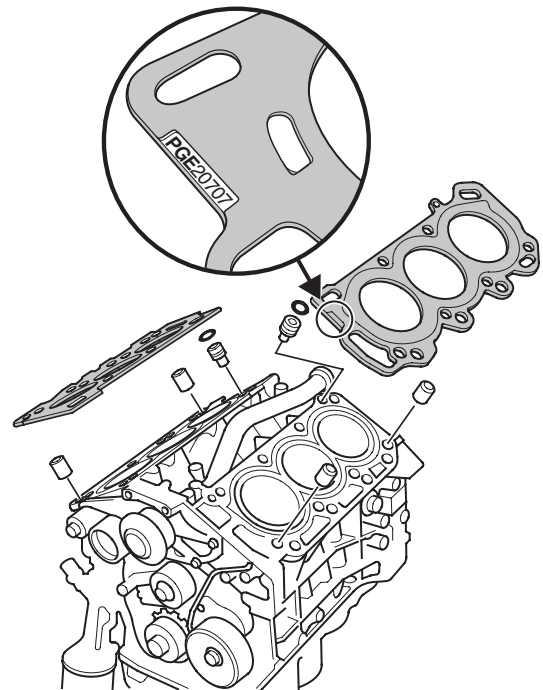
Don't let this happen to you! You've just replaced the cylinder heads on a '99-03 Odyssey or '03 Pilot and you hear a ticking noise when you start up the engine. You may have inadvertently installed the wrong cylinder head gaskets! Some cylinder head gasket kits incorrectly got an 86 mm-diameter-bore gasket instead of the correct 89 mm-diameter-bore gasket.

The ticking noise is actually the pistons hitting the head gasket as they cross top dead center (TDC). Double-check the replacement cylinder head gasket before you install it. If it's got a **P8C** stamped on it (P/N 12251-P8C-A01, H/C 6485775), it's the wrong gasket. If it's got a **PGE** stamped on it (P/N 12251-PGE-A01, H/C 6321491), it's the right one.

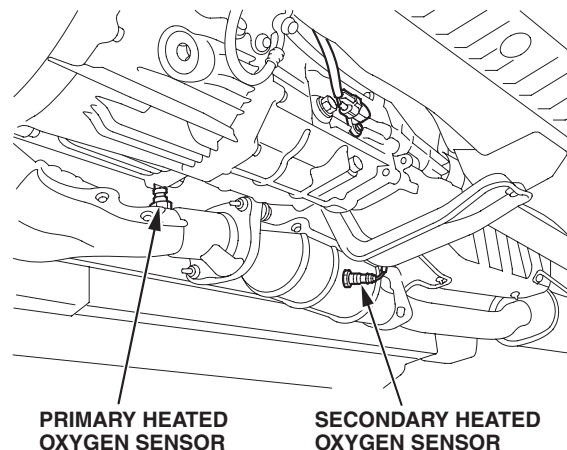
If you've just replaced the trans on a '00-03 S2000, and the MIL comes on with a DTC P0133 [primary heated oxygen sensor (primary HO2S) (sensor 1) slow response] or DTC P0420 (catalyst system efficiency below threshold) set, make sure you installed the primary and secondary heated oxygen sensors correctly. The primary sensor mounts into the exhaust pipe in front of the catalytic converter, and its 4P connector has male terminals. The secondary sensor mounts right into the catalytic converter. It's very easy to get these two sensors mixed up after working on the trans, the clutch, or the exhaust system.
