# DCM Firmware Update (LG)

The information contained in this bulletin supersedes Service Bulletin No. T-SB-0027-24.

## DCM Firmware Update (LG)

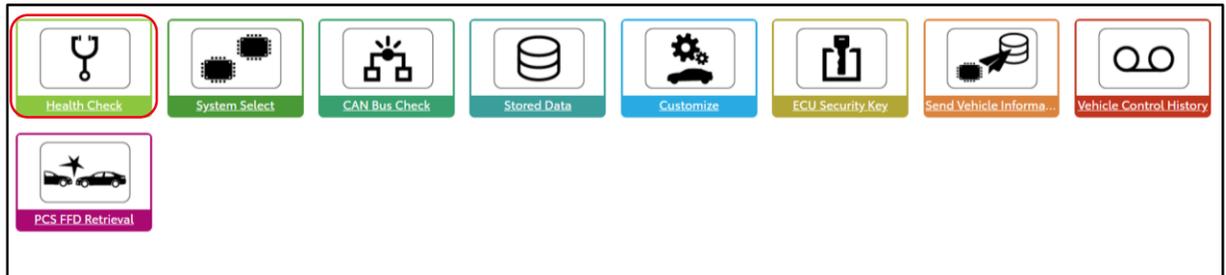
**Figure 1.**

2. Using GTS+, perform a Health Check and clear ALL DTCs.

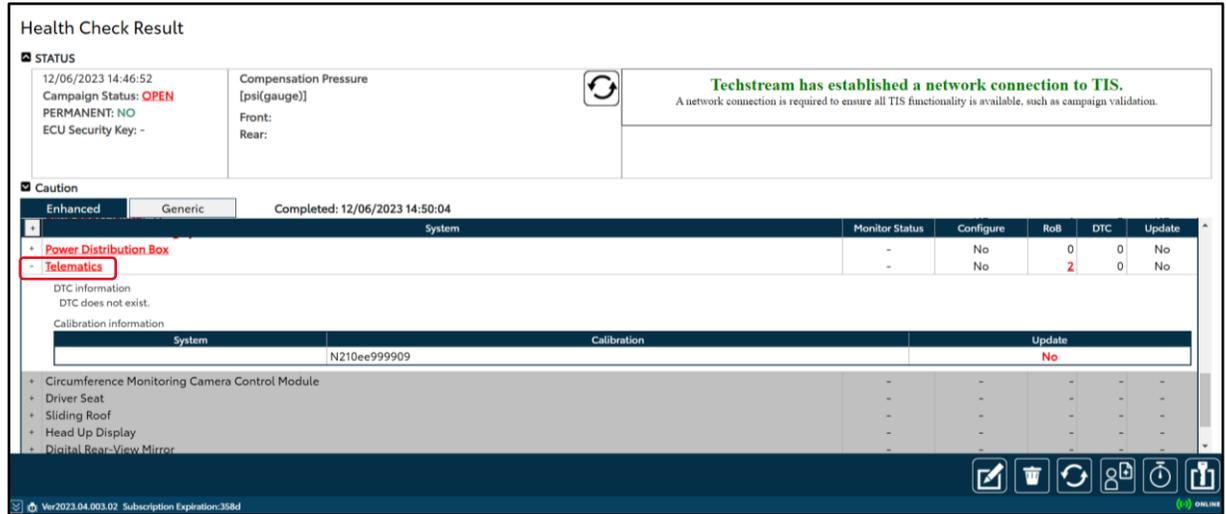
**Figure 2.**

- Verify the current firmware version by expanding (+) the Telematics menu.

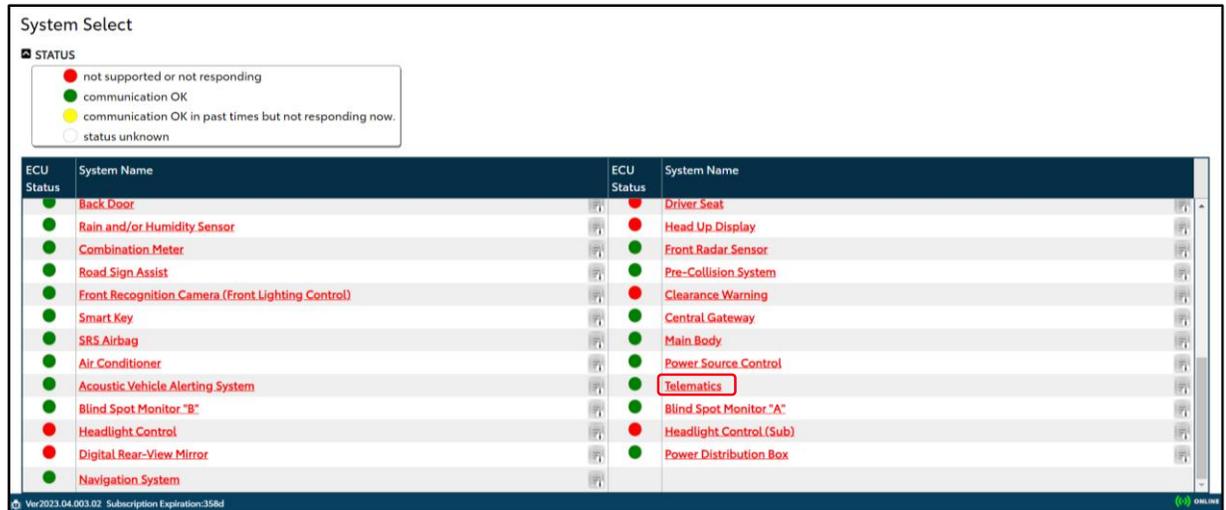
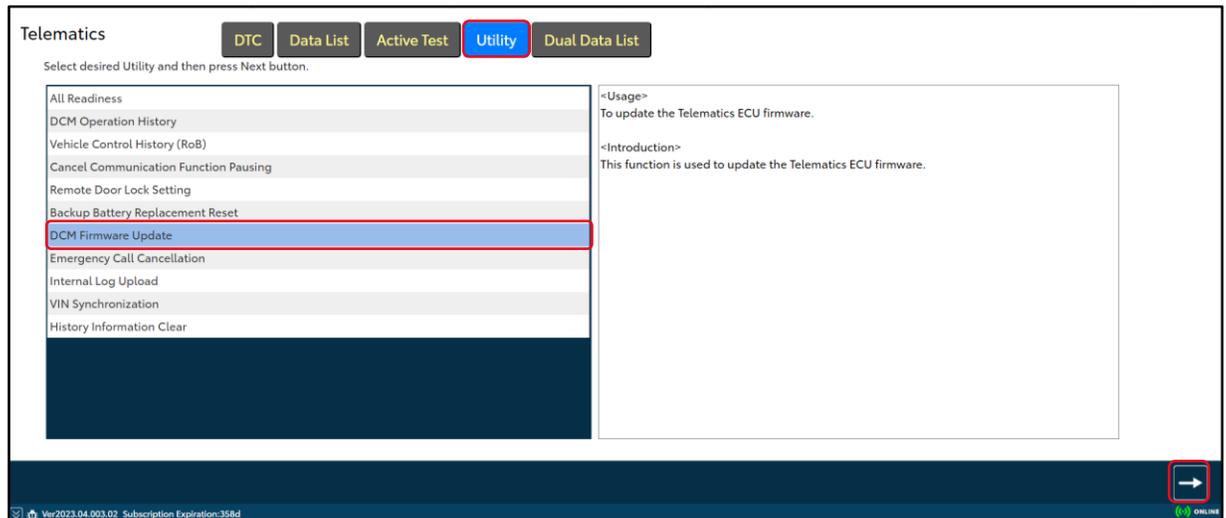
Go to *System Select – Telematics – Utility – DCM Firmware Update – Next Arrow* as shown in Figures 3 and 4.

5. Perform the DCM firmware update utility.

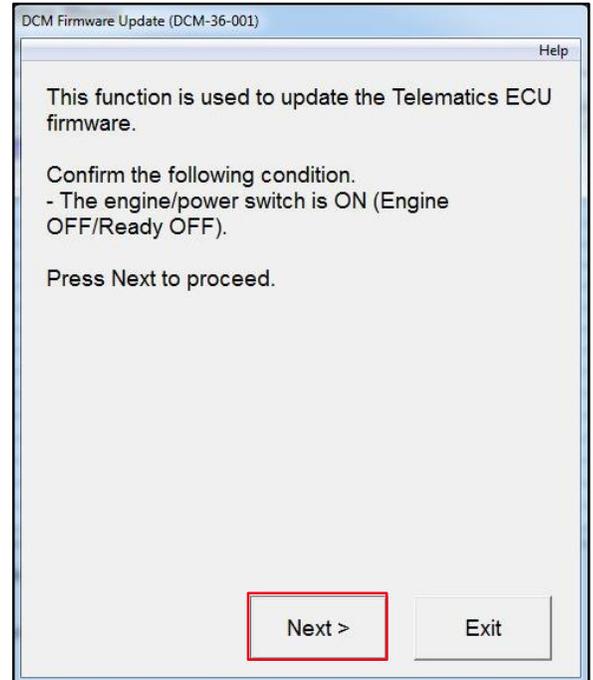
**Figure 5.**

- Click Next when the DCM Firmware Update screen appears.

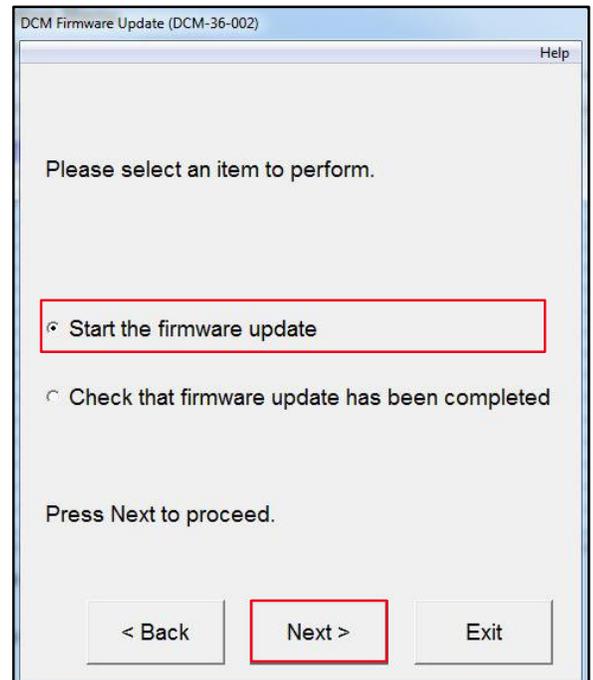
**Figure 6.**

- Select Start the firmware update and click Next when the item selection screen appears.

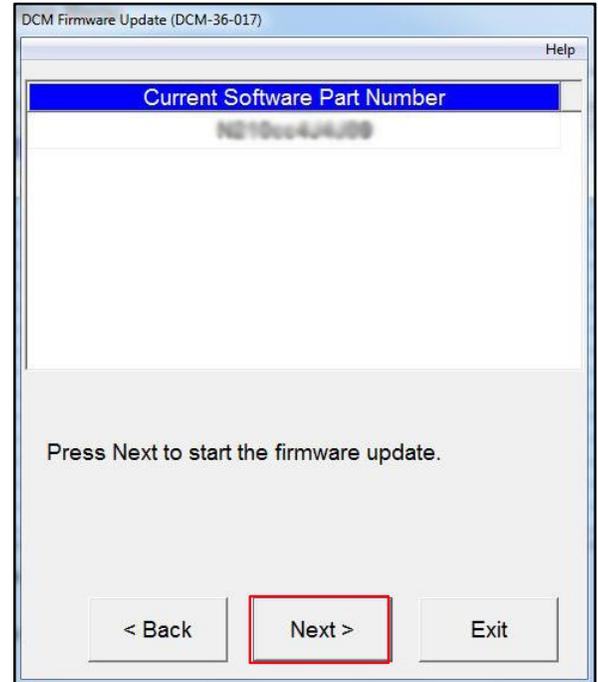
**Figure 7.**

- Click Next when the Current Firmware Part Number screen appears.

If the screen in Figure 7 does NOT appear and an error message displays, begin the Firmware Update Procedure again from step 5. A battery reset **MUST** be performed.

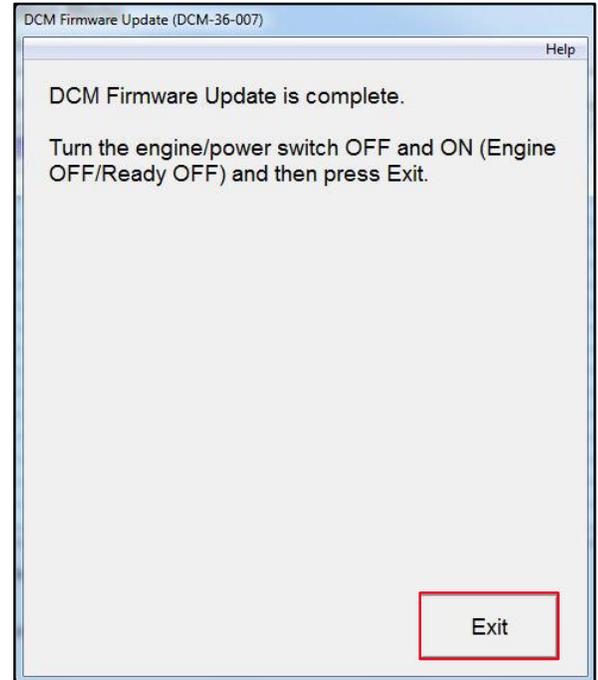
**Figure 9.**

10. The three conditions below will indicate that the firmware update process is complete:
  - The green LED will stay ON.
  - The DCM Firmware Update is complete message will appear on Techstream.
  - The service mode message will appear on the display screen.

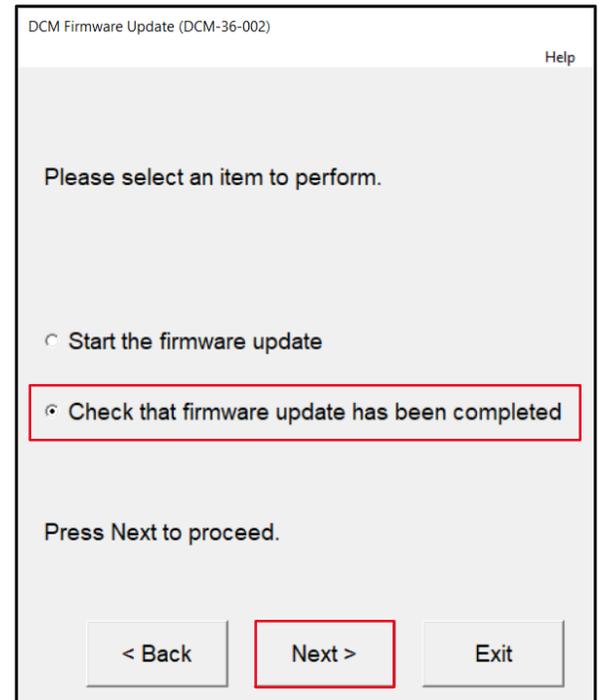
**Figure 10.**

11. Select Check that the firmware update has been completed and click Next.

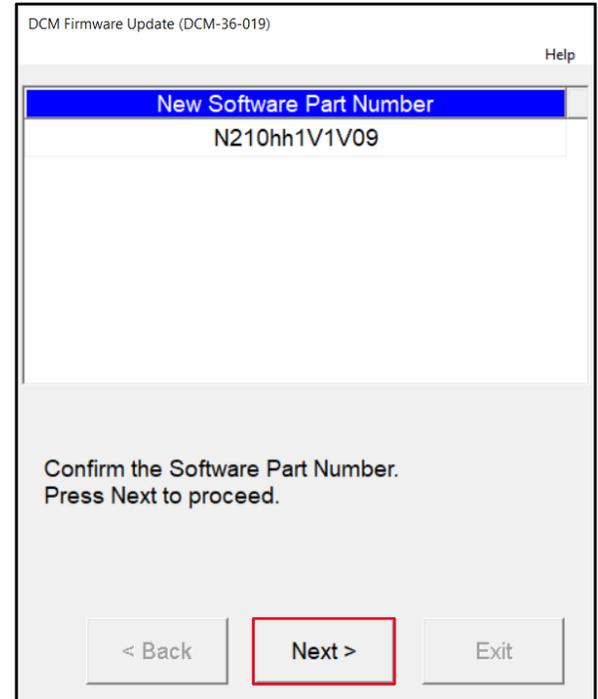
**Figure 11.**

12. Verify the New Software Part Number version matches or is newer than the current version listed in [Table 1](#).

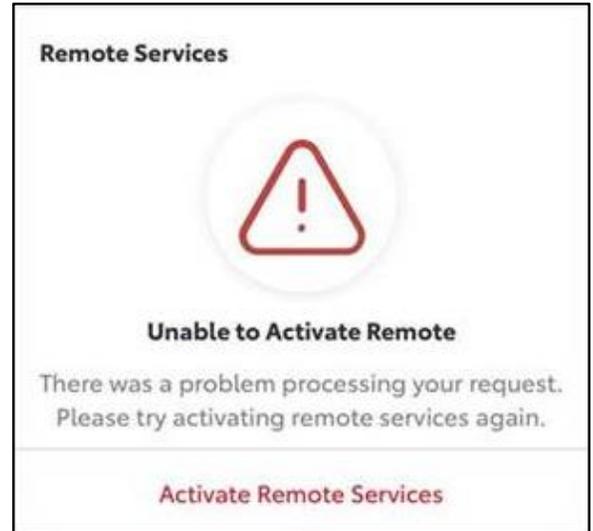
**Figure 12.**

14. If the Unable to Activate Remote message is displayed, perform steps 15 – 17 in the Toyota app.

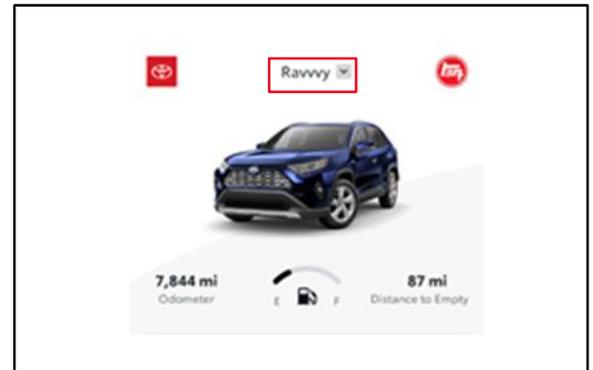
**Figure 13.**

15. Click the down arrow next to the vehicle name or nickname.

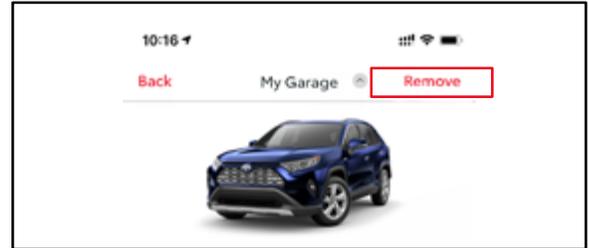
**Figure 14.**

16. Click Remove.

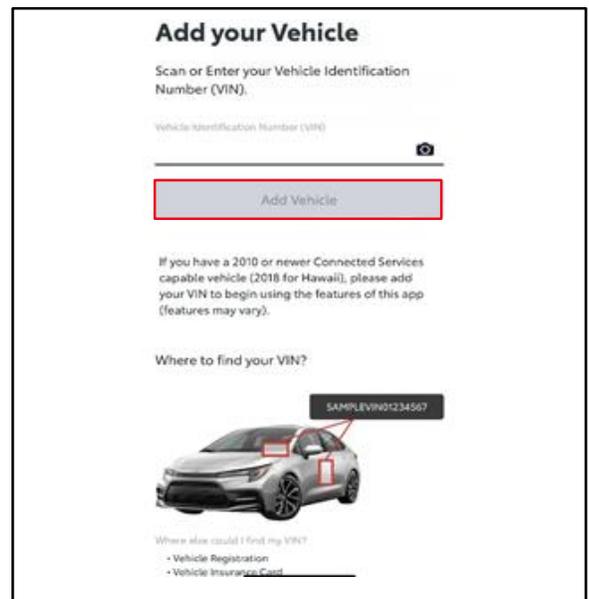
**Figure 15.**

17. Click Add Vehicle to perform the enrollment again.
