Last Modified: 12-04-2024	6.11:8.1.0	Doc ID: RM100000028X2J
Model Year Start: 2023	Model: Prius Prime	Prod Date Range: [12/2022 -]
Title: BRAKE CONTROL / DYNAMIC CONTROL SYSTEMS: ELECTRONICALLY CONTROLLED BRAKE SYSTEM: Steering Angle Sensor Wrong Installation (X0455); 2023 - 2024 MY Prius Prius Prime [12/2022 -]

Steering Angle Sensor Wrong Installation (X0455)

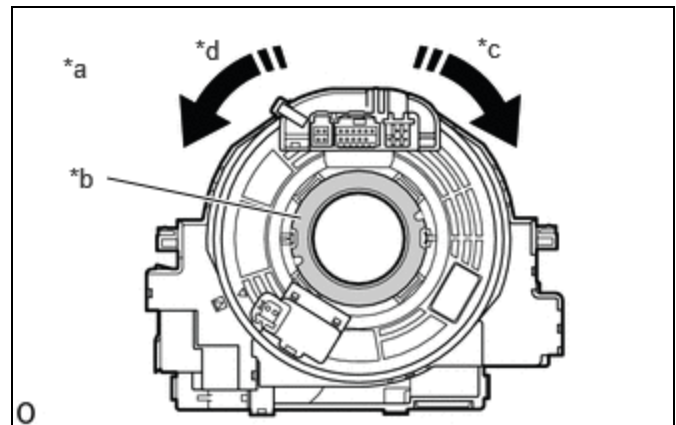
- If the value is +/- 360 deg (+/-15 deg), the steering angle sensor was incorrectly installed by 1 rotation.
- If the value is +/- 720 deg (+/-15 deg), the steering angle sensor was incorrectly installed by 2 rotations.
- In situations other than the above, the steering angle sensor may have been incorrectly installed by 3 or more rotations.

In this case, it is possible that the proper installation or removal procedures were not followed, and the steering angle sensor may have been damaged.

*a	The shape may vary depending on the vehicle model
*b	Interlock
*c	Clockwise
*d	Counterclockwise

(b) Based on the internal steering angle value that was saved to the GTS memory earlier, rotate the spiral cable with sensor sub-assembly.

- Rotate the steering angle sensor without disconnecting it from the spiral cable.
- Make sure to follow the adjustment method shown in the table.
- Failure to observe the following precautions may result in damage to the spiral cable with sensor sub-assembly.

- When rotating the spiral cable with sensor sub-assembly, make sure to push on the interlock to release the interlock.
- Do not turn the spiral cable with sensor sub-assembly using the airbag wire harness.
- Do not forcibly rotate the part.
- Make sure to perform the correct number of rotations in the correct direction.

STEERING ANGLE SIGNAL INFORMATION	CORRECTION METHOD
360 deg (+/-15 deg)	Rotate clockwise (to the right), 1 rotation.
-360 deg (+/-15 deg)	Rotate counterclockwise (to the left), 1 rotation.
720 deg (+/-15 deg)	Rotate clockwise (to the right), 2 rotations.
- 720 deg (+/-15 deg)	Rotate counterclockwise (to the left), 2 rotations.
