Last Modified: 12-04-2024	6.11:8.1.0	Doc ID: RM100000028VR3
Model Year Start: 2023	Model: Prius Prime	Prod Date Range: [12/2022 -]
Title: PARK ASSIST / MONITORING: INTUITIVE PARKING ASSIST SYSTEM: C1AE487; Ultrasonic Sensor (Front Right Corner) Missing Message; 2023 - 2024 MY Prius Prius Prime [12/2022 -]

DTC	C1AE487	Ultrasonic Sensor (Front Right Corner) Missing Message
------------	----------------	---

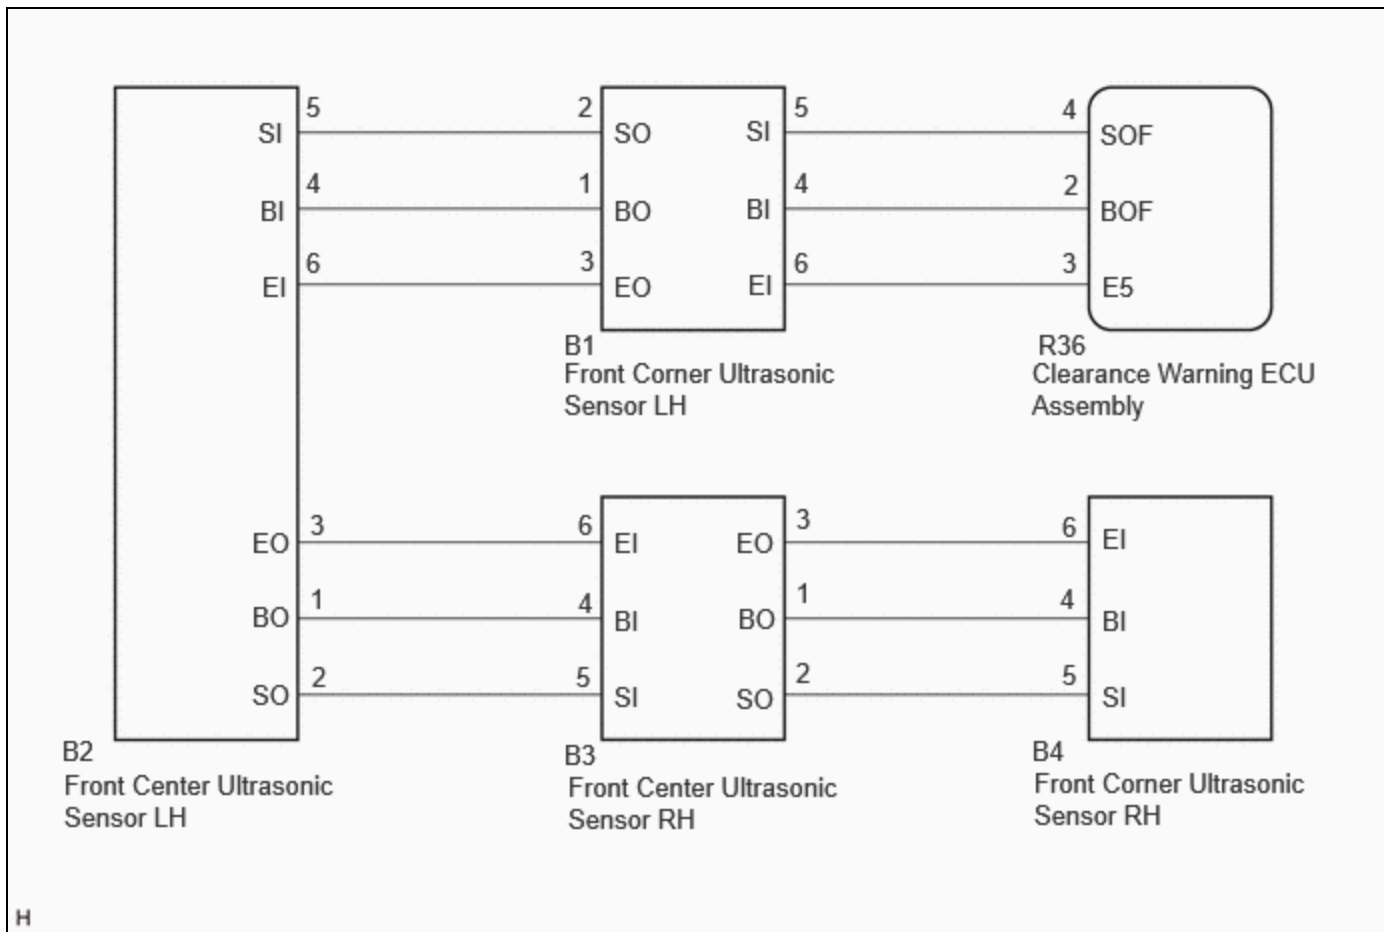
WIRING DIAGRAM

This DTC is stored when an open circuit or short occurs in the communication line between the front corner ultrasonic sensor RH and the front center ultrasonic sensor RH, or when a malfunction occurs in the front corner ultrasonic sensor RH.

DTC NO.	DETECTION ITEM	DTC DETECTION CONDITION	TROUBLE AREA	DTC OUTPUT FROM	PRIORITY
C1AE487	Ultrasonic Sensor (Front Right Corner) Missing Message	Front corner ultrasonic sensor RH lost communication	<ul style="list-style-type: none"> • Front corner ultrasonic sensor RH • Harness or connector • Clearance warning ECU assembly 	Clearance Warning	B
