Last Modified: 12-04-2024	6.11:8.1.0	Doc ID: RM100000028VR7
Model Year Start: 2023	Model: Prius Prime	Prod Date Range: [12/2022 -]
Title: PARK ASSIST / MONITORING: INTUITIVE PARKING ASSIST SYSTEM: C1AE687; Ultrasonic Sensor (Rear Left Corner) Missing Message; 2023 - 2024 MY Prius Prius Prime [12/2022 -]

DTC	C1AE687	Ultrasonic Sensor (Rear Left Corner) Missing Message
------------	----------------	---

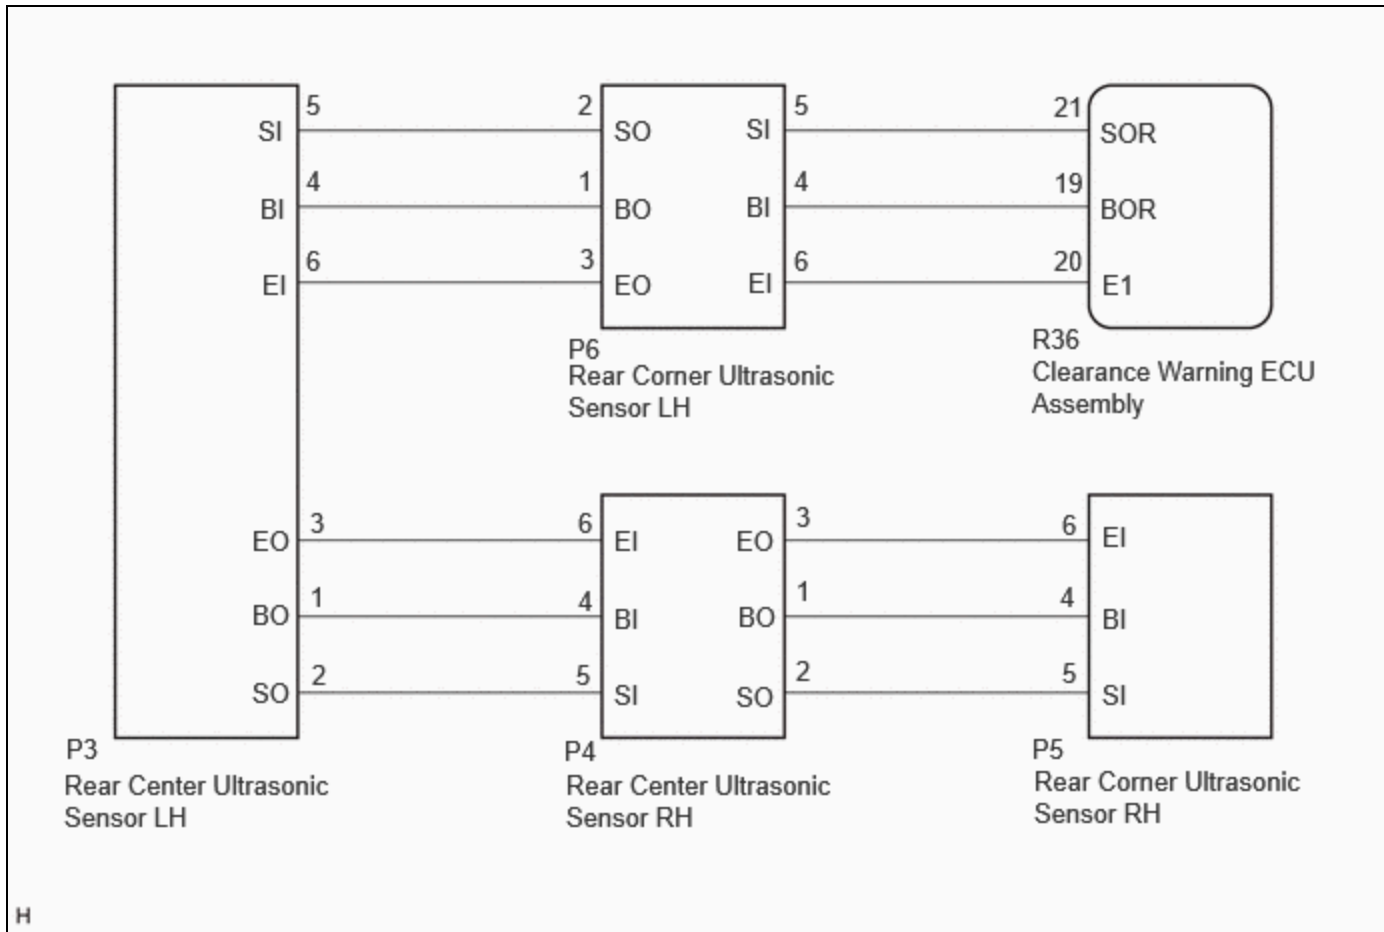
WIRING DIAGRAM

This DTC is output when an open circuit or short occurs in the communication line between the rear corner ultrasonic sensor LH and the clearance warning ECU assembly, or when a malfunction occurs in the rear corner ultrasonic sensor LH.
