Last Modified: 12-04-2024	6.11:8.1.0	Doc ID: RM10000002BLBR
Model Year Start: 2023	Model: Prius Prime	Prod Date Range: [03/2023 -]
Title: AUDIO / VIDEO: RADIO ANTENNA CORD (for Back Door): REMOVAL; 2023 - 2024 MY Prius Prius Prime [03/2023 -]

REMOVAL

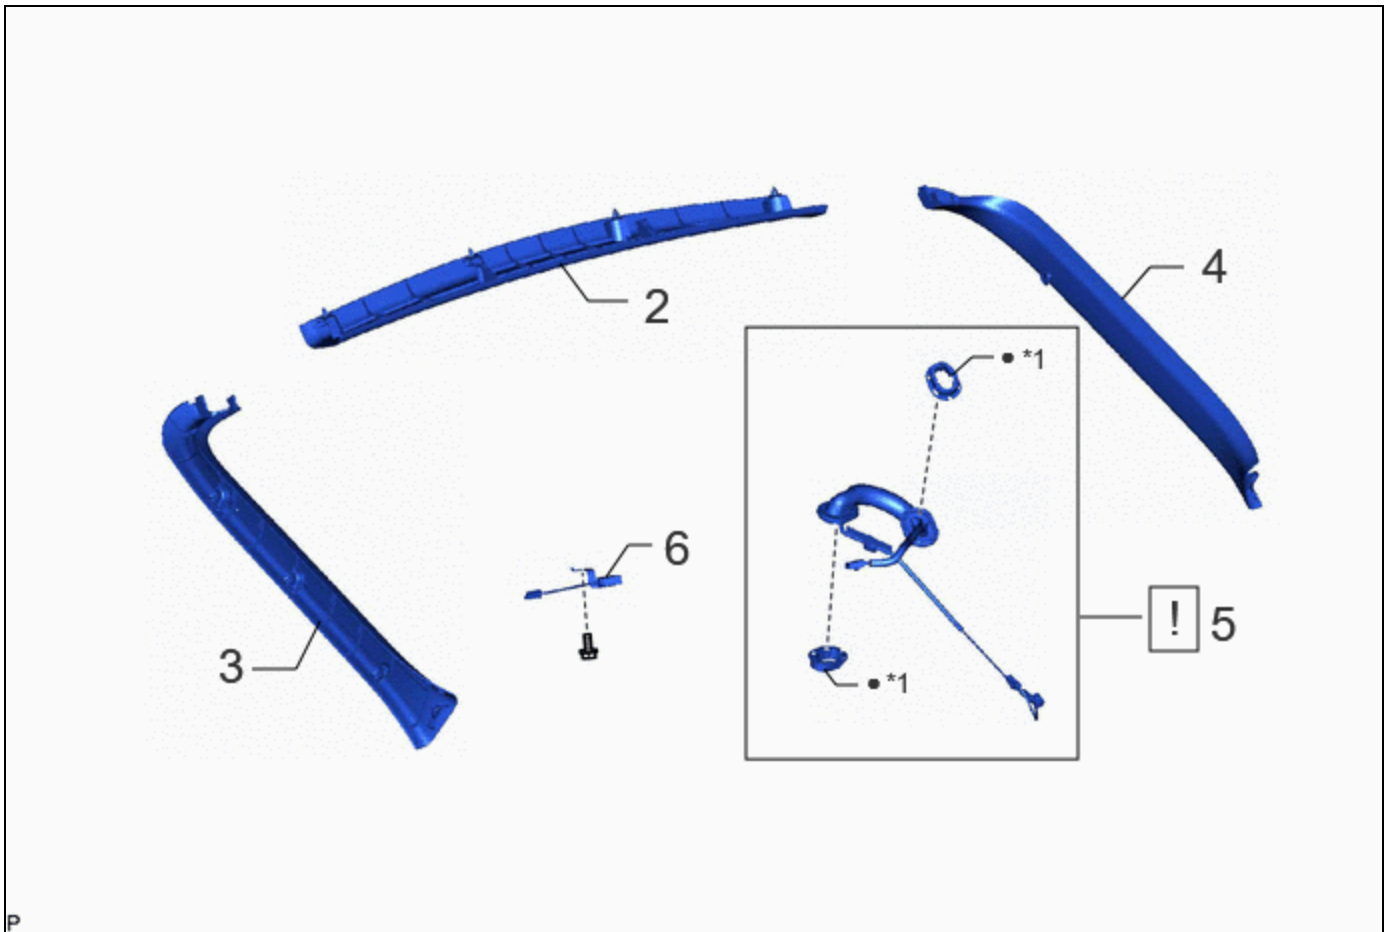
PROCEDURE	PART NAME CODE			
2 BACK DOOR UPPER TRIM PANEL ASSEMBLY	64790B	-	-	-
3 BACK DOOR SIDE GARNISH LH	67938A	-	-	-
4 BACK DOOR SIDE GARNISH RH	67937B	-	-	-
5 NO. 4 ANTENNA CORD SUB-ASSEMBLY	86101Q	INFO	-	-
6 NO. 5 ANTENNA CORD SUB-ASSEMBLY	86101R	-	-	-

*1	NO. 1 WIRING HARNESS PROTECTOR	-	-
•	Non-reusable part	-	-
