Last Modified: 12-04-2024	6.11:8.1.0	Doc ID: RM1000000029620
Model Year Start: 2023	Model: Prius Prime	Prod Date Range: [12/2022 -]
Title: AUDIO / VIDEO: RADIO RECEIVER: REMOVAL; 2023 - 2024 MY Prius Prius Prime [12/2022 -]

REMOVAL

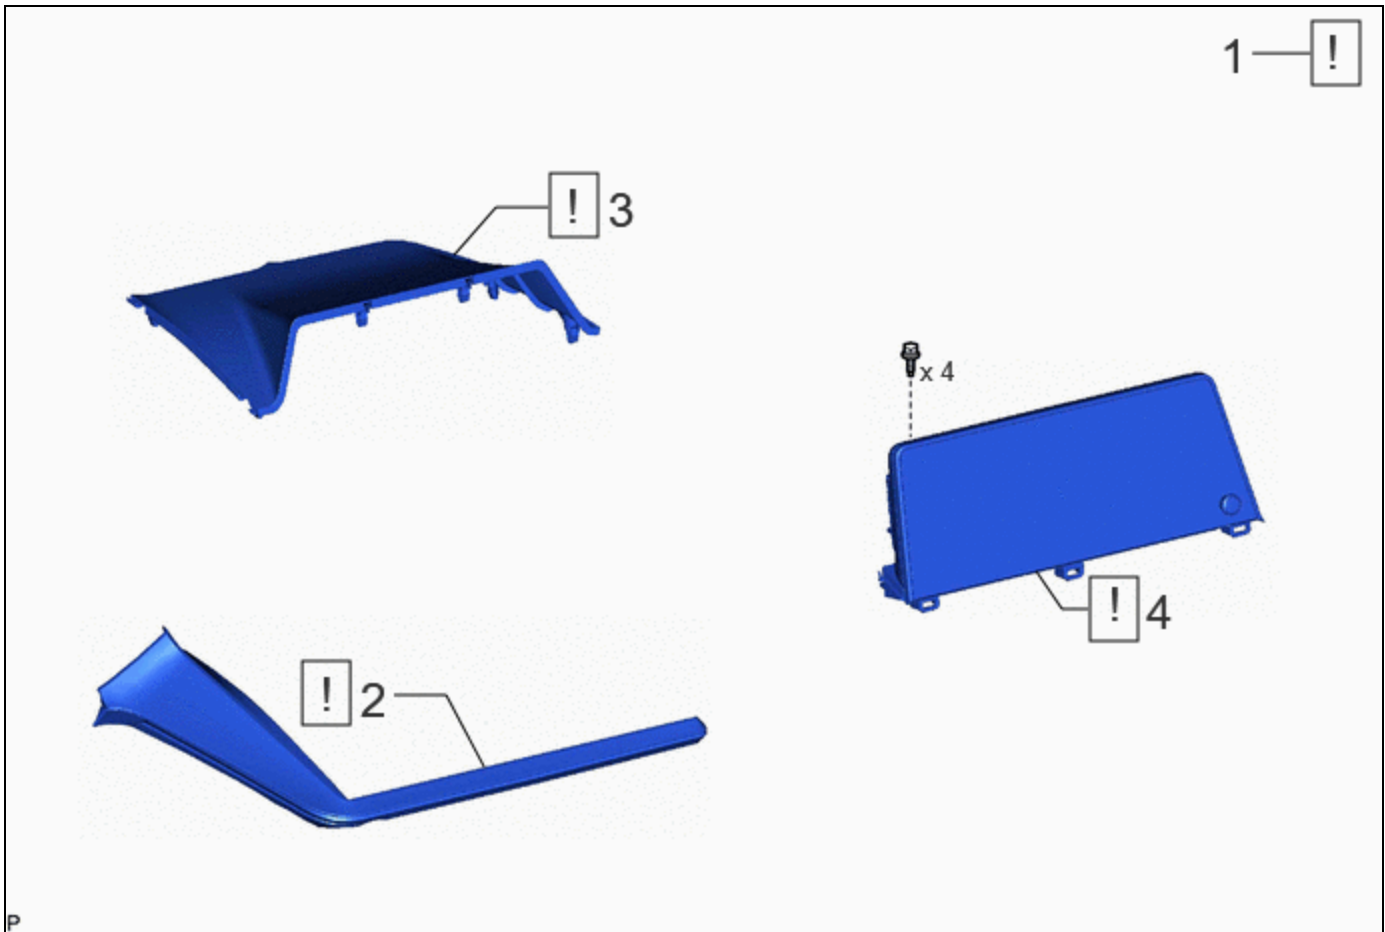
COMPONENTS (REMOVAL)

PROCEDURE	PART NAME CODE			
1	PRECAUTION	-	INFO	-	-
2	CENTER INSTRUMENT CLUSTER FINISH PANEL ASSEMBLY	55420A	INFO	-	-
3	CENTER UPPER INSTRUMENT CLUSTER FINISH PANEL	55422C	INFO	-	-
4	RADIO AND DISPLAY RECEIVER ASSEMBLY WITH BRACKET	-	INFO	-	-

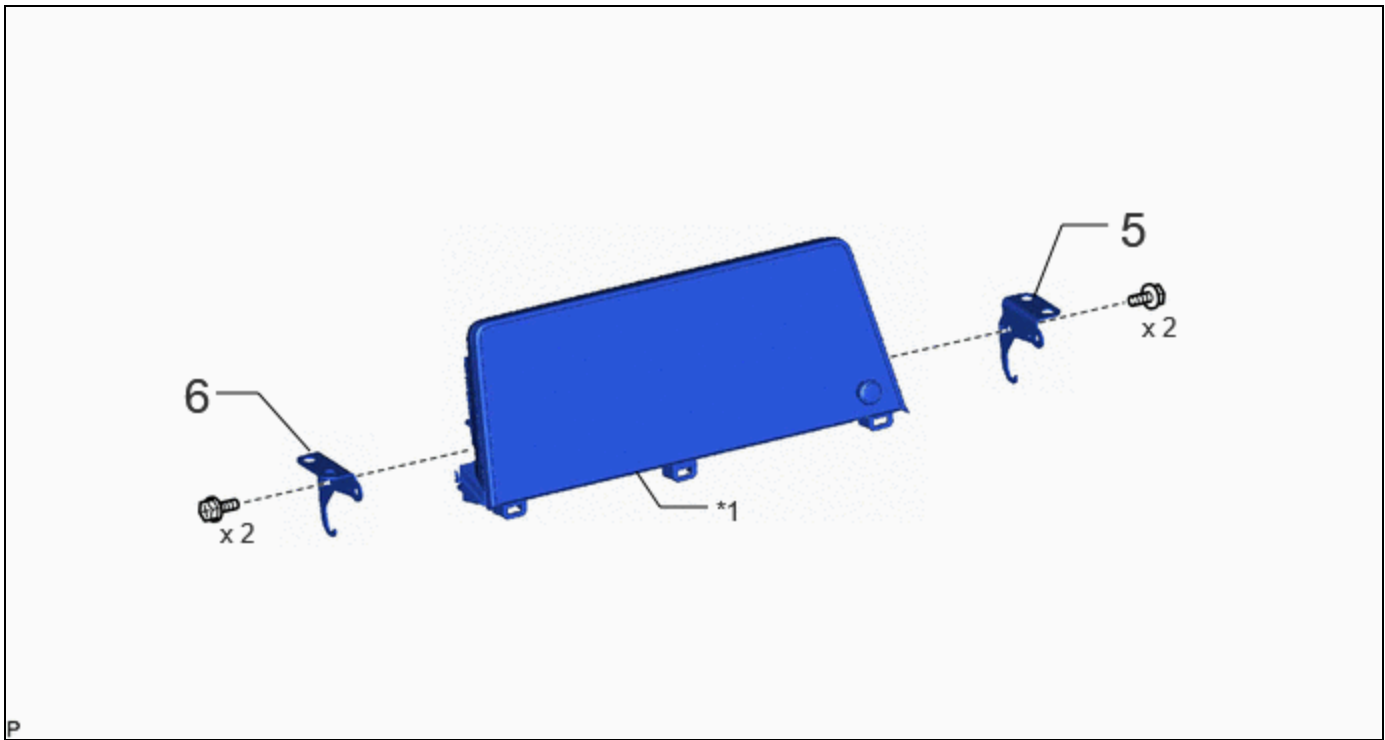
PROCEDURE		PART NAME CODE			
5	NO. 1 RADIO RECEIVER BRACKET	86211J	-	-	-
6	NO. 2 RADIO RECEIVER BRACKET	86212C	-	-	-

*1	RADIO AND DISPLAY RECEIVER ASSEMBLY	-	-
----	-------------------------------------	---	---
