Last Modified: 12-04-2024	6.11:8.1.0	Doc ID: RM10000002A07E
Model Year Start: 2023	Model: Prius Prime	Prod Date Range: [12/2022 -]
Title: PA10/PB10/PB12 (HYBRID TRANSMISSION / TRANSAXLE): SHIFT LEVER: REMOVAL; 2023 - 2024 MY Prius Prius Prime [12/2022 -]

REMOVAL

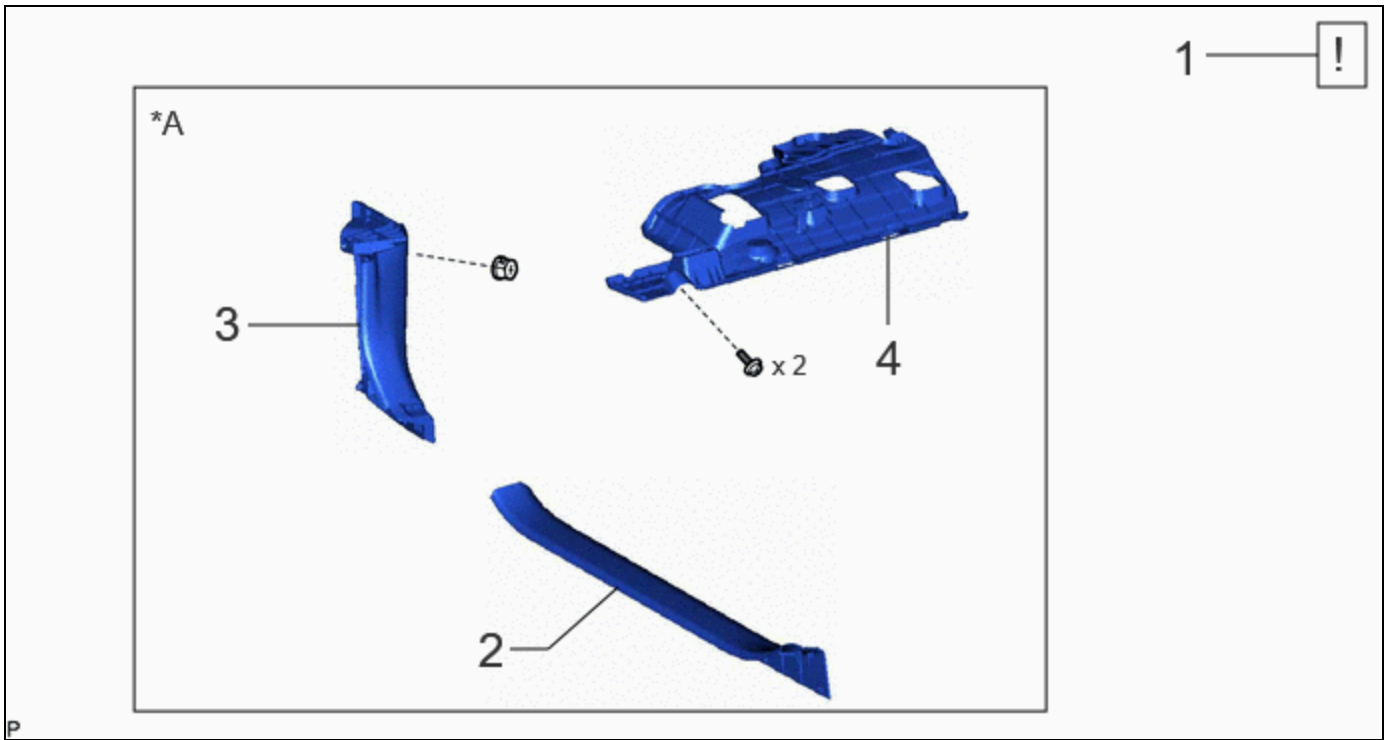
COMPONENTS (REMOVAL)

PROCEDURE		PART NAME CODE			
1	SECURE VEHICLE	-	INFO	-	-
2	FRONT DOOR SCUFF PLATE LH	67914	-	-	-
3	COWL SIDE TRIM BOARD LH	62112	-	-	-
4	NO. 1 INSTRUMENT PANEL UNDER COVER SUB-ASSEMBLY	55606	-	-	-

*A	w/ Knee Airbag	-	-
----	----------------	---	---

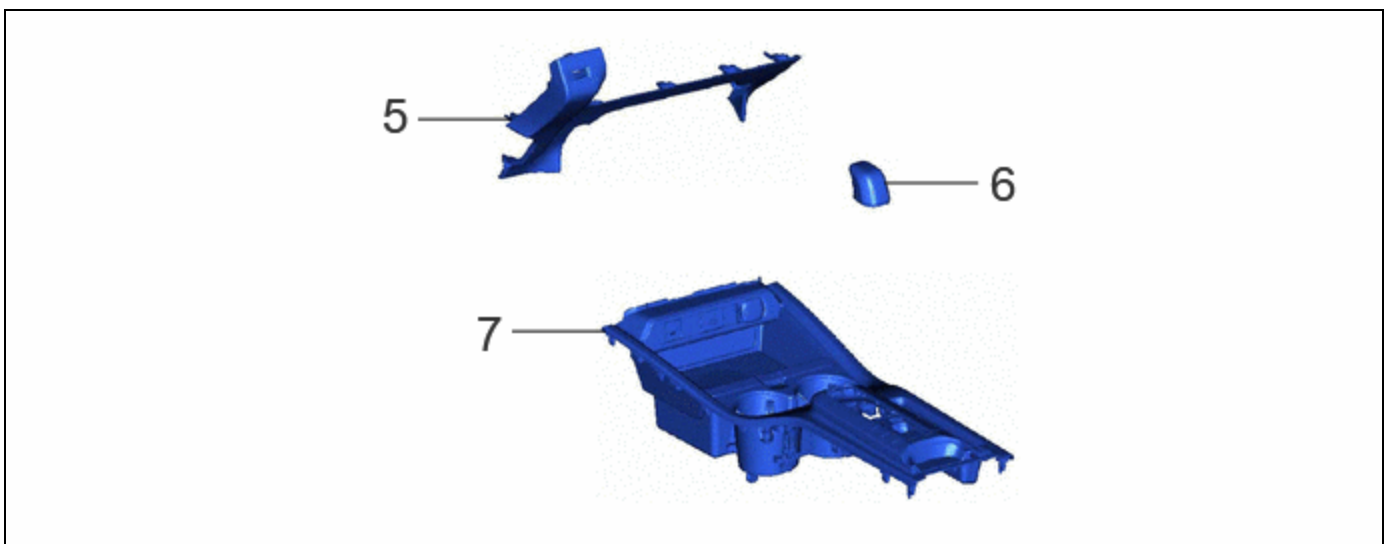
5	LOWER CENTER INSTRUMENT PANEL FINISH PANEL	55434B	-	-	-
6	SHIFT LEVER KNOB SUB-ASSEMBLY	33504F	-	-	-
7	UPPER CONSOLE PANEL SUB-ASSEMBLY	58804A	-	-	-

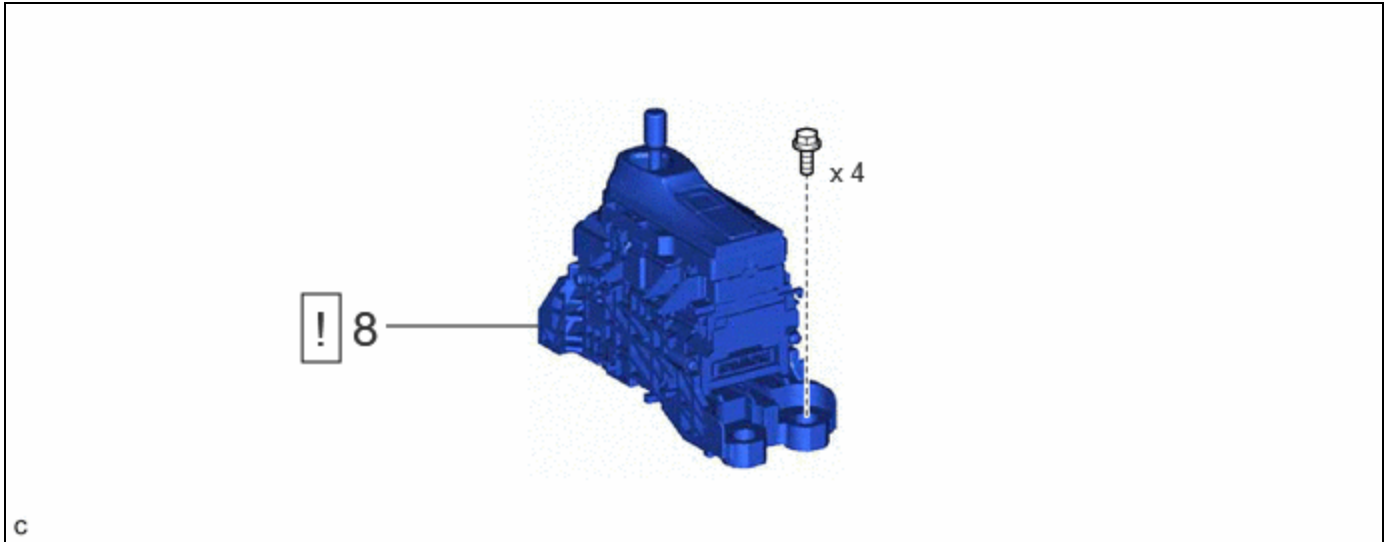
8	TRANSMISSION FLOOR SHIFT ASSEMBLY	33550	INFO	-	-

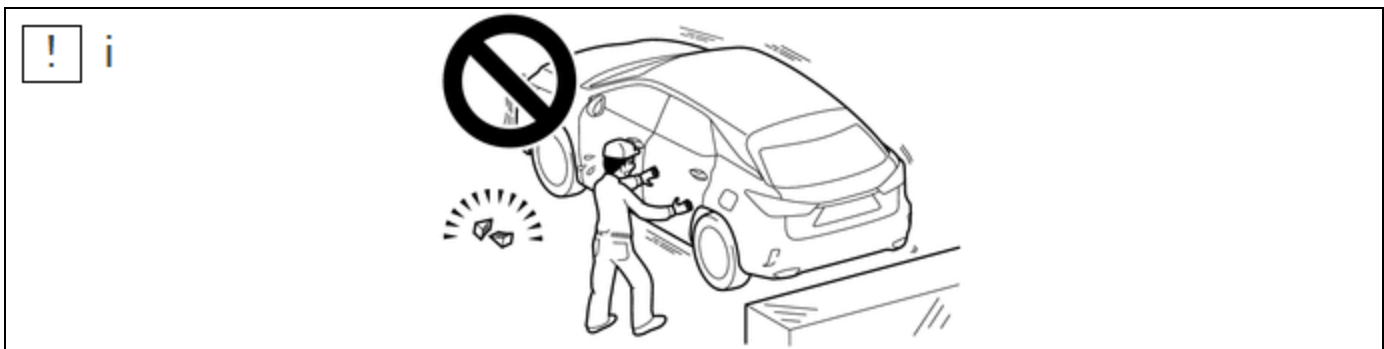
1. SECURE VEHICLE

(1) Fully apply the parking brake and chock a wheel.

- Make sure to apply the parking brake and chock a wheel before performing this procedure.
- If the vehicle is not secure and the shift lever is moved to N, the vehicle may suddenly move, possibly resulting in an accident or serious injury.

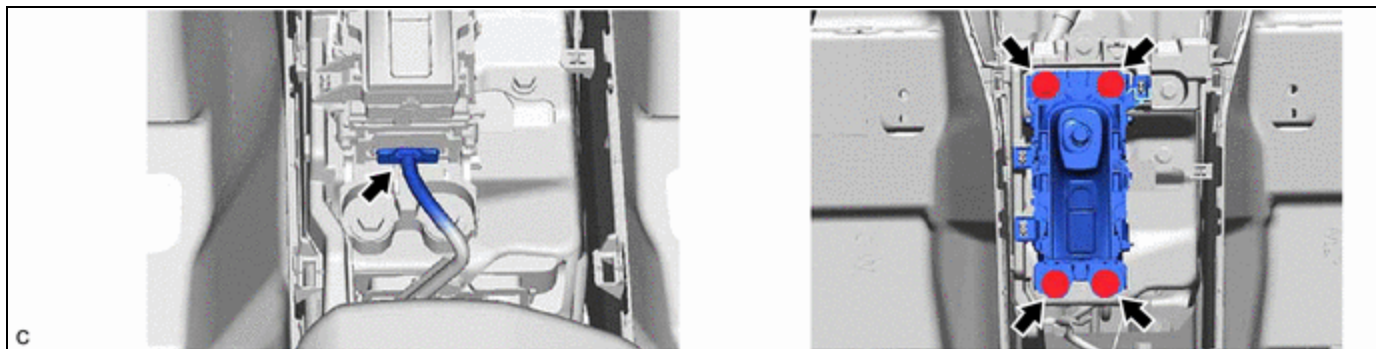
8. REMOVE TRANSMISSION FLOOR SHIFT ASSEMBLY

When disconnecting a wire harness of any component connected to the supply power of the integrated capacitor (integration control supply) or when removing the integrated capacitor (integration control supply), make sure to wait 5 minutes or more after turning the ignition switch off for self-diagnosis to complete and the voltage of the integrated capacitor (integration control supply) to discharge.
