Last Modified: 12-04-2024	6.11:8.1.0	Doc ID: RM100000002BI2O		
Model Year Start: 2023	Model: Prius Prime	Prod Date Range: [03/2023 -]		
Title: HYBRID / BATTERY CONTROL: HYBRID CONTROL SYSTEM (for PHEV Model): Motor High-voltage Circuit;				
2023 - 2024 MY Prius Prime [03/202	3 -]

Motor High-voltage Circuit

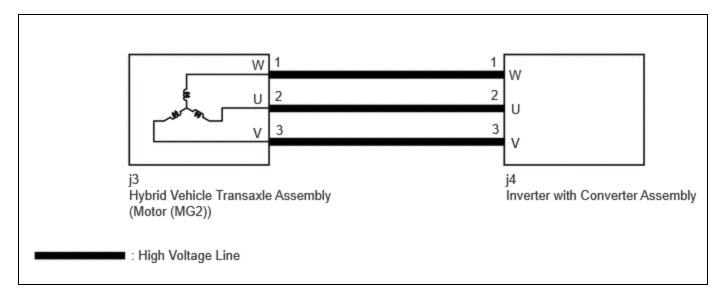
WIRING DIAGRAM

AREA	INSPECTION
Motor cable connection check	Check for open or short circuit in the connection condition of the cable from the inverter to the motor.
Motor and motor cable	Check the motor (including cable) internal resistance and insulation resistance with body ground to check for an open or short circuit.

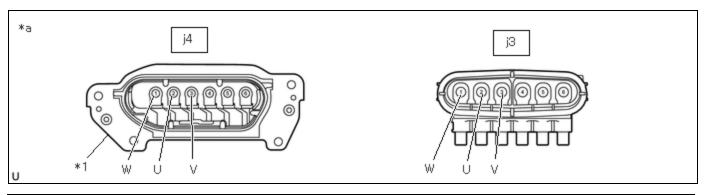
*1	Shielded Ground	-	-
*a	Motor Cable	-	-

TESTER CONNECTION	CONDITION	SPECIFIED CONDITION	RESULT
j4-1 (W) or j3-1 (W) - Shield ground	Ignition switch off	100 MΩ or higher	ΜΩ
j4-2 (U) or j3-2 (U) - Shield ground	Ignition switch off	100 MΩ or higher	ΜΩ
j4-3 (V) or j3-3 (V) - Shield ground	Ignition switch off	100 MΩ or higher	ΜΩ

TESTER CONNECTION	CONDITION	SPECIFIED CONDITION	RESULT
j4-1 (W) - j3-1 (W)	Ignition switch off	Below 1 Ω	Ω
j4-2 (U) - j3-2 (U)	Ignition switch off	Below 1 Ω	Ω
j4-3 (V) - j3-3 (V)	Ignition switch off	Below 1 Ω	Ω
j4-1 (W) - j3-2 (U)	Ignition switch off	100 MΩ or higher	ΜΩ
j4-2 (U) - j3-3 (V)	Ignition switch off	100 MΩ or higher	ΜΩ
j4-3 (V) - j3-1 (W)	Ignition switch off	100 MΩ or higher	MΩ
