Last Modified: 12-04-2024	6.11:8.1.0	Doc ID: RM100000002BJBS
Model Year Start: 2023	Model: Prius Prime	Prod Date Range: [03/2023 -]
Title: SEAT BELT: FRONT SEAT OUTER BELT ASSEMBLY: REMOVAL; 2023 - 2024 MY Prius Prius Prime [03/2023 -]

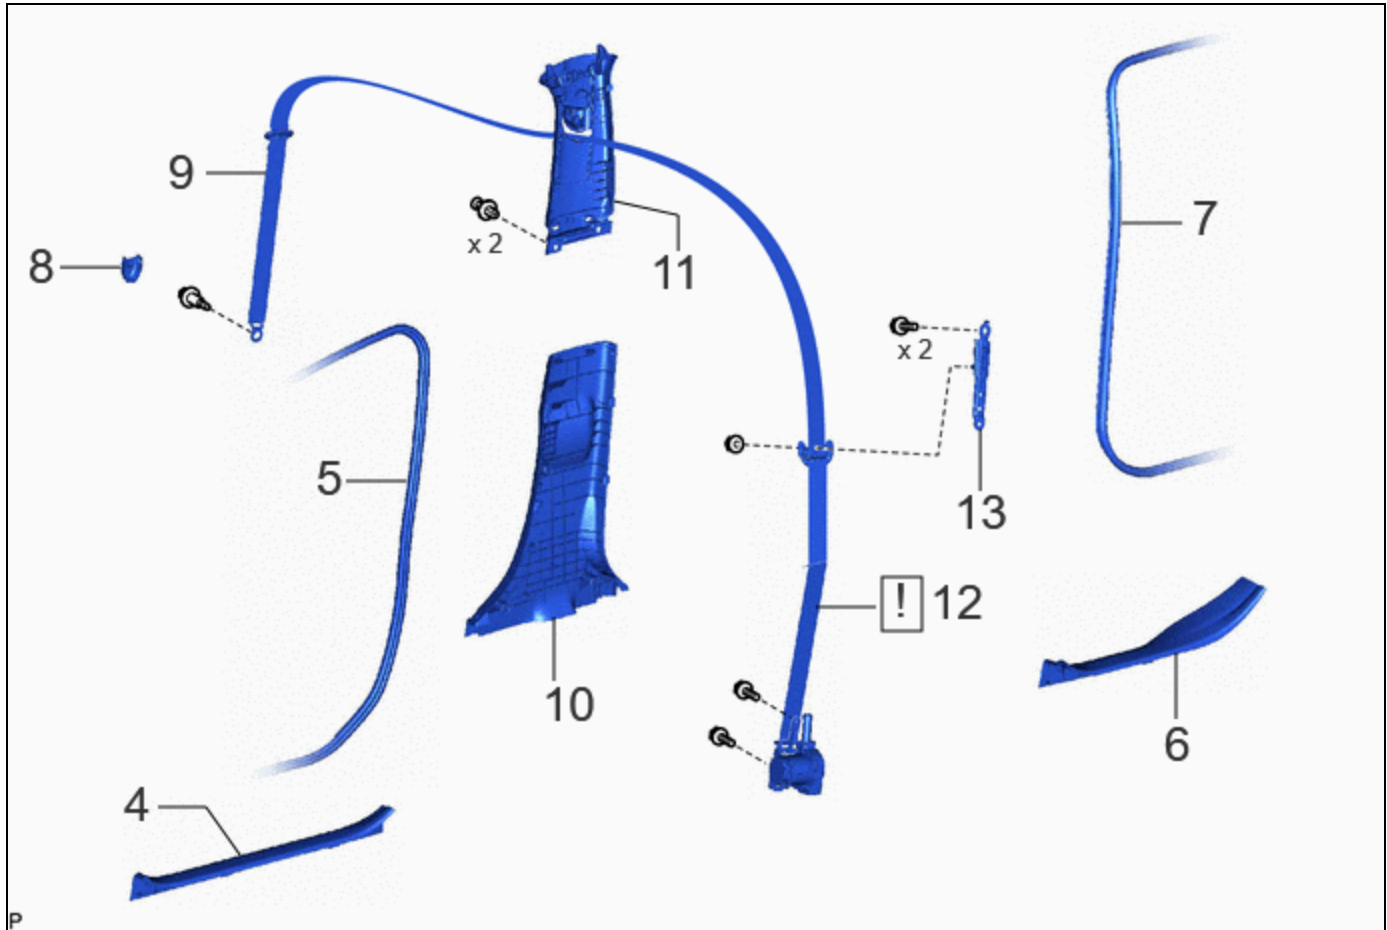
COMPONENTS (REMOVAL)

PROCEDURE		PART NAME CODE			
4	FRONT DOOR SCUFF PLATE	67914	-	-	-
5	FRONT DOOR OPENING TRIM WEATHERSTRIP	62312B	-	-	-
6	REAR DOOR SCUFF PLATE INSIDE	67918F	-	-	-
7	REAR DOOR OPENING TRIM WEATHERSTRIP	62332A	-	-	-
8	LAP BELT OUTER ANCHOR COVER	73233	-	-	-
9	DISCONNECT FRONT SEAT OUTER BELT ASSEMBLY	73220	-	-	-
10	CENTER PILLAR LOWER GARNISH	62414A	-	-	-
11	CENTER PILLER GARNISH ASSEMBLY	62420A	-	-	-
12	REMOVE FRONT SEAT OUTER BELT ASSEMBLY	73220	INFO	-	-
13	FRONT SHOULDER BELT ANCHOR ADJUSTER ASSEMBLY	73200A	-	-	-

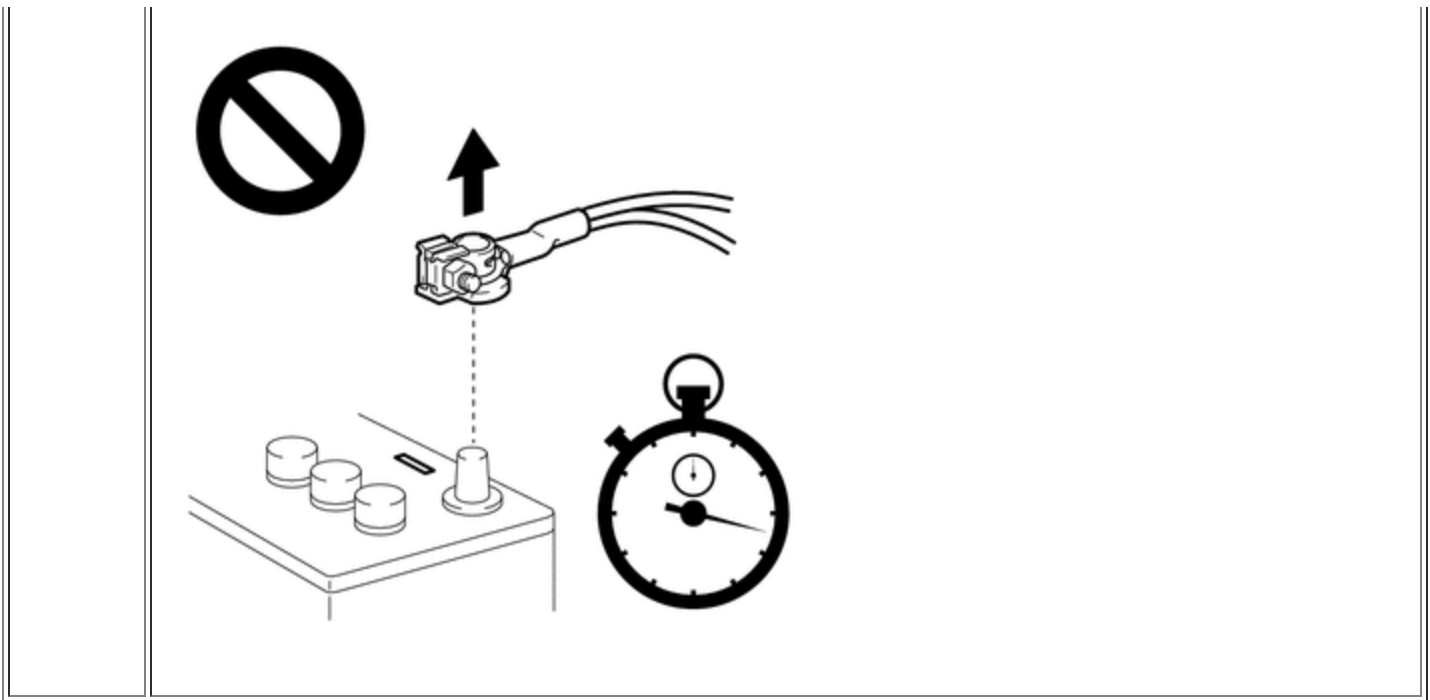
3. DISCONNECT CABLE FROM NEGATIVE AUXILIARY BATTERY TERMINAL

<p>CAUTION: Wait at least 60 seconds after disconnecting the cable from the negative (-) auxiliary battery terminal to disable the SRS system.</p>
---	---

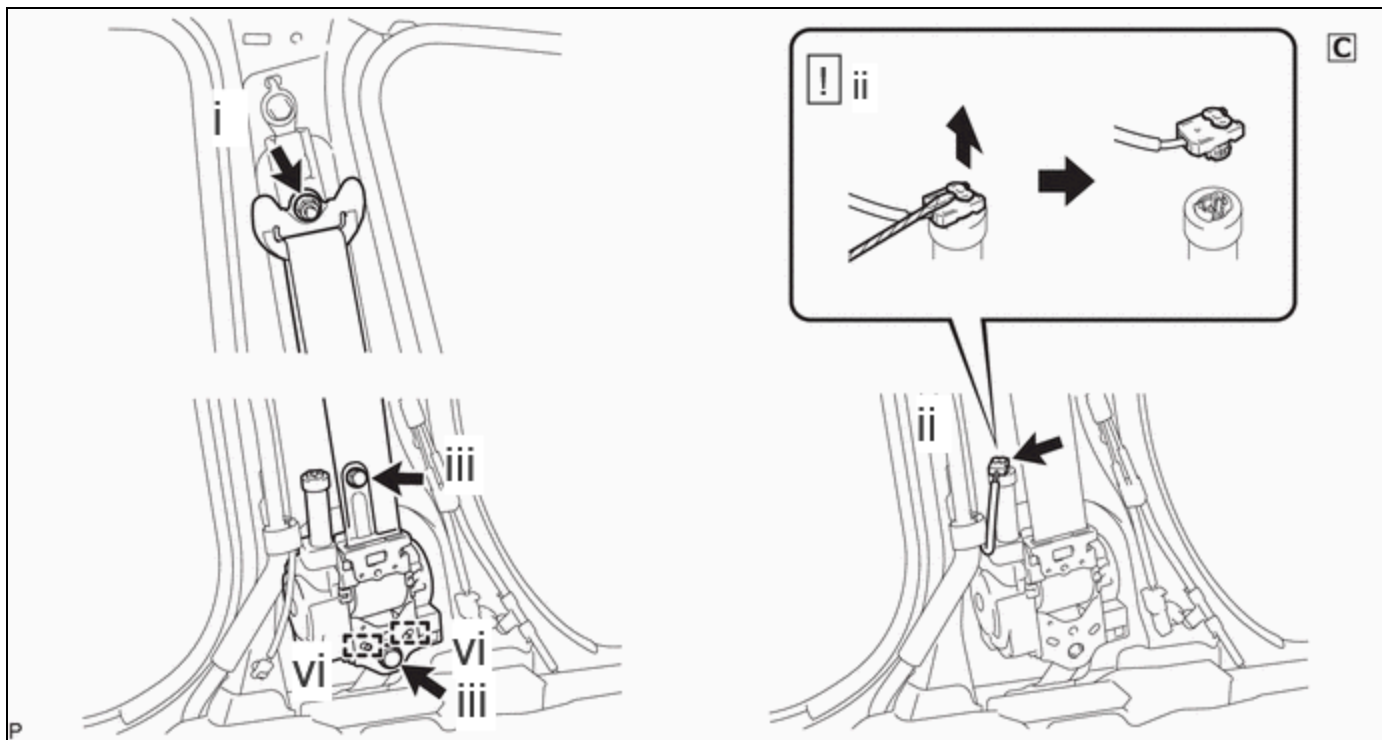
12. REMOVE FRONT SEAT OUTER BELT ASSEMBLY

- (1) Remove the nut and disconnect the shoulder anchor of the front seat outer belt assembly.
- (2) Using a screwdriver with its tip wrapped with protective tape, pull out the locking button as shown in the illustration to release the lock and disconnect the pretensioner connector.
- (3) Remove the 2 bolts.
- (4) Disengage the 2 guides to remove the front seat outer belt assembly.

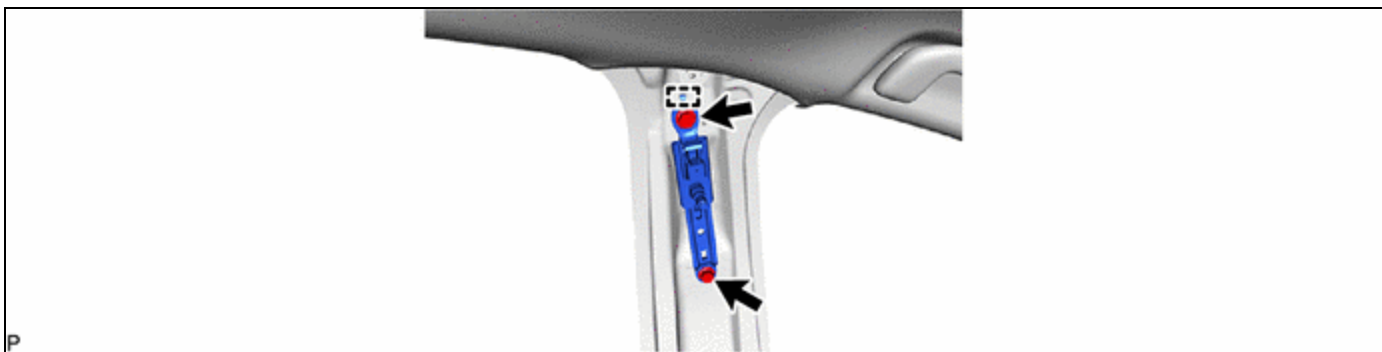
13. REMOVE FRONT SHOULDER BELT ANCHOR ADJUSTER ASSEMBLY

Perform this procedure only when replacement of the front shoulder belt anchor adjuster assembly is necessary.
