<b>Last Modified:</b> 12-04-2024	6.11:8.1.0	<b>Doc ID:</b> RM100000029ZOA
<b>Model Year Start:</b> 2023	<b>Model:</b> Prius Prime	<b>Prod Date Range:</b> [12/2022 - ]
<b>Title:</b> SEAT BELT: OCCUPANT DETECTION SENSOR (for Front Passenger Side): INSPECTION; 2023 - 2024 MY Prius Prius Prime [12/2022 - ]

### 1. INSPECT OCCUPANT DETECTION SENSOR (SEPARATE TYPE FRONT SEAT CUSHION PAD)

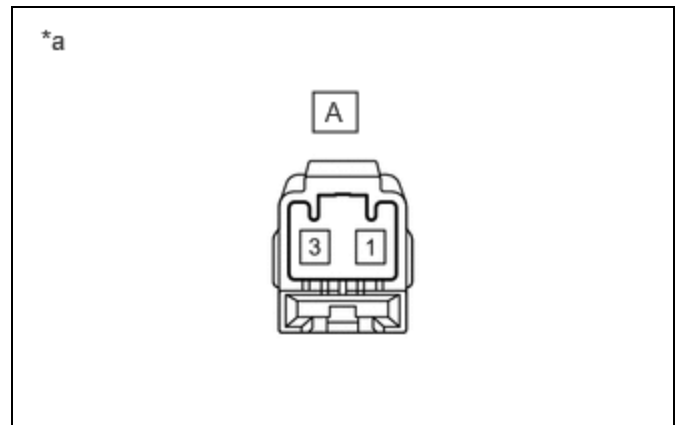
TESTER CONNECTION	CONDITION	SPECIFIED CONDITION	RESULT
A-1 - A-3	Front passenger side seat occupied	Below 100 Ω	Ω
A-1 - A-3	Front passenger side seat not occupied	1 MΩ or higher	MΩ

*a	Component without harness connected (Occupant Detection Sensor (Separate Type Front Seat Cushion Pad))
----	--

If the result is not as specified, replace the occupant detection sensor (separate type front seat cushion pad).
