HEATING / AIR CONDITIONING: AIR CONDITIONING SYSTEM (for PHEV Model): B141A11; Room Temperature Sensor Circuit ...

B141A11 Room Temperature Sensor Circuit Short to Ground

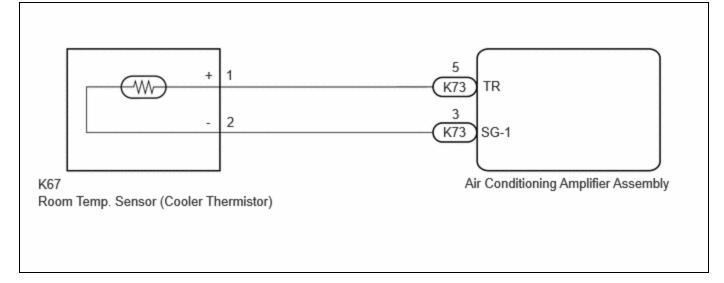
WIRING DIAGRAM

The room temp. sensor (cooler thermistor) is installed in the instrument panel to detect the cabin temperature, which is used to control the air conditioning system. The resistance of the room temp. sensor (cooler thermistor) changes in accordance with the cabin temperature. As the temperature decreases, the resistance increases. As the temperature increases, the resistance decreases.

The air conditioning amplifier assembly applies voltage to the room temp. sensor (cooler thermistor) and reads voltage changes due to changes in the resistance of the room temp. sensor (cooler thermistor).

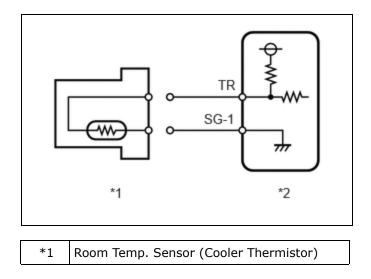
- (a) Turn the ignition switch off.
- (b) Disconnect the room temp. sensor (cooler thermistor) connector.

*2 Air Conditioning Amplifier Assembly
