<b>Last Modified:</b> 12-04-2024	6.11:8.1.0	<b>Doc ID:</b> RM100000002B6LM
<b>Model Year Start:</b> 2023	<b>Model:</b> Prius Prime	<b>Prod Date Range:</b> [03/2023 - ]
<b>Title:</b> INTERIOR PANELS / TRIM: FRONT CONSOLE BOX: REMOVAL; 2023 - 2024 MY Prius Prius Prime [03/2023 - ]

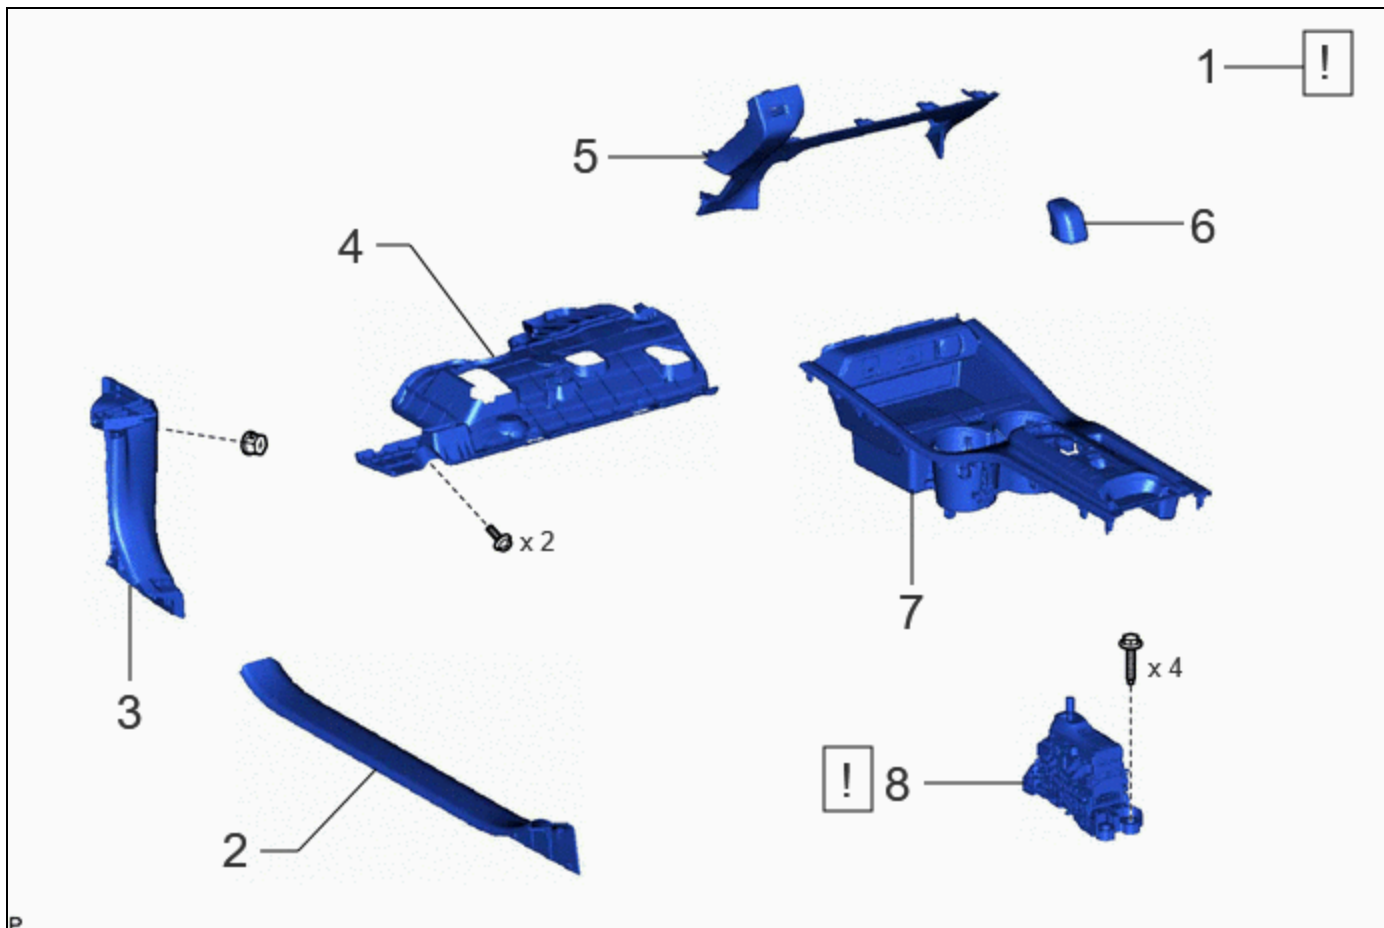
#### COMPONENTS (REMOVAL)

1	SECURE VEHICLE	-	INFO	-	-
2	FRONT DOOR SCUFF PLATE LH	67914	-	-	-
3	COWL SIDE TRIM BOARD LH	62112	-	-	-
4	NO. 1 INSTRUMENT PANEL UNDER COVER SUB-ASSEMBLY	55606	-	-	-
5	LOWER CENTER INSTRUMENT PANEL FINISH PANEL	55434B	-	-	-
6	SHIFT LEVER KNOB SUB-ASSEMBLY	33504F	-	-	-
7	UPPER CONSOLE PANEL SUB-ASSEMBLY	58804A	-	-	-
8	TRANSMISSION FLOOR SHIFT ASSEMBLY	33550	INFO	-	-

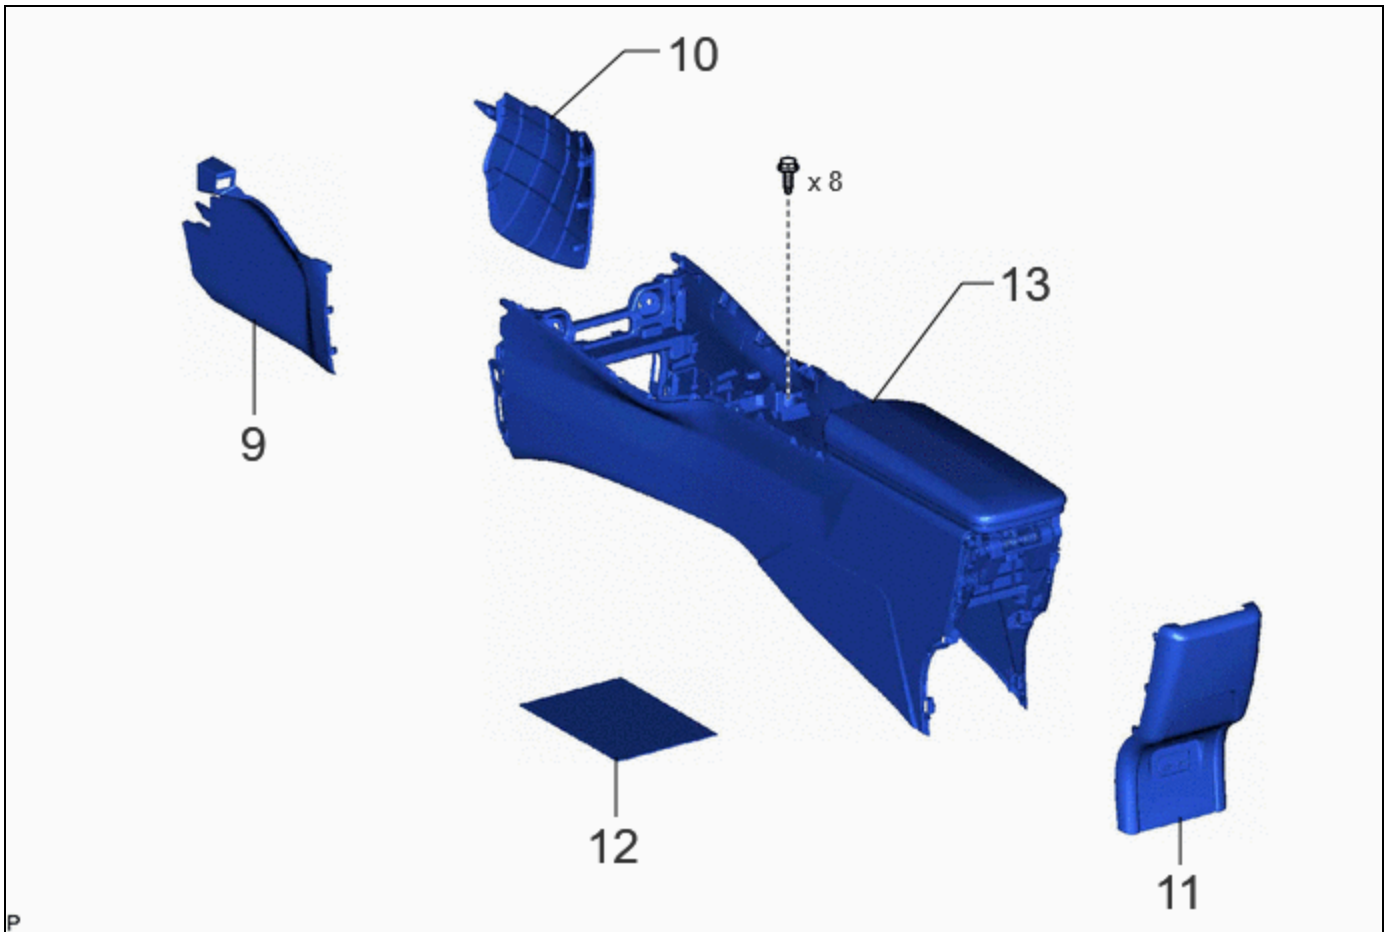
9	FRONT NO. 1 CONSOLE BOX INSERT	58816D	-	-	-
10	FRONT NO. 2 CONSOLE BOX INSERT	58817A	-	-	-
11	CONSOLE REAR END PANEL SUB-ASSEMBLY	58903A	-	-	-

12	CONSOLE BOX CARPET	58815A	-	-	-
13	REAR CONSOLE BOX ASSEMBLY	58910C	-	-	-

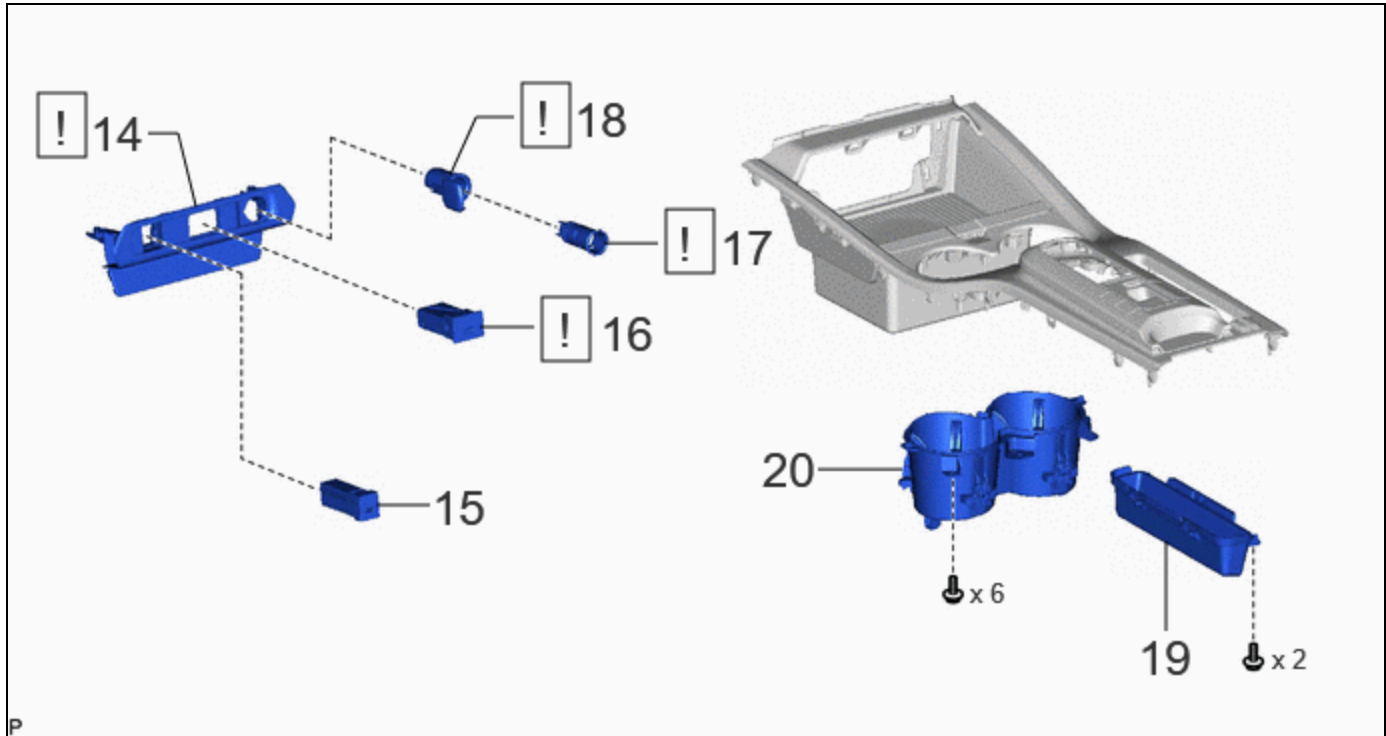
14	FRONT CONSOLE BOX COVER	58818A	<a href="#">INFO</a>	-	-
15	STEREO JACK ADAPTER ASSEMBLY	86190E	-	-	-
16	USB CHARGER SOCKET	85532	<a href="#">INFO</a>	-	-
17	NO. 1 POWER OUTLET SOCKET ASSEMBLY	85530	<a href="#">INFO</a>	-	-
18	NO. 1 POWER OUTLET SOCKET COVER	85535B	<a href="#">INFO</a>	-	-
19	CONSOLE BOX POCKET	-	-	-	-
20	CONSOLE CUP HOLDER BOX SUB-ASSEMBLY	58803C	-	-	-

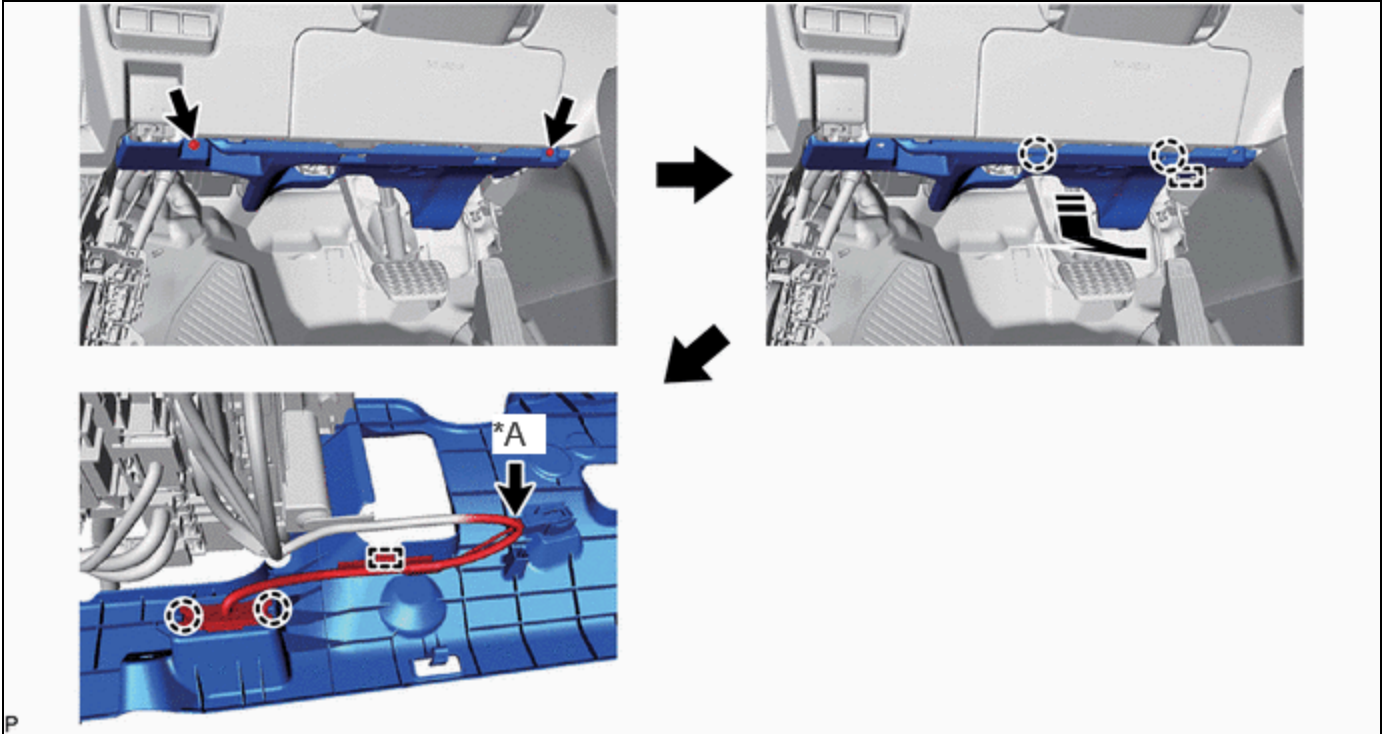
**4. REMOVE NO. 1 INSTRUMENT PANEL UNDER COVER SUB-ASSEMBLY**

*A	w/ Illumination	-	-
	Remove in this Direction	-	-

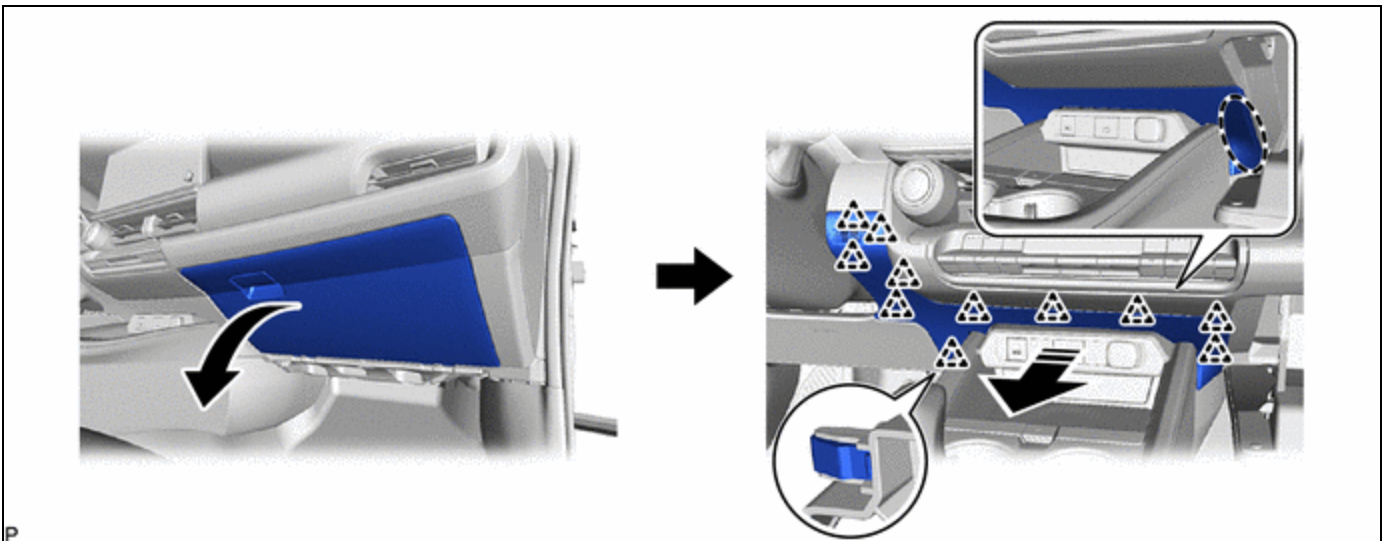
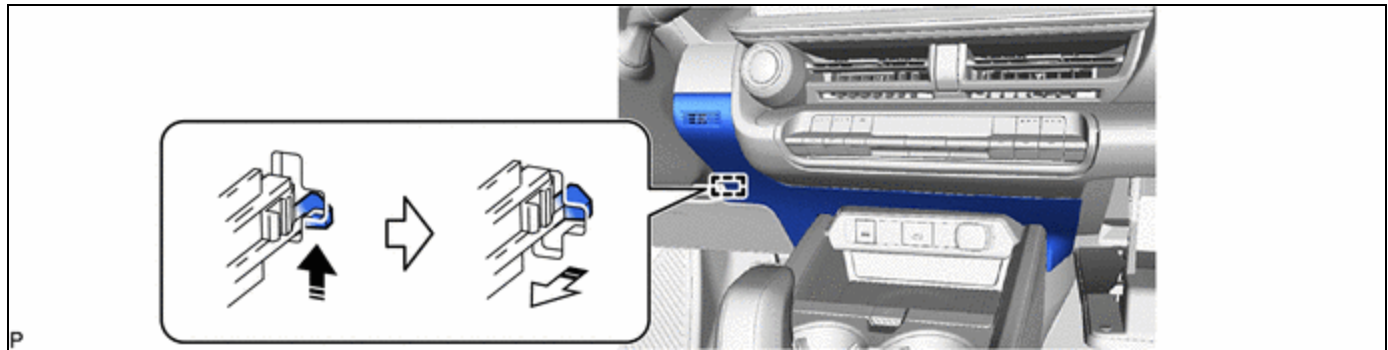
**5. REMOVE LOWER CENTER INSTRUMENT PANEL FINISH PANEL**

(b) w/ Knee Airbag:

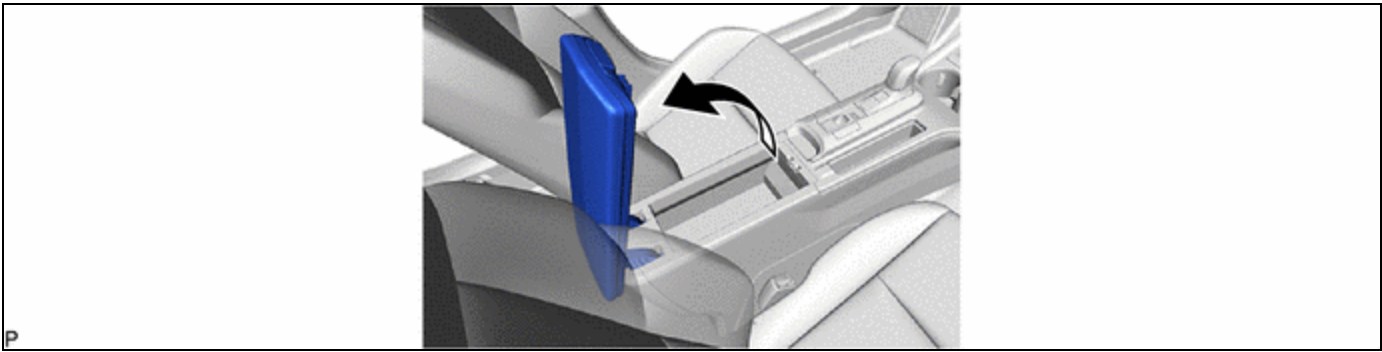
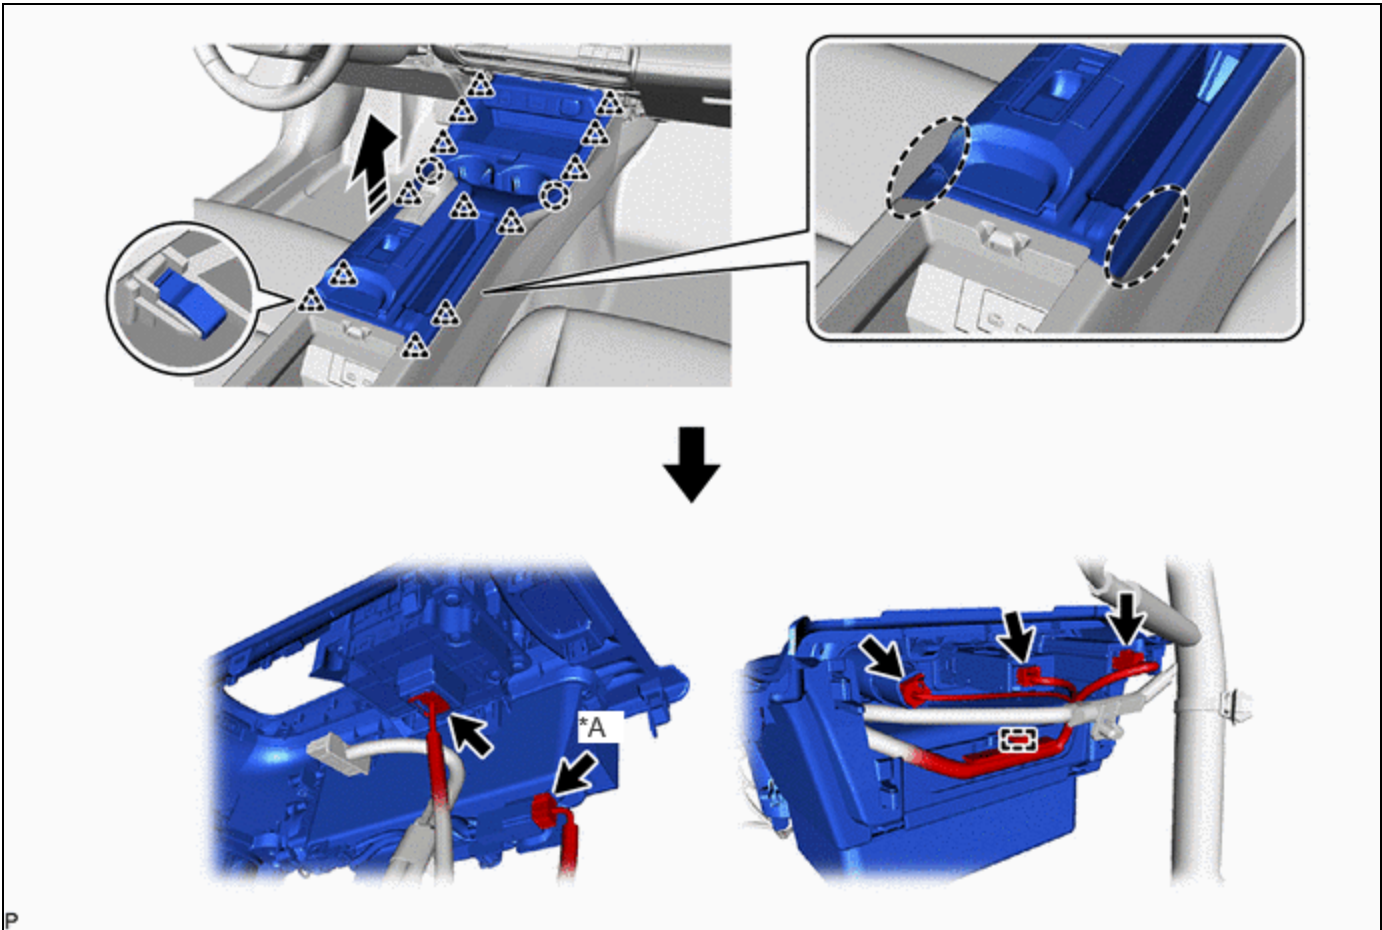
**7. REMOVE UPPER CONSOLE PANEL SUB-ASSEMBLY**

*A	w/ Wireless Charger	-	-
	Place Hand Here		Remove in this Direction

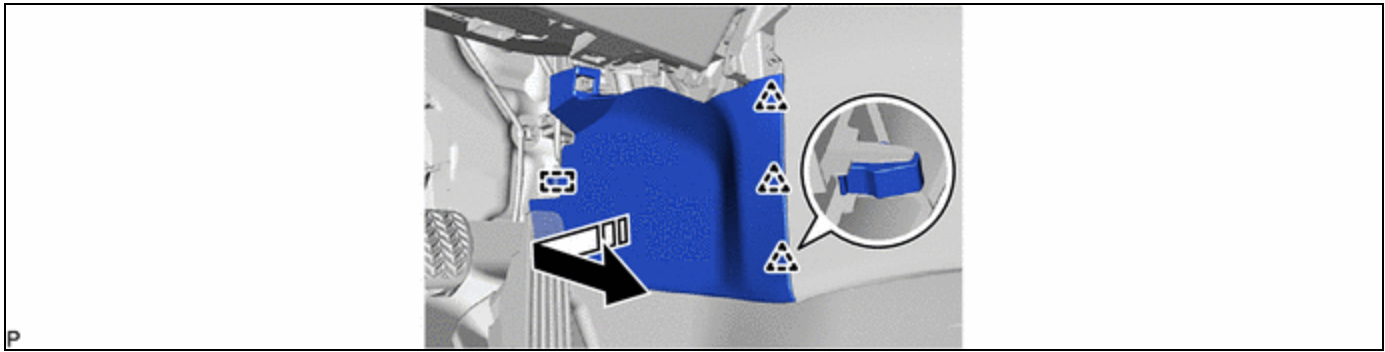
**9. REMOVE FRONT NO. 1 CONSOLE BOX INSERT**

Remove in this Direction	-	-
---	--------------------------	---	---

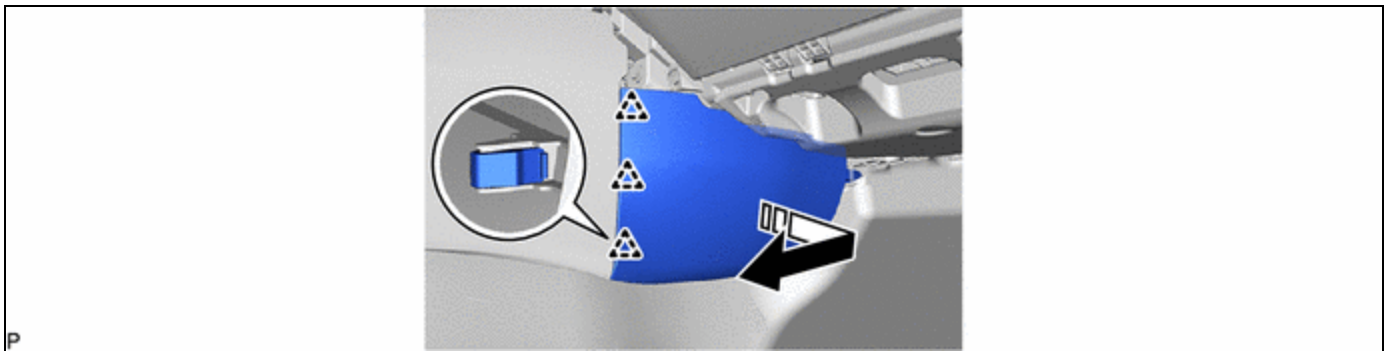
**10. REMOVE FRONT NO. 2 CONSOLE BOX INSERT**

Remove in this Direction	-	-
---	--------------------------	---	---

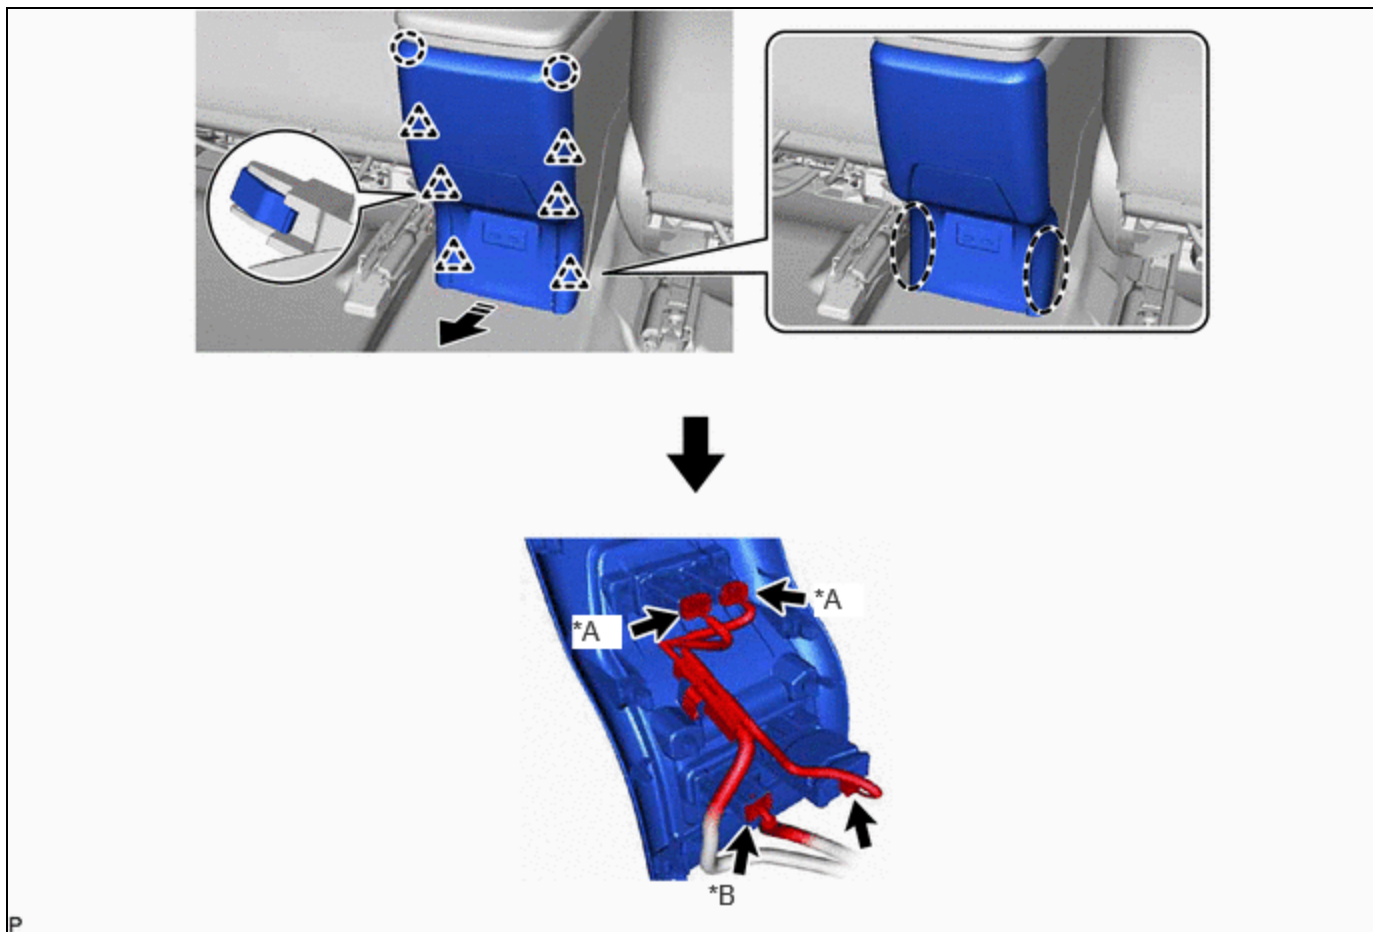
**11. REMOVE CONSOLE REAR END PANEL SUB-ASSEMBLY**

*A	w/ Seat Heater System	*B	w/ Power Outlet Socket
	Place Hand Here		Remove in this Direction

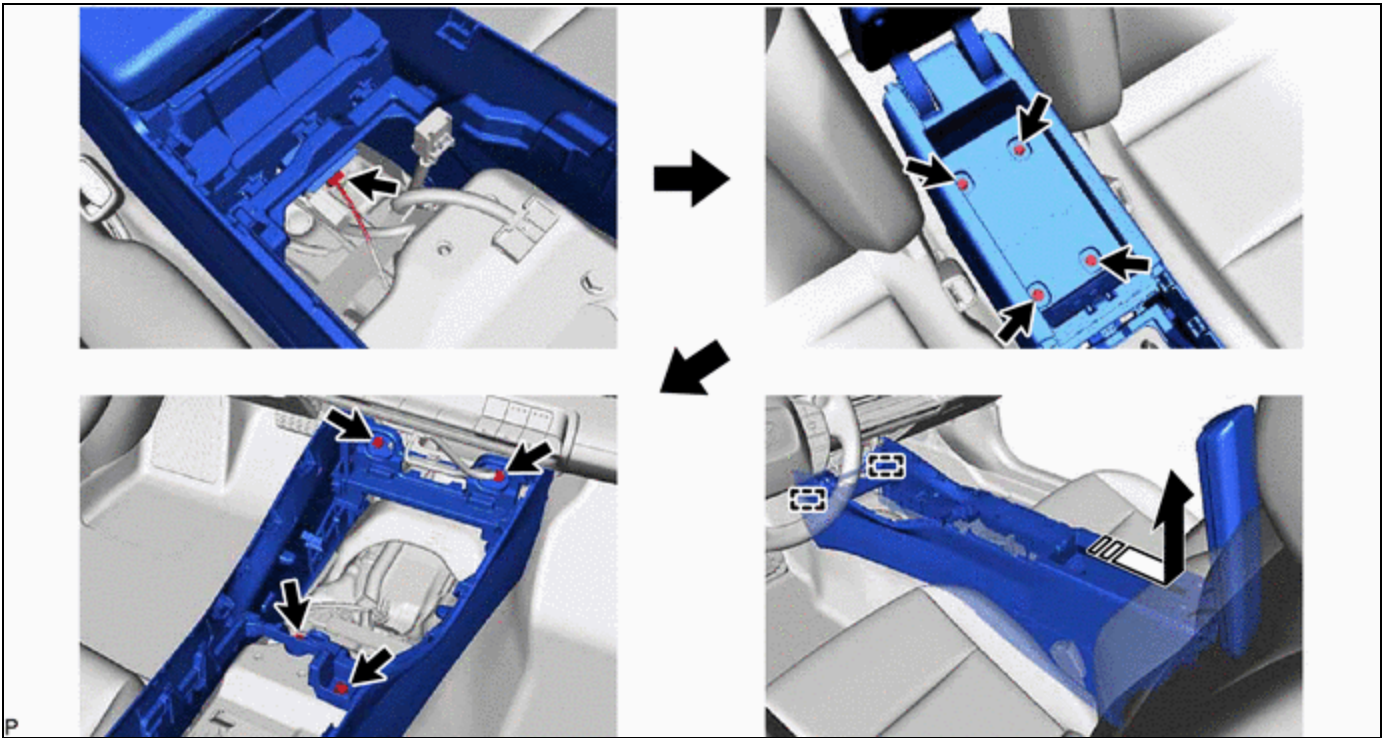
**13. REMOVE REAR CONSOLE BOX ASSEMBLY**

Remove in this Direction	-	-
--	--------------------------	---	---

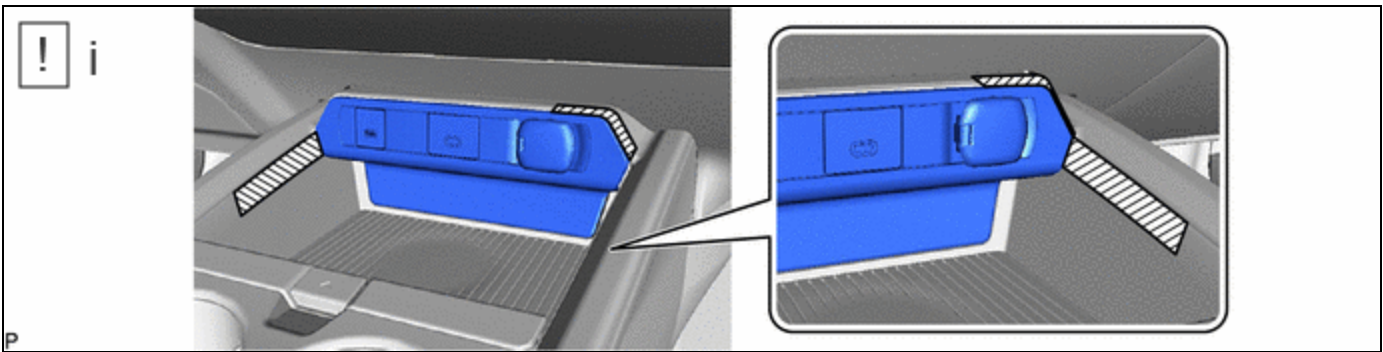
### 14. REMOVE FRONT CONSOLE BOX COVER

(1) Apply protective tape to the area shown in the illustration.

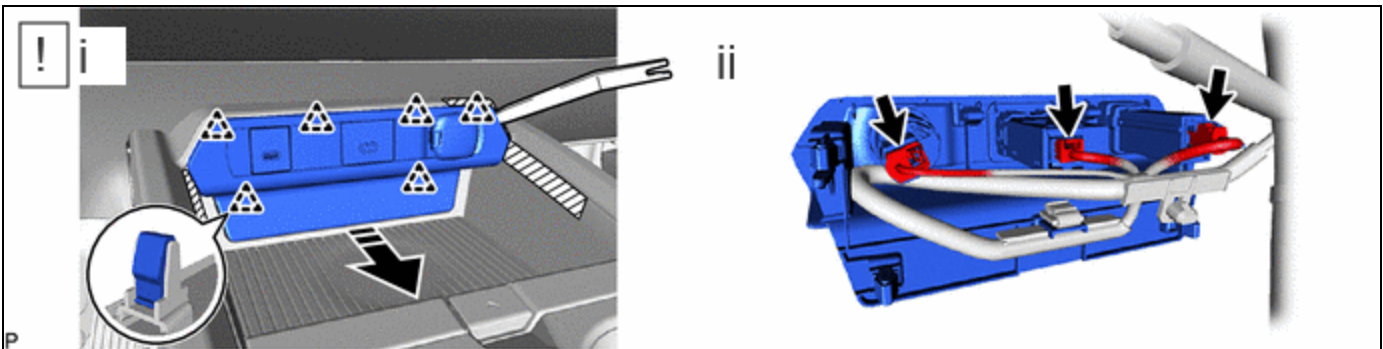
(1) Using a moulding remover, disengage the 6 clips as shown in the illustration to remove the front console box cover.

(2) Disconnect each connector.

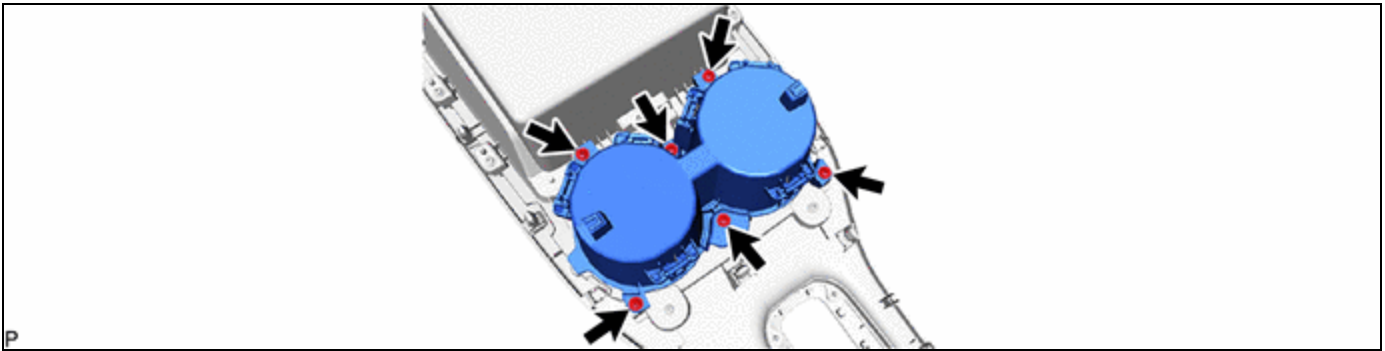
## 20. REMOVE CONSOLE CUP HOLDER BOX SUB-ASSEMBLY

Perform this procedure only when replacement of the console cup holder box sub-assembly is necessary.
