<b>Last Modified:</b> 12-04-2024	6.11:8.1.0	<b>Doc ID:</b> RM1000000289P7
<b>Model Year Start:</b> 2023	<b>Model:</b> Prius Prime	<b>Prod Date Range:</b> [12/2022 - ]
<b>Title:</b> ADVANCED DRIVER ASSISTANCE SYSTEM: FRONT SIDE RADAR SENSOR: TARGET ADJUSTMENT(TRIANGLE TARGET); 2023 - 2024 MY Prius Prius Prime [12/2022 - ]

## TARGET ADJUSTMENT(TRIANGLE TARGET)

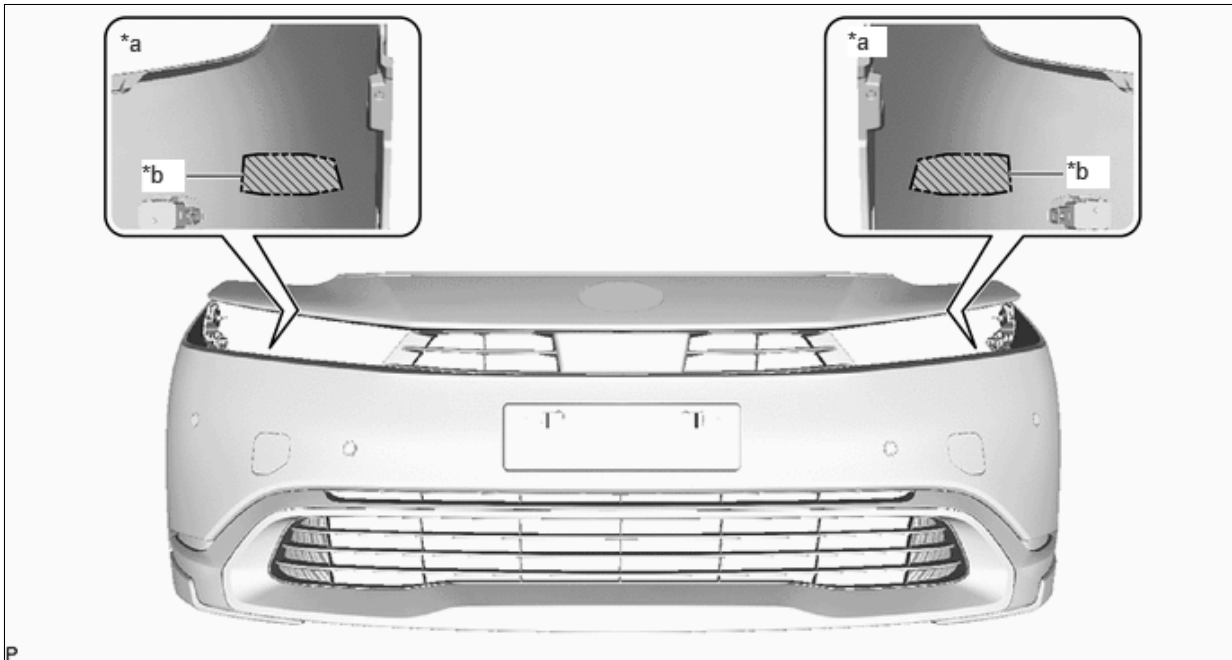
If body repair has been performed at a radio wave transmission area of the front bumper cover, make sure to perform "Check Reflection Power".

*a	Bumper Rear Side	*b	Scribed Line
	Radio Wave Transmission Area	-	-

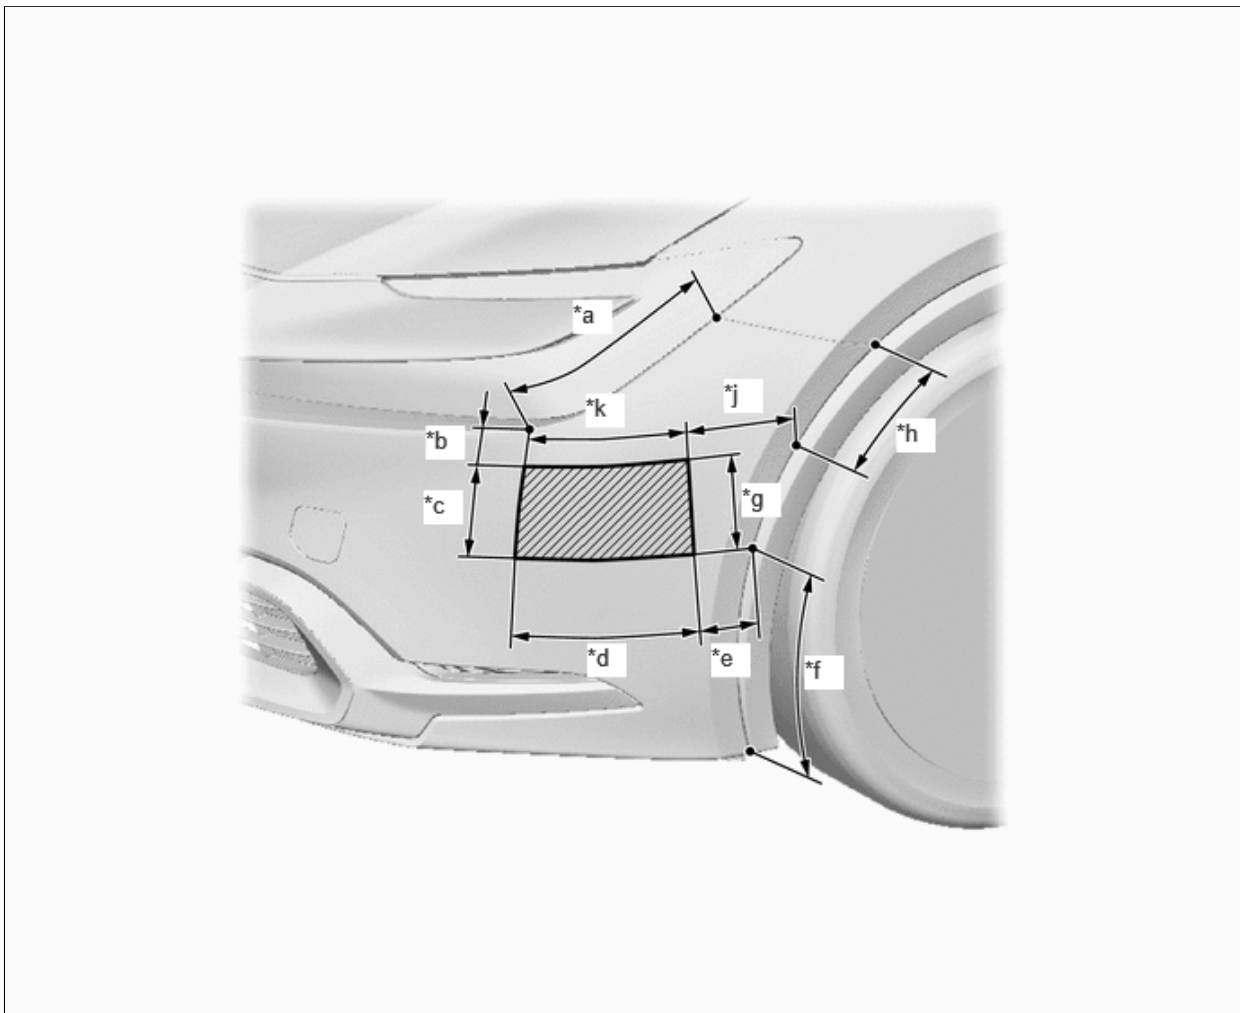
*a	282 mm (11.10 in.)	*b	48 mm (1.89 in.)
*c	122 mm (4.80 in.)	*d	224 mm (8.82 in.)
*e	79 mm (3.11 in.)	*f	291 mm (11.46 in.)
*g	122 mm (4.80 in.)	*h	156 mm (6.14 in.)
*j	146 mm (5.75 in.)	*k	206 mm (8.11 in.)

Radio Wave Transmission Area	-	-

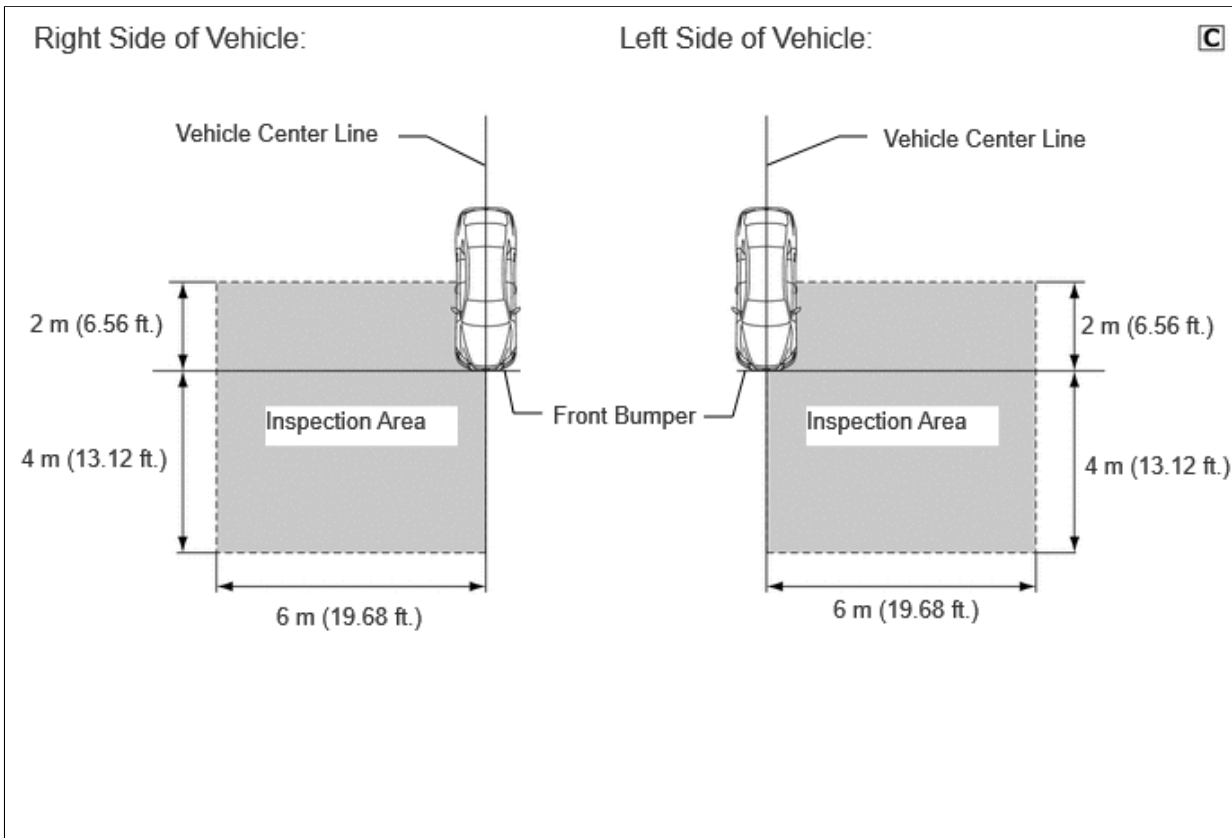
- (a) When performing the front side radar beam axis confirmation, move the vehicle to a place where the space shown in the illustration can be secured.

- Do not place any objects other than the reflector (such as a large metallic object) in the inspection area or allow people to enter the inspection area (W 6 m [19.68 ft.] x L 6 m [19.68 ft.] x H 3 m [9.84 ft.]) shown in the illustration.

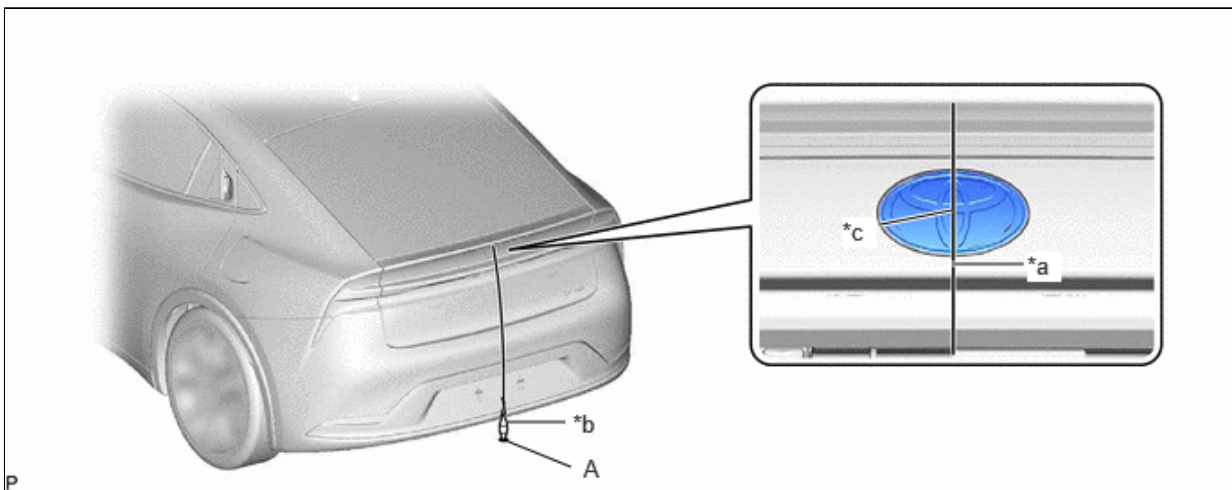
- (1) Hang a weight with a pointed tip from the center of the rear emblem, and mark the rear center point of the vehicle (point A) on the ground.

*a	String	*b	Weight
*c	Center	-	-

Lightly flick the string with your fingers several times to confirm that the string is perpendicular to the ground.

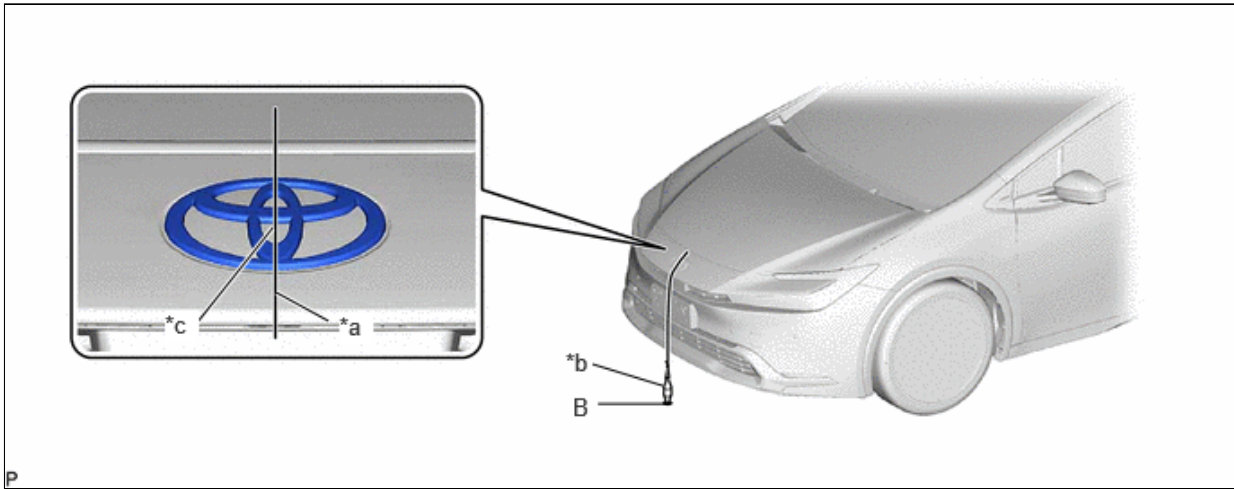
(2) Hang a weight with a pointed tip from the center of the radiator grille (or front panel) emblem, and mark the front center point of the vehicle (point B) on the ground.

*a	String	*b	Weight
*c	Center	-	-

Lightly flick the string with your fingers several times to confirm that the string is perpendicular to the ground.

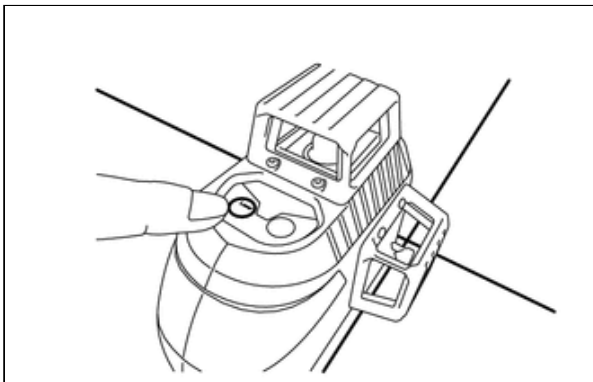
1. Press the laser mode button on the laser line marker to activate the laser line emitters.

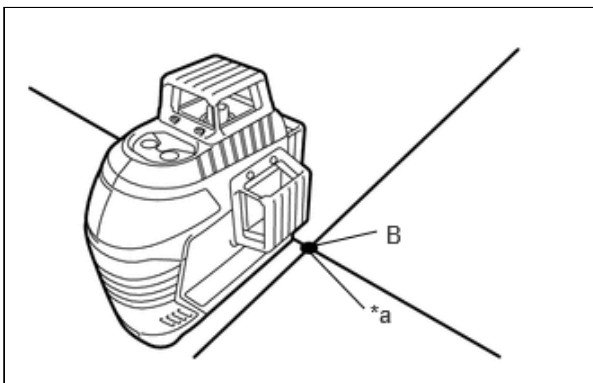
2. Align the laser beam ground marking point (cross portion) with point B.

*a	Ground Marking Point (Cross Portion)
----	--------------------------------------

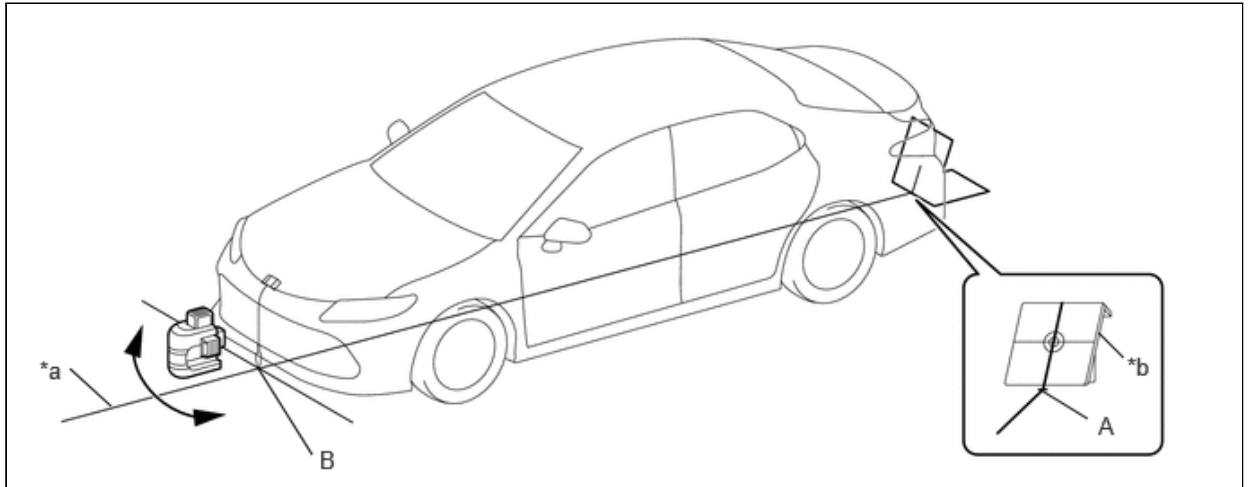
3. Align the center of the target panel with point A, and set the target panel so that it faces forward.

*a	Center Line	*b	Target Panel
----	-------------	----	--------------

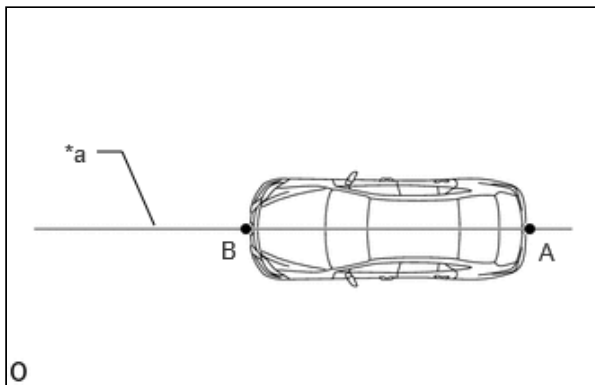
5. Using a laser marker, create a vehicle center line that connects point A and point B.

*a	Vehicle Center Line
----	---------------------

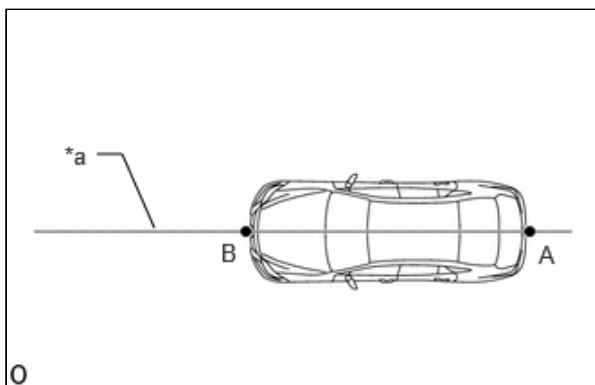
1. Draw a vehicle center line so that it passes through mark A and B (front and rear center points).

*a	Vehicle Center Line
----	---------------------

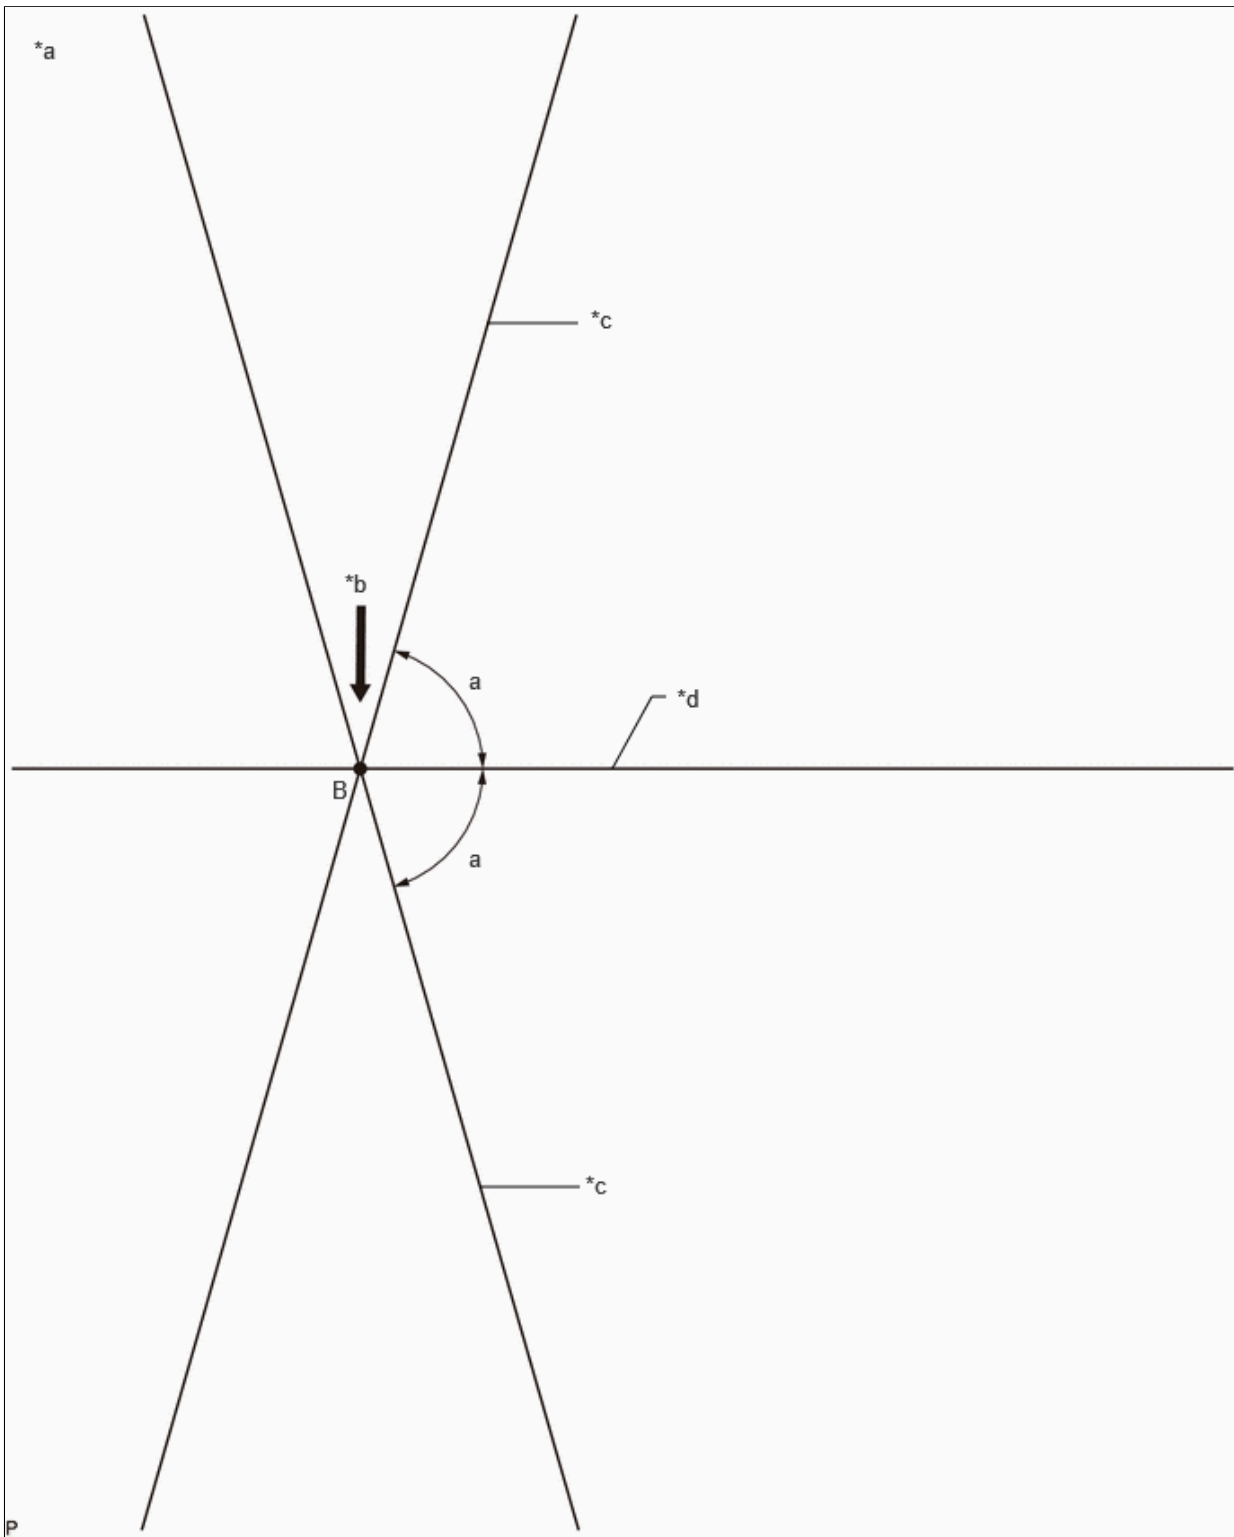
(5) Enlarge and print out the poster shown in the illustration.

*a	Poster	*b	Edge of Front Bumper
*c	Line C	*d	Vehicle Center Line

PART	ANGLE
a	74°

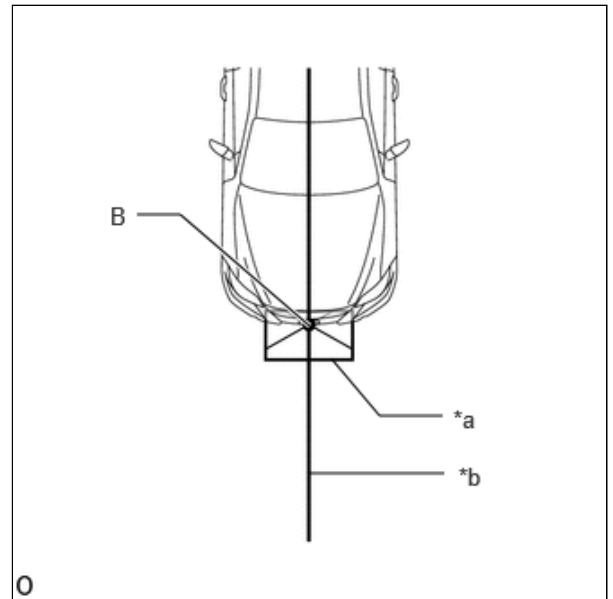
(6) Attach the printed poster to the floor with the vehicle center line aligned with point B as shown in the illustration.

*a	Poster
*b	Vehicle Center Line

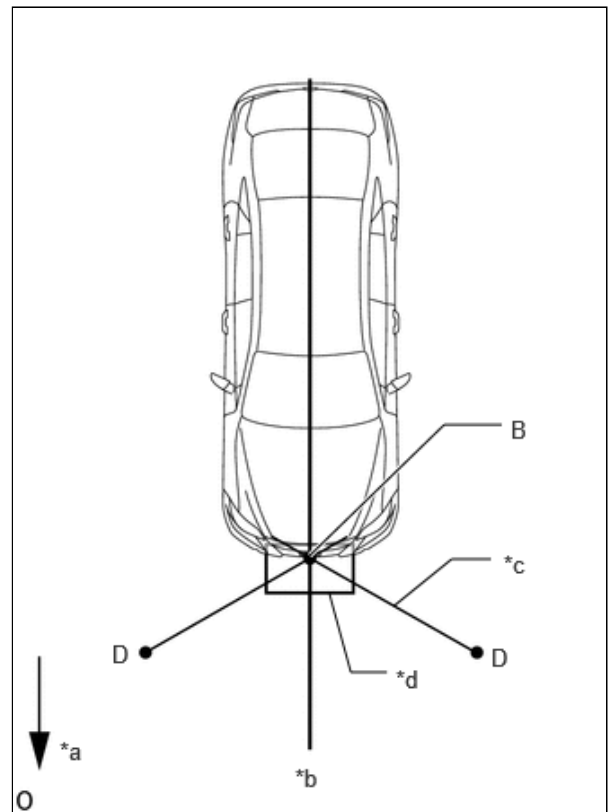
(7) Align a piece of string with line C and mark point D at a distance of 3088 mm (10.13 ft.) from point B.

*a	Vehicle Front
*b	Vehicle Center Line
*c	String
*d	Poster

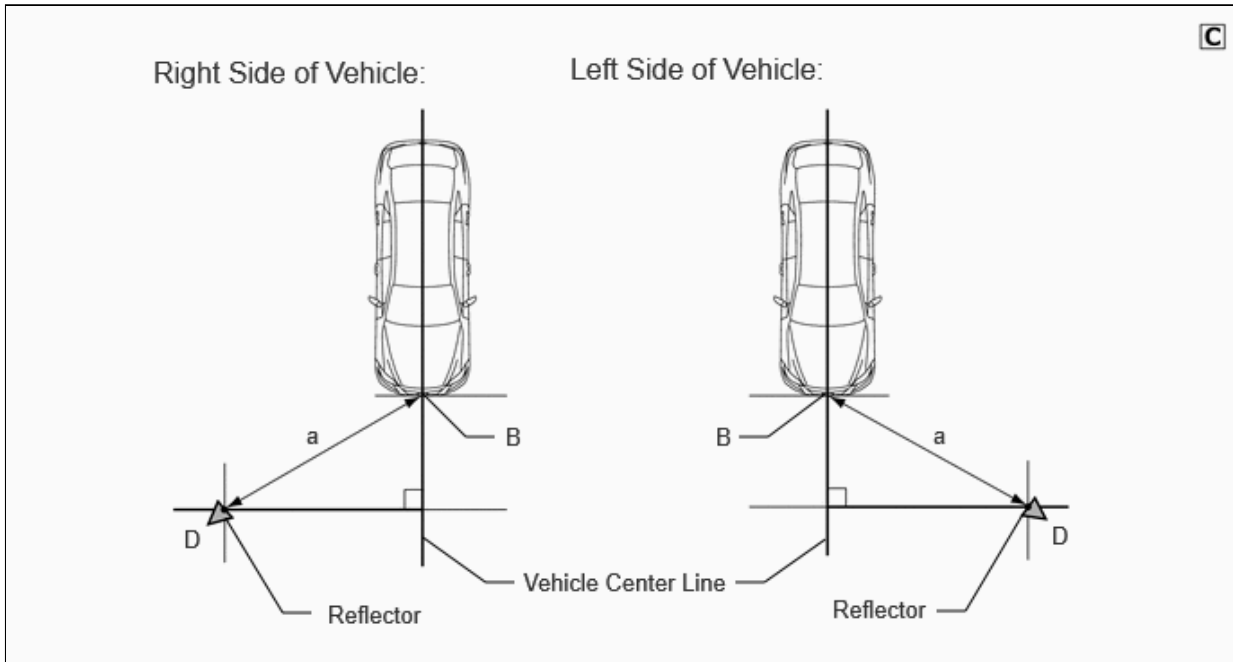
(8) Set the reflector at the point D shown in the illustration below.

PART	LENGTH
a	3088 mm (10.13 ft.)

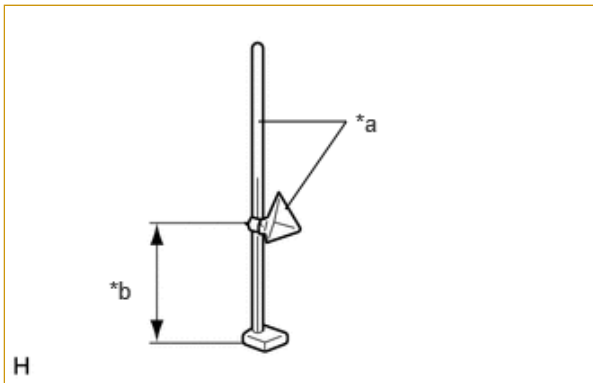
- Set the reflector so that its center is 551 mm (1.81 ft.) above the ground.

*a	SST (reflector)
*b	551 mm (1.81 ft.)

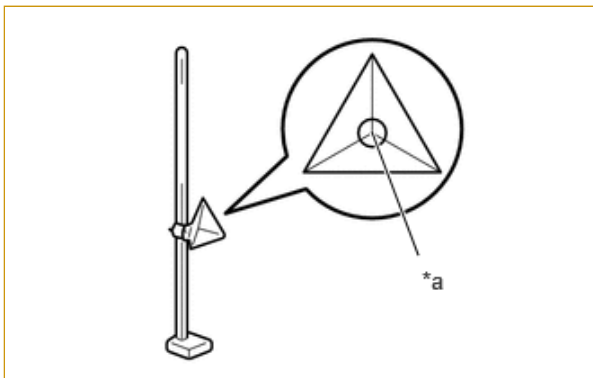
- The center of the triangular pyramid is the reference point for the setting position and angle.

\*a Center of Triangular Pyramid

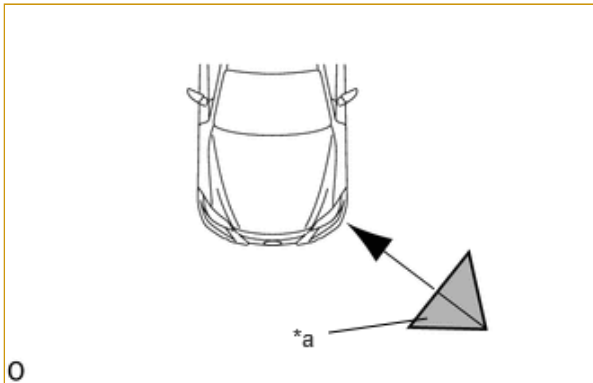
\*a SST (reflector)
