Last Modified: 12-04-2024	6.11:8.1.0	Doc ID: RM100000002A06U
Model Year Start: 2023	Model: Prius	Prod Date Range: [12/2022 -]
Title: PA10/PB10/PB12 (HYBRID TRANSMISSION / TRANSAXLE): PA10 HYBRID VEHICLE TRANSAXLE: REMOVAL; 2023 - 2024 MY Prius [12/2022 -]

REMOVAL

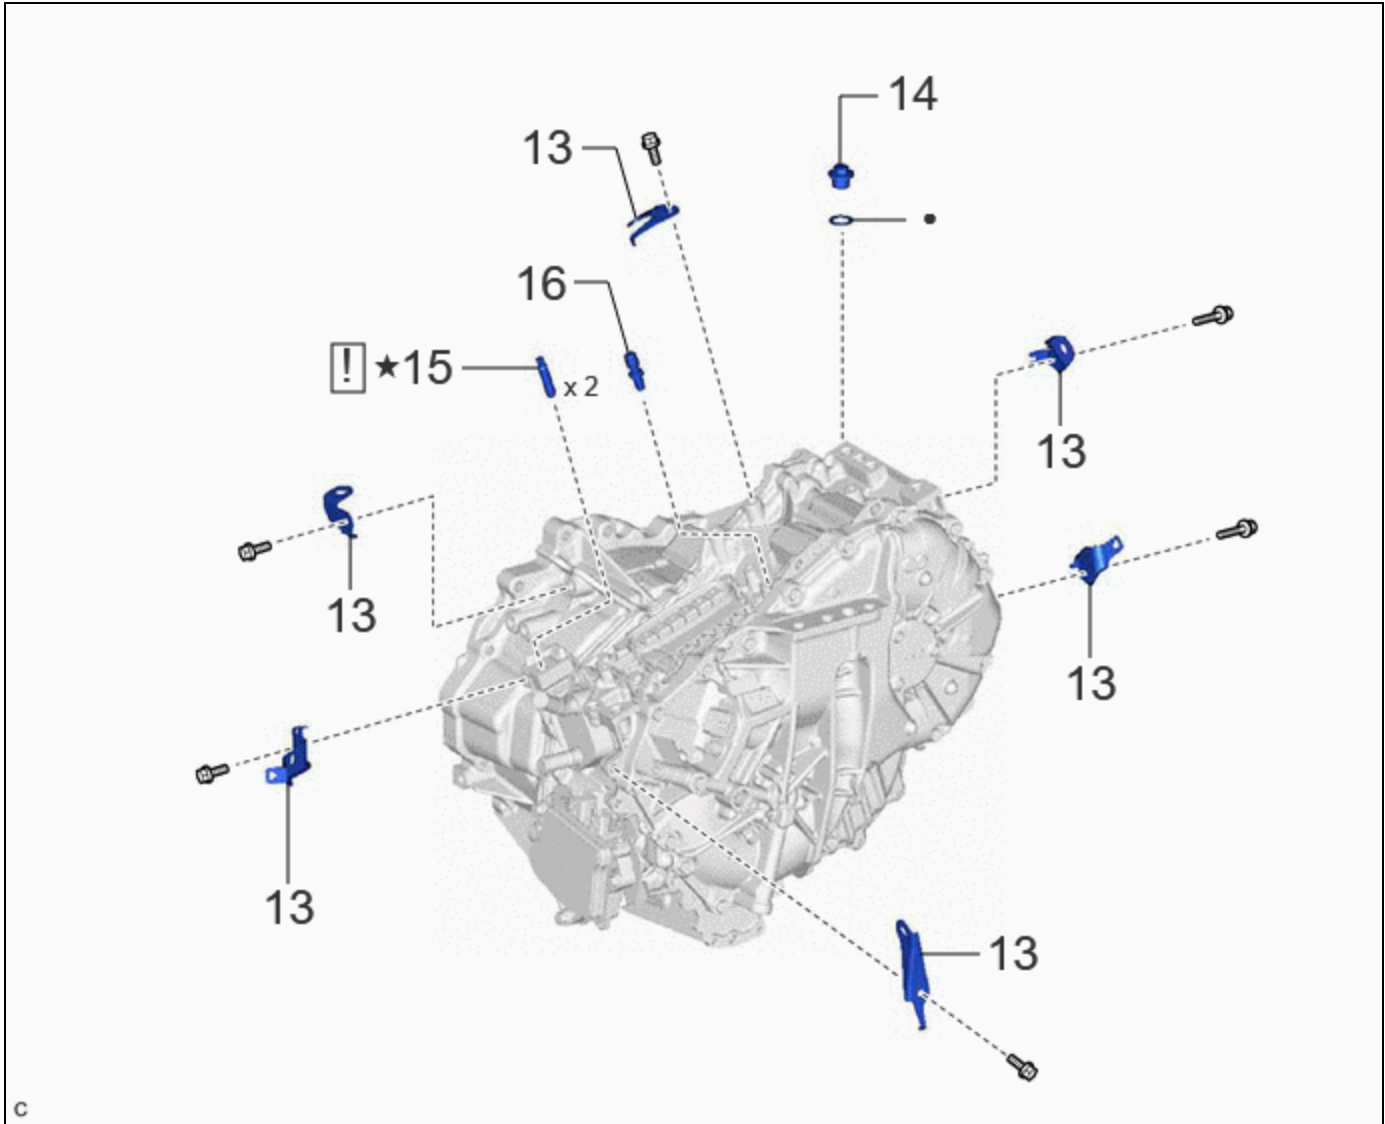
13	WIRE HARNESS CLAMP BRACKET	-	-	-	-
14	TRANSAXLE HOUSING PLUG	-	-	-	-
15	STUD BOLT	-

-	-
16	TRANSAXLE BREATHER PLUG	30900N	-	-	-

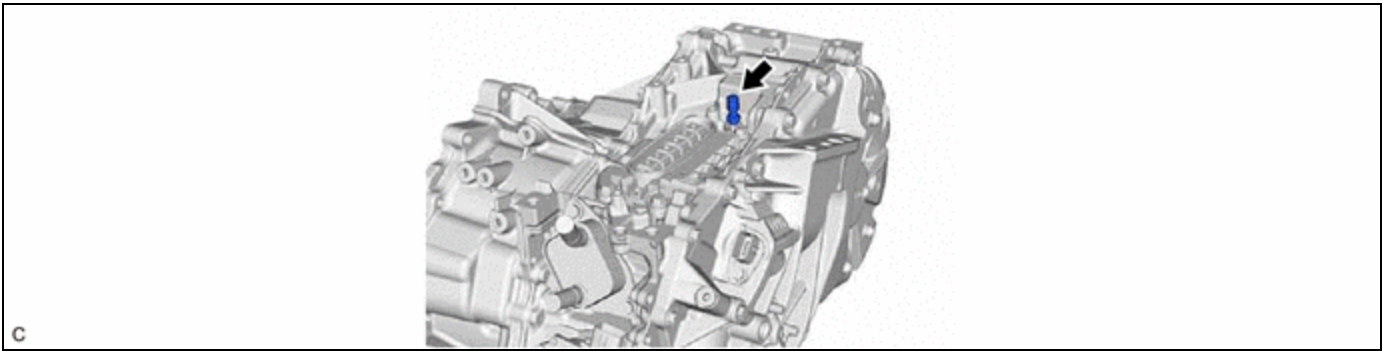
16. REMOVE TRANSAXLE BREATHER PLUG

Perform this procedure only when replacement of the transaxle breather plug is necessary.
