Last Modified: 12-04-2024	6.11:8.1.0	Doc ID: RM10000002A070
Model Year Start: 2023	Model: Prius Prime	Prod Date Range: [12/2022 -]
Title: PA10/PB10/PB12 (HYBRID TRANSMISSION / TRANSAXLE): SHIFT CONTROL ACTUATOR: REMOVAL; 2023 - 2024 MY Prius Prime [12/2022 -]

REMOVAL

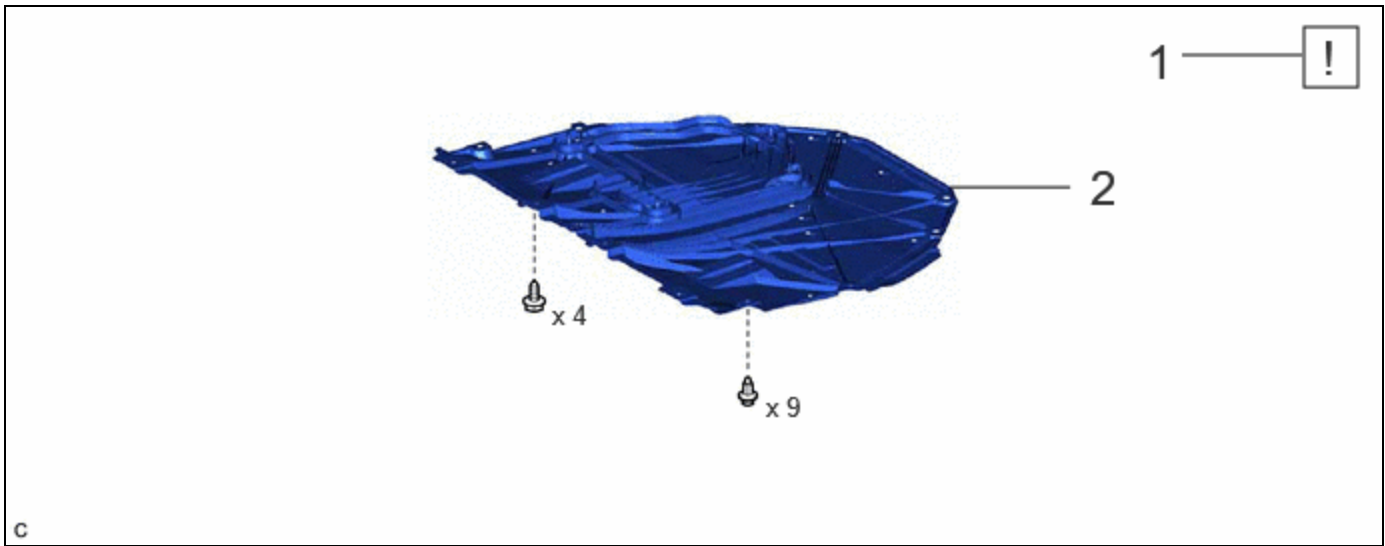
COMPONENTS (REMOVAL)

1	SECURE VEHICLE	-	INFO	-	-
2	NO. 1 ENGINE UNDER COVER ASSEMBLY	51410	-	-	-

PROCEDURE	PART NAME CODE	!		
3 SHIFT CONTROL ACTUATOR ASSEMBLY	35580	INFO	-	-
4 SHIFT CONTROL ACTUATOR BRACKET	35541	-	-	-
5 SHIFT CONTROL ACTUATOR SEAL	35563	INFO	-	-

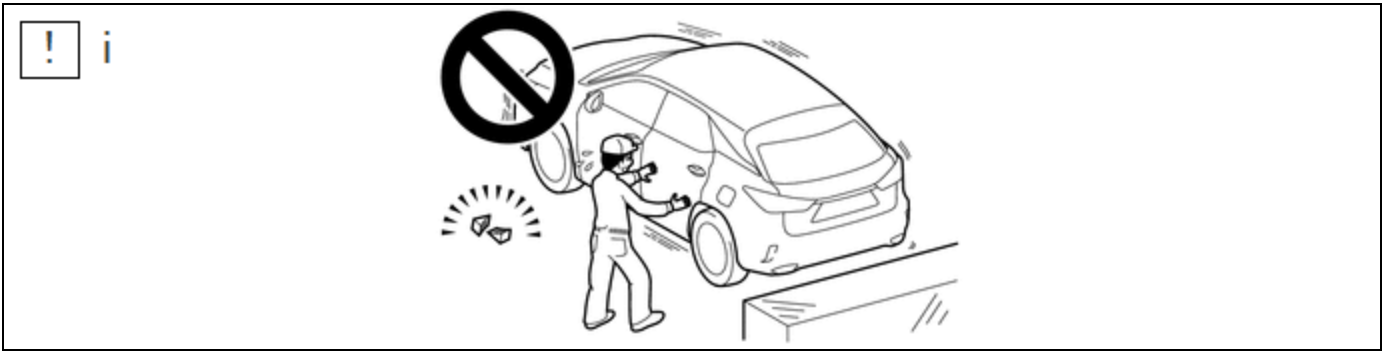
1. SECURE VEHICLE

(1) Fully apply the parking brake and chock a wheel.

- Make sure to apply the parking brake and chock a wheel before performing this procedure.
- If the vehicle is not secure and the shift lever is moved to N, the vehicle may suddenly move, possibly resulting in an accident or serious injury.

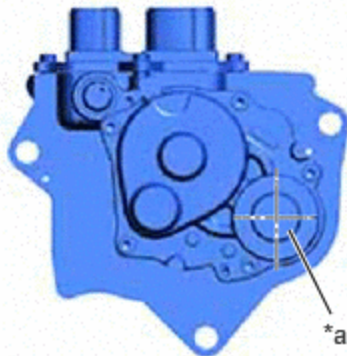
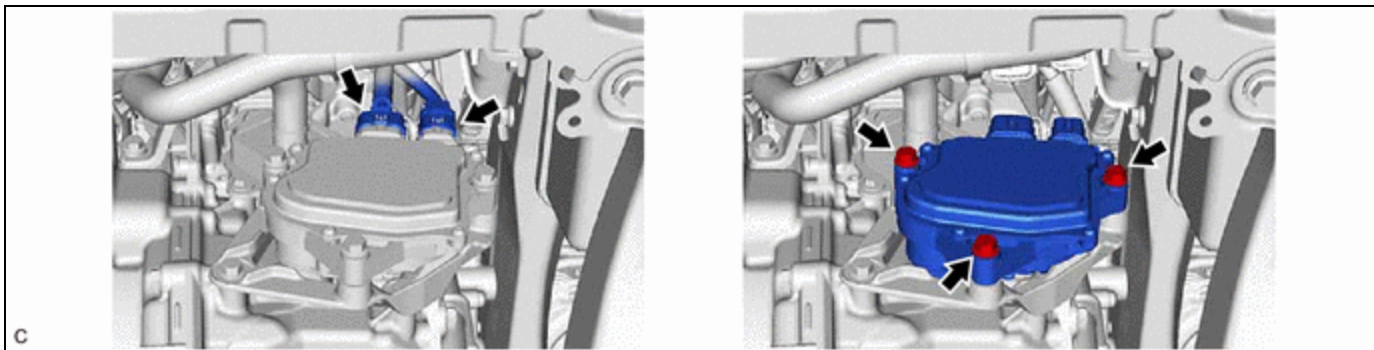
3. REMOVE SHIFT CONTROL ACTUATOR ASSEMBLY

- When disconnecting a wire harness of any component connected to the supply power of the integrated capacitor (integration control supply) or when removing the integrated capacitor (integration control supply), make sure to wait 5 minutes or more after turning the ignition switch off for self-diagnosis to complete and the voltage of the integrated capacitor (integration control supply) to discharge.
- Do not rotate the spline part (*a) of the shift control actuator assembly.

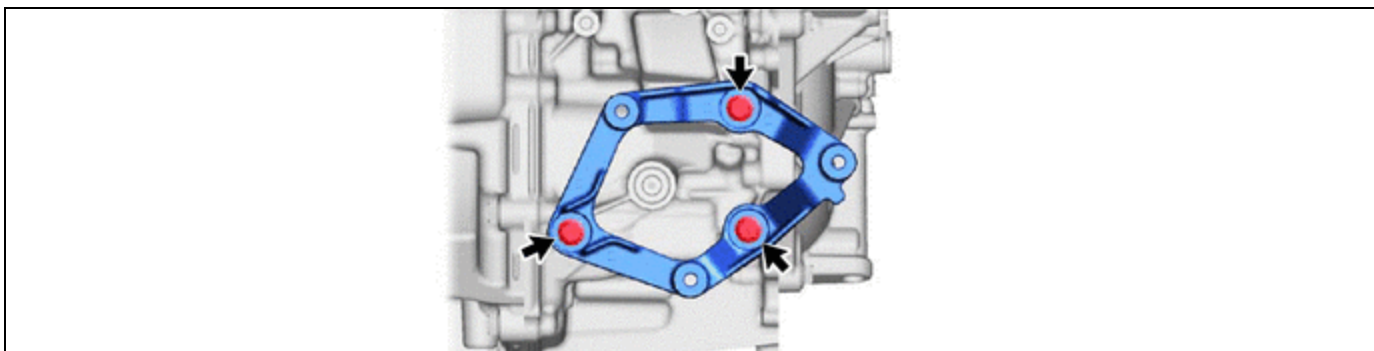
4. REMOVE SHIFT CONTROL ACTUATOR BRACKET

Perform this procedure only when replacement of the shift control actuator bracket is necessary.

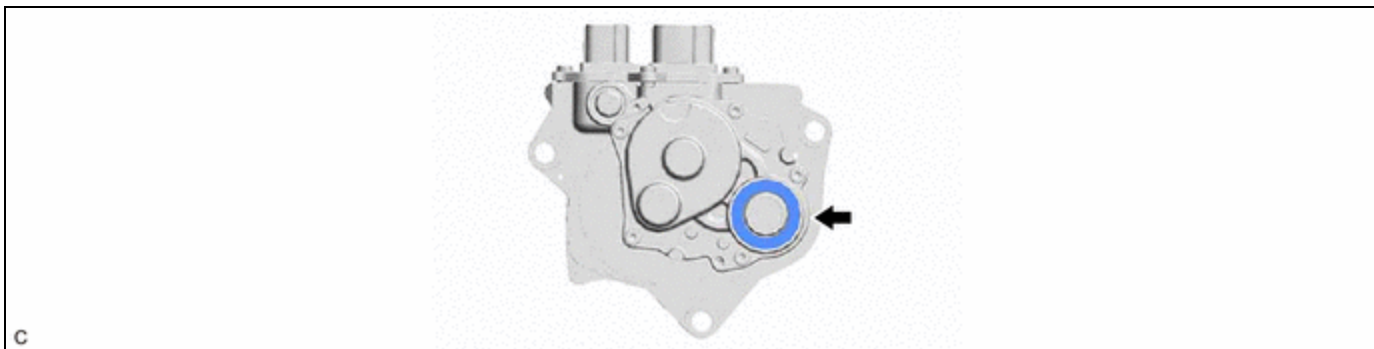
5. REMOVE SHIFT CONTROL ACTUATOR SEAL

- Remove all fragments of the shift control actuator seal.
- The shift control actuator seal may remain attached to the hybrid vehicle transaxle assembly side. Make sure to remove it.
- Do not use a sharp tool such as a scraper.

Perform this procedure only when replacement of the shift control actuator seal is necessary.
