Last Modified: 12-04-2024	6.11:8.1.0	Doc ID: RM100000002BJB8
Model Year Start: 2023	Model: Prius Prime	Prod Date Range: [03/2023 -]
Title: SEAT: LUMBAR SUPPORT ADJUSTER ASSEMBLY: REMOVAL; 2023 - 2024 MY Prius Prius Prime [03/2023 -]

REMOVAL

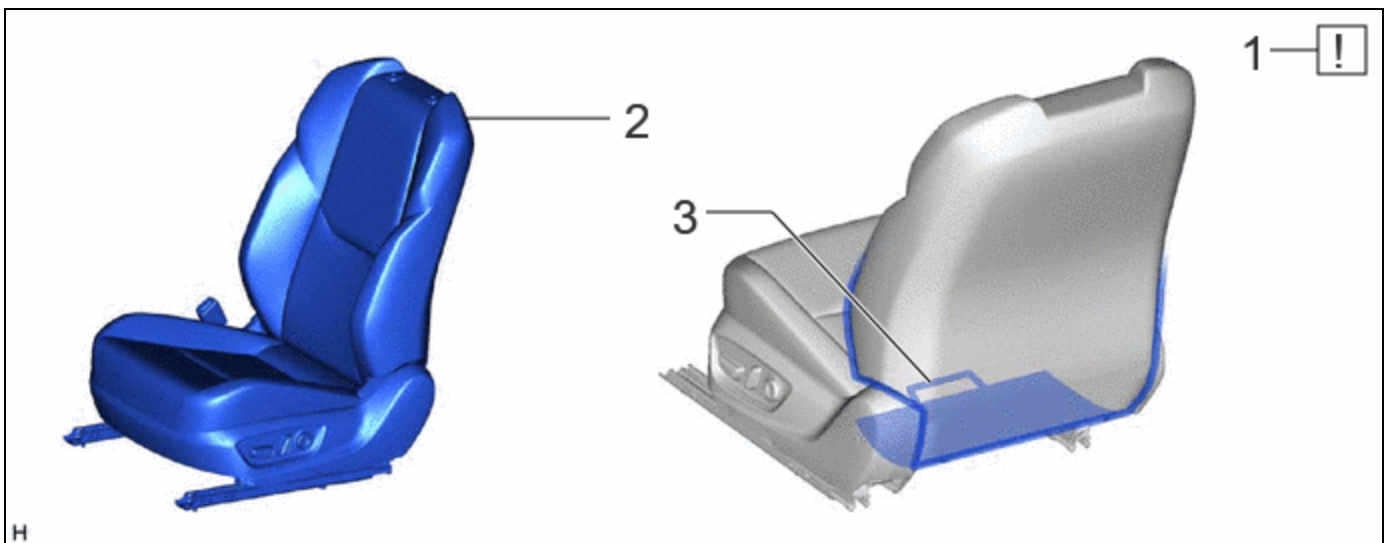
COMPONENTS (REMOVAL)

PROCEDURE	PART NAME CODE			
1 PRECAUTION	-	INFO	-	-

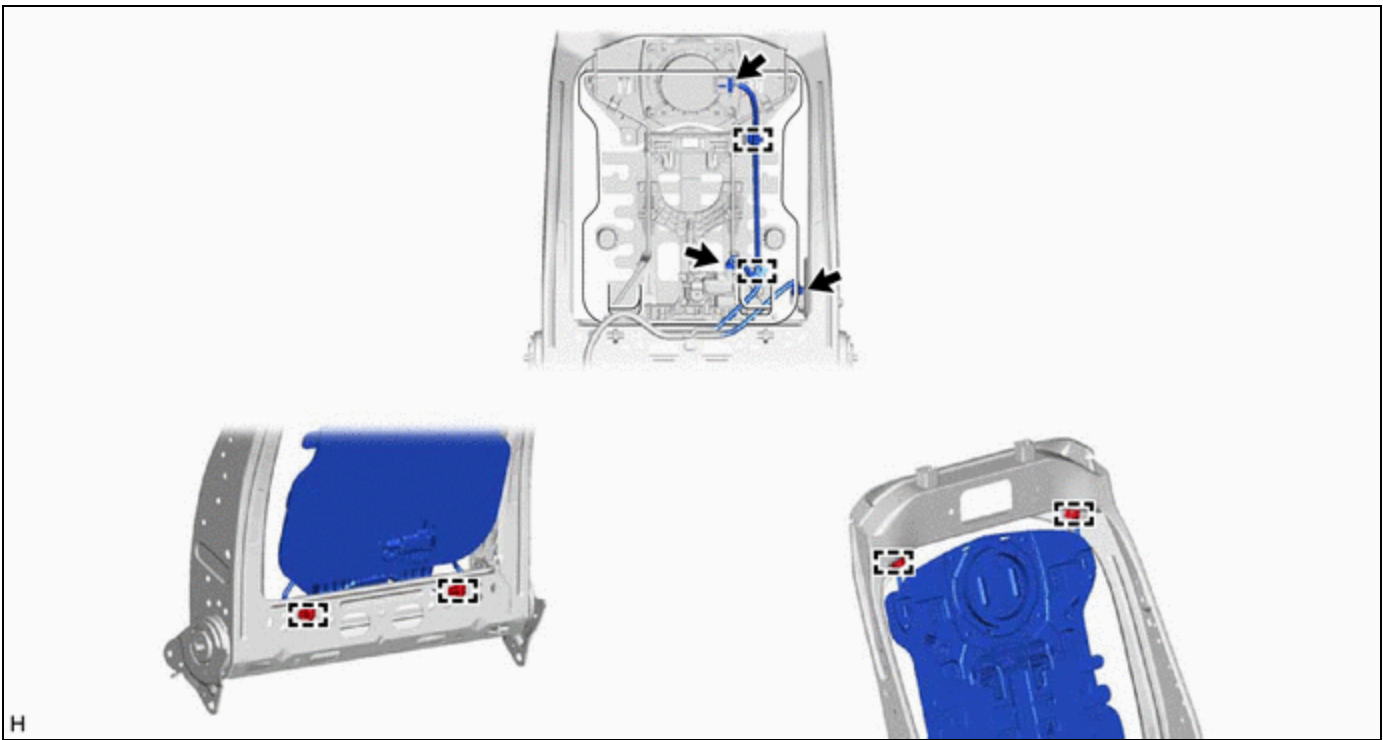
10. REMOVE LUMBAR SUPPORT ADJUSTER ASSEMBLY

As the illustration shown is an example, the actual details may differ.

10	LUMBAR SUPPORT ADJUSTER ASSEMBLY	72760D	-	-	-
11	FRONT SEATBACK FELT	79977H	-	-	-
12	SEATBACK CLIMATE CONTROL BLOWER	85867A	-	-	-
13	FRONT NO. 2 SEATBACK EDGE PROTECTOR	71588	-	-	-
