<b>Last Modified:</b> 12-04-2024	6.11:8.1.0	<b>Doc ID:</b> RM100000029ZW8
<b>Model Year Start:</b> 2023	<b>Model:</b> Prius Prime	<b>Prod Date Range:</b> [12/2022 - ]
<b>Title:</b> HEATING / AIR CONDITIONING: AMBIENT TEMPERATURE SENSOR: REMOVAL; 2023 - 2024 MY Prius Prius Prime [12/2022 - ]

## REMOVAL

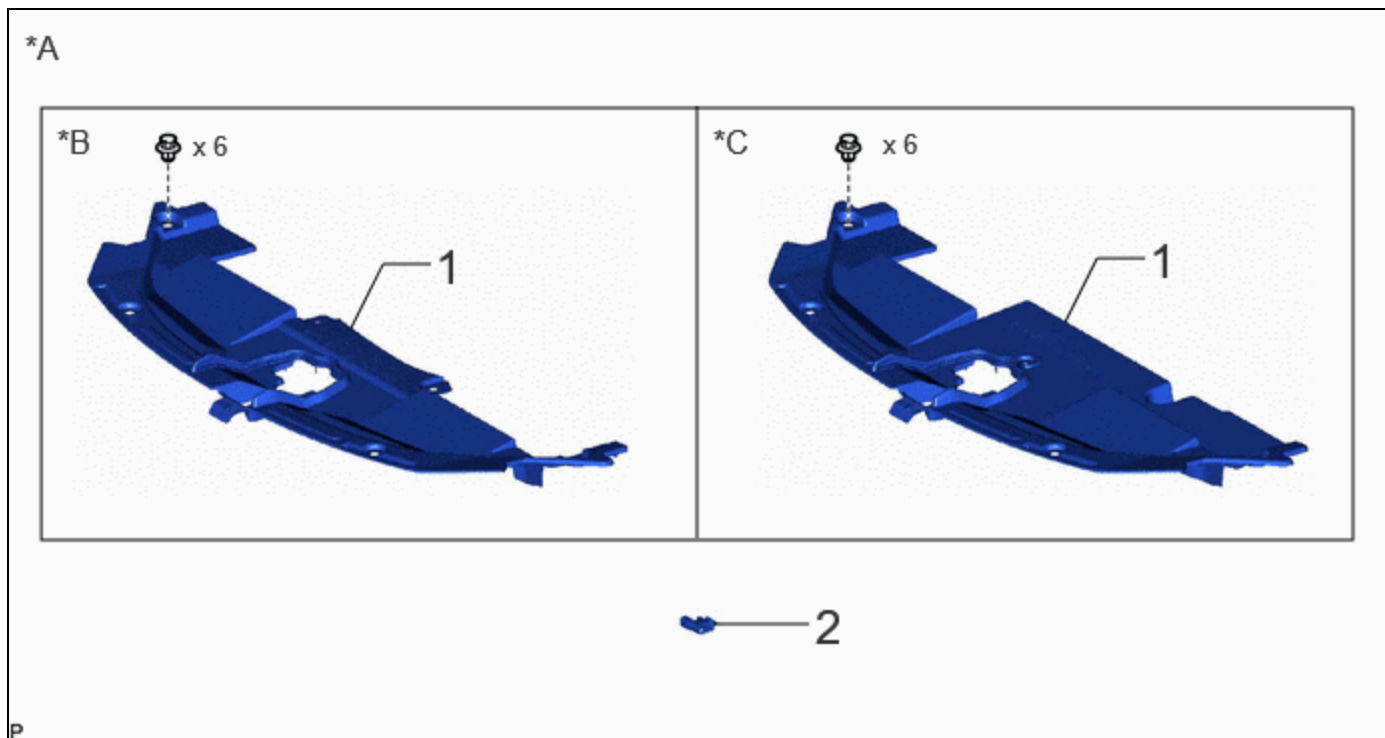
#### COMPONENTS (REMOVAL)

1	RADIATOR SUPPORT OPENING COVER	53289A	-	-	-
2	THERMISTOR ASSEMBLY	88790B	-	-	-

*A	w/o Grille Shutter	*B	for M20A-FXS
*C	for 2ZR-FXE	-	-

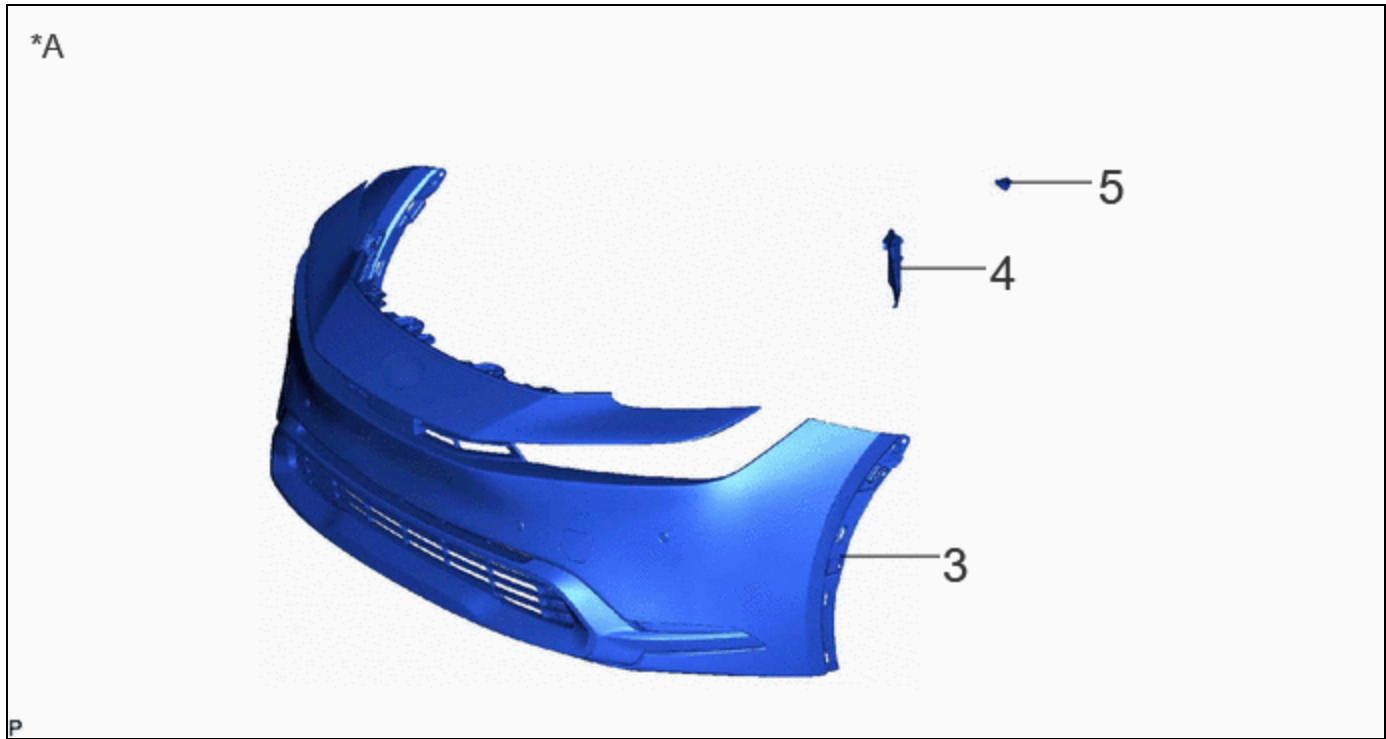
3	FRONT BUMPER ASSEMBLY	-	-	-	-
4	FRONT RADIATOR SIDE AIR GUIDE PLATE LH	16695A	-	-	-
5	THERMISTOR ASSEMBLY	88790B	-	-	-

*A	w/ Grille Shutter	-	-
----	-------------------	---	---

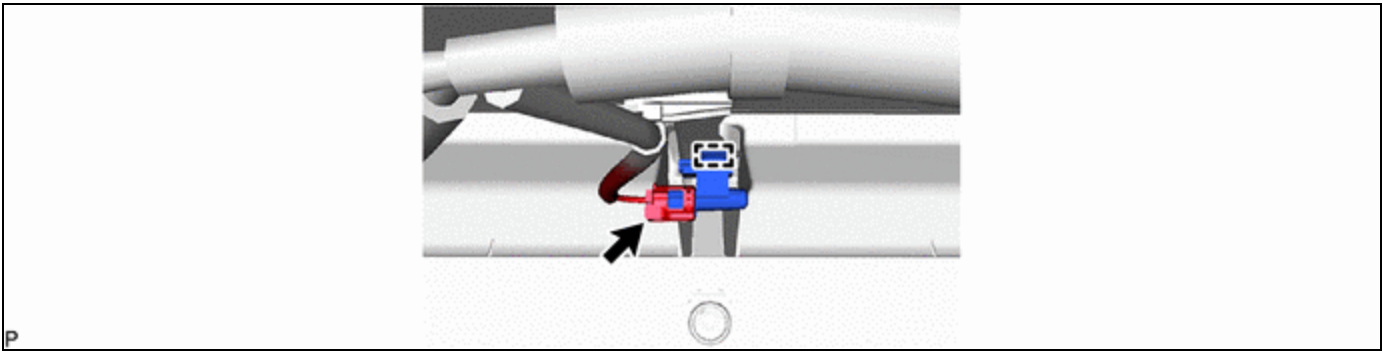
### 2. REMOVE THERMISTOR ASSEMBLY (w/o Grille Shutter)

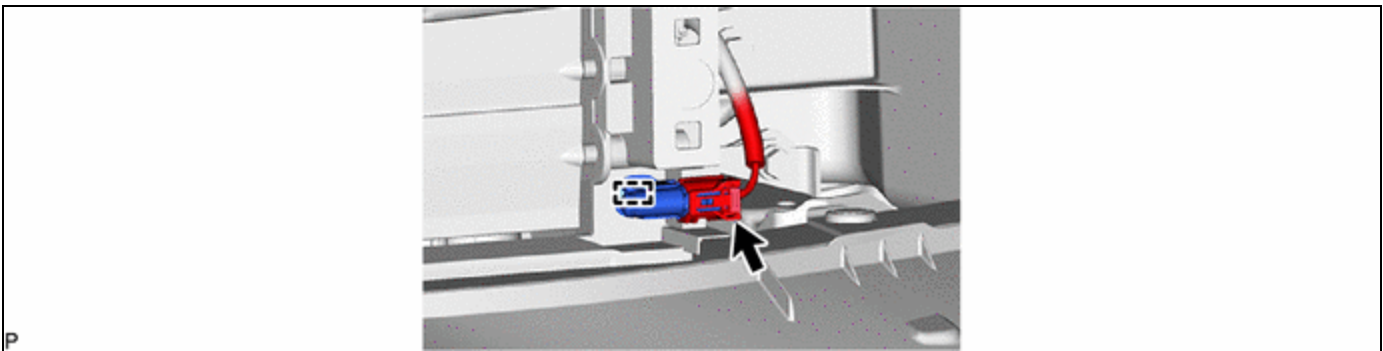
**5. REMOVE THERMISTOR ASSEMBLY (w/ Grille Shutter)**
