<b>Last Modified:</b> 12-04-2024	6.11:8.1.0	<b>Doc ID:</b> RM100000002B1EK
<b>Model Year Start:</b> 2023	<b>Model:</b> Prius Prime	<b>Prod Date Range:</b> [03/2023 - ]
<b>Title:</b> INTERIOR PANELS / TRIM: FLOOR CARPET: REMOVAL; 2023 - 2024 MY Prius Prius Prime [03/2023 - ]

## REMOVAL

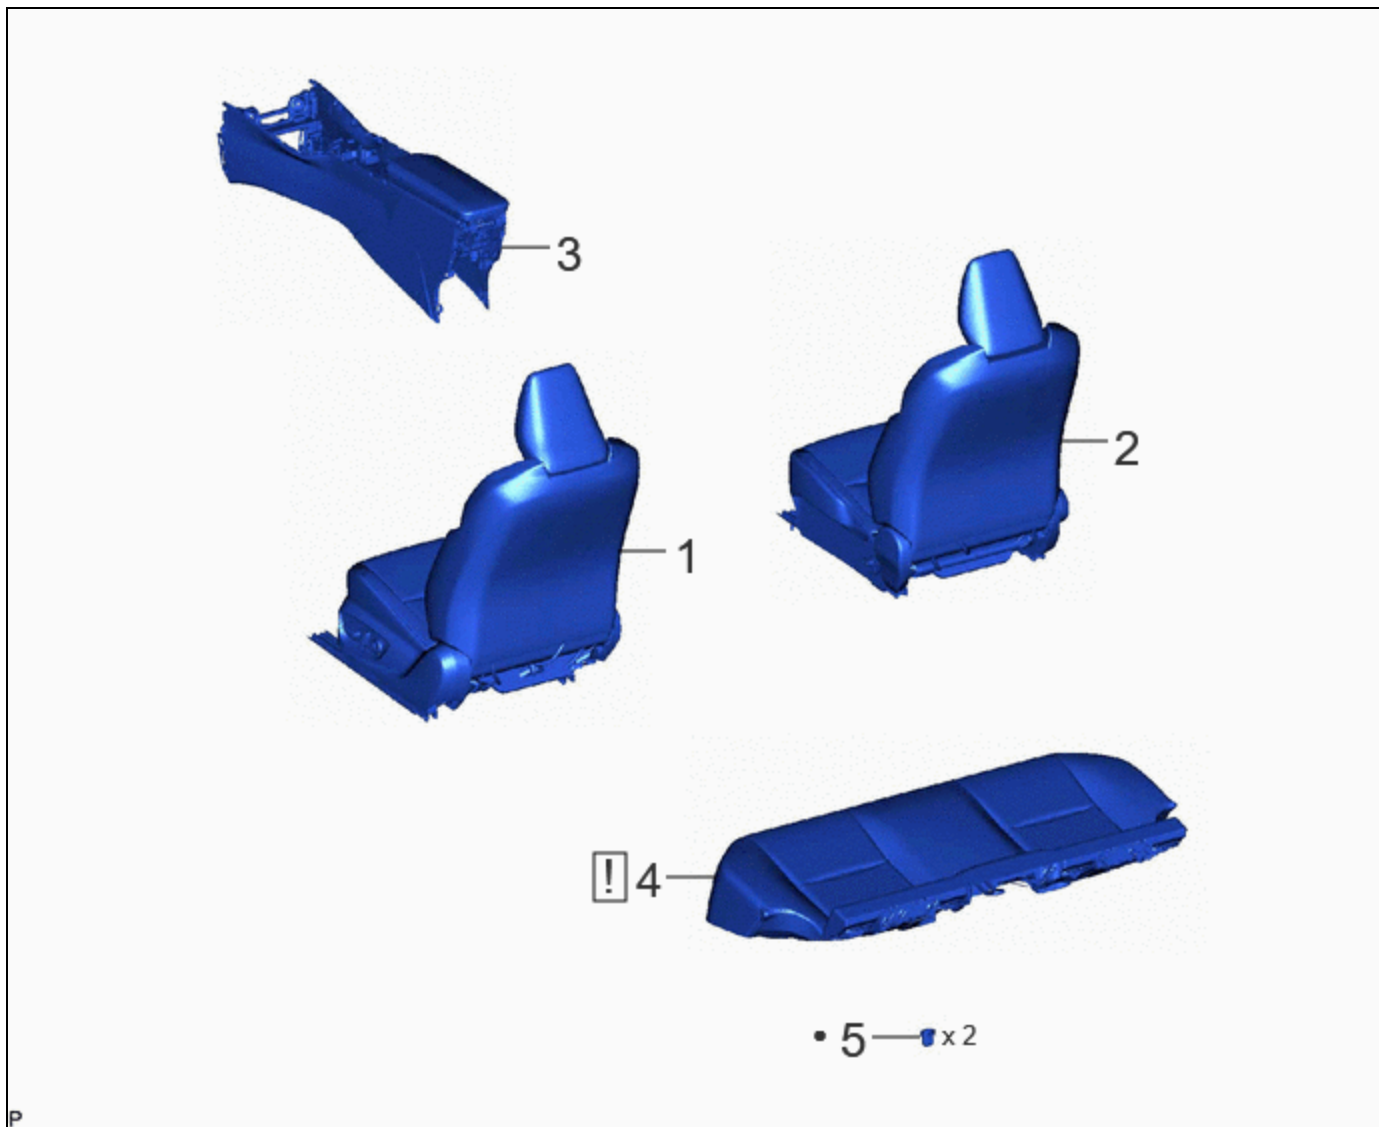
1	FRONT SEAT ASSEMBLY LH	-	-	-	-
2	FRONT SEAT ASSEMBLY RH	-	-	-	-
3	REAR CONSOLE BOX ASSEMBLY	-	-	-	-
4	REAR SEAT CUSHION ASSEMBLY	-	<a href="#">INFO</a>	-	-
5	REAR SEAT CUSHION LOCK HOOK	72693	-	-	-

•	Non-reusable part	-	-
---	-------------------	---	---

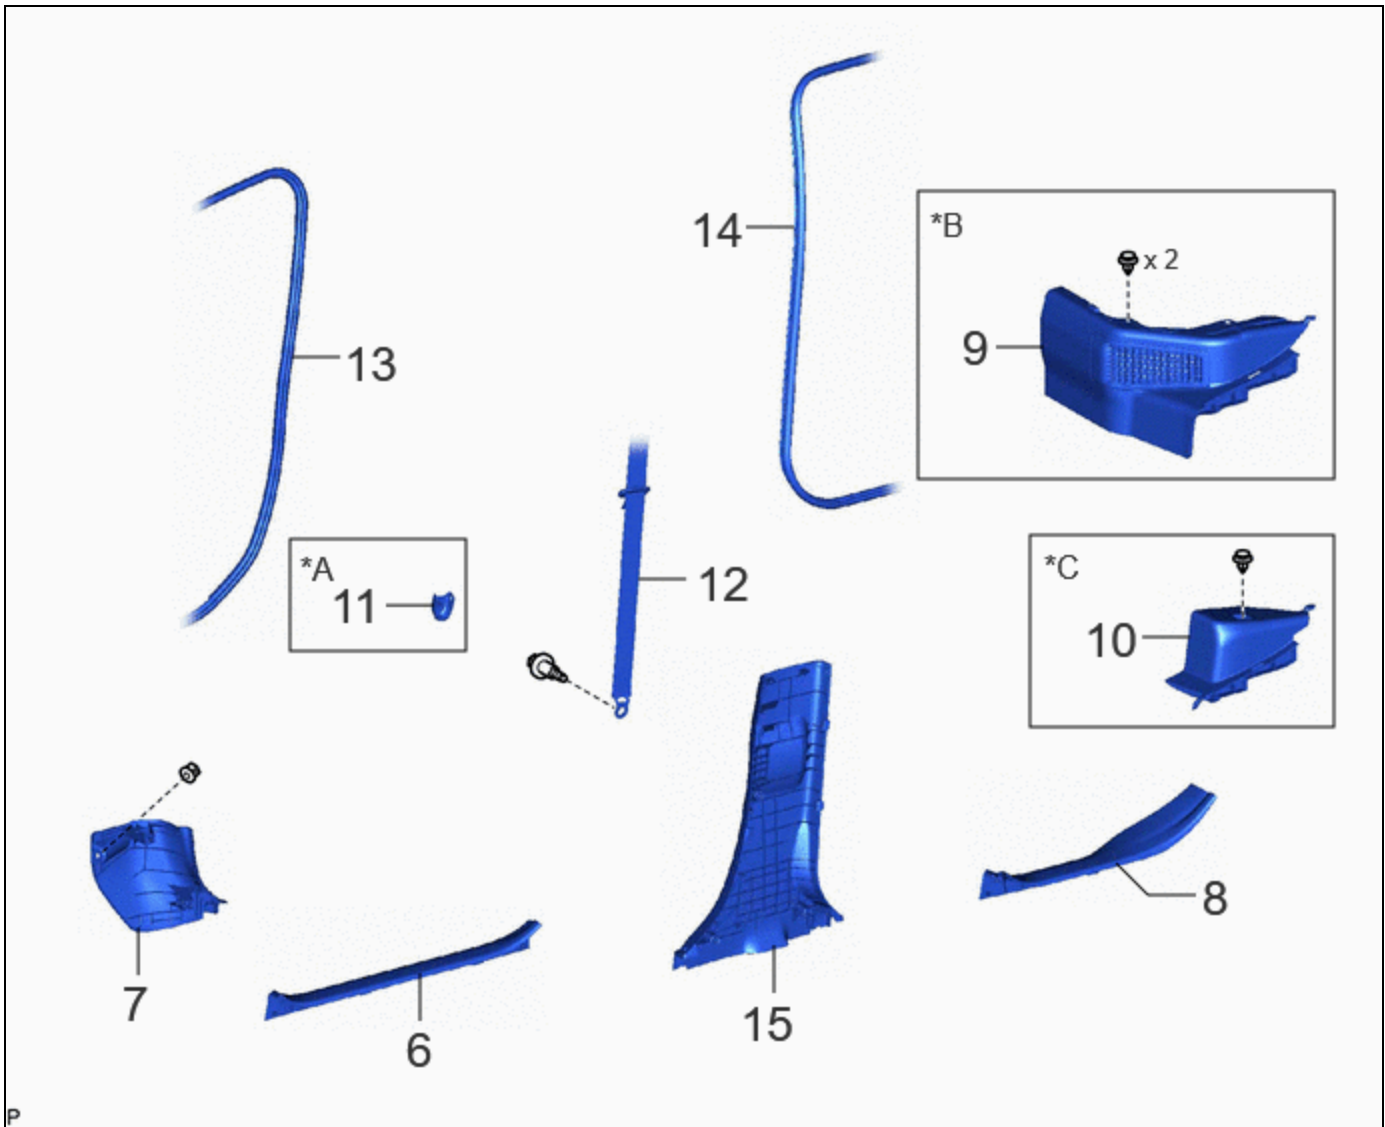
PROCEDURE		PART NAME CODE			
6	FRONT DOOR SCUFF PLATE LH	67914	-	-	-
7	COWL SIDE TRIM BOARD LH	62112	-	-	-
8	REAR DOOR SCUFF PLATE INSIDE LH	67918F	-	-	-
9	REAR UNDER SIDE COVER LH	76974E	-	-	-
10	REAR SEAT CUSHION COVER LH	72998	-	-	-
11	LAP BELT OUTER ANCHOR COVER	73233	-	-	-
12	FRONT SEAT OUTER BELT ASSEMBLY LH	73220	-	-	-
13	FRONT DOOR OPENING TRIM WEATHERSTRIP LH	62312B	-	-	-
14	REAR DOOR OPENING TRIM WEATHERSTRIP LH	62332A	-	-	-
15	CENTER PILLAR LOWER GARNISH LH	62414A	-	-	-

*A	for LH Side	*B	for HEV Model
----	-------------	----	---------------

*C	for PHEV Model	-	-
----	----------------	---	---

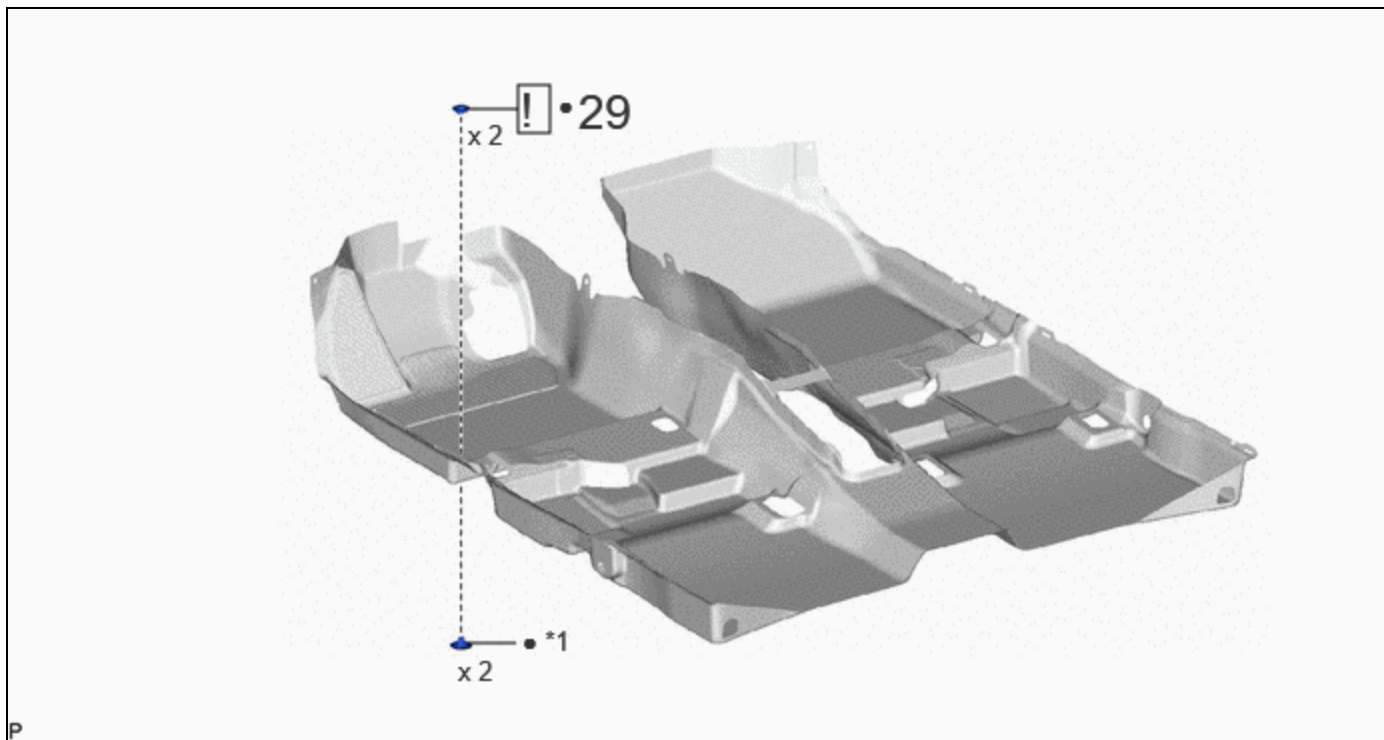
PROCEDURE		PART NAME CODE			
29	MAT SET UPPER PLATE	58694B	<a href="#">INFO</a>	-	-

*1	MAT SET LOWER PLATE	-	-
•	Non-reusable part	-	-
