<b>Last Modified:</b> 12-04-2024	6.11:8.1.0	<b>Doc ID:</b> RM100000002B7BL
<b>Model Year Start:</b> 2023	<b>Model:</b> Prius Prime	<b>Prod Date Range:</b> [03/2023 - ]
<b>Title:</b> HYBRID / BATTERY CONTROL: SERVICE PLUG GRIP (for PHEV Model): REMOVAL; 2023 - 2024 MY Prius Prime [03/2023 - ]

## REMOVAL

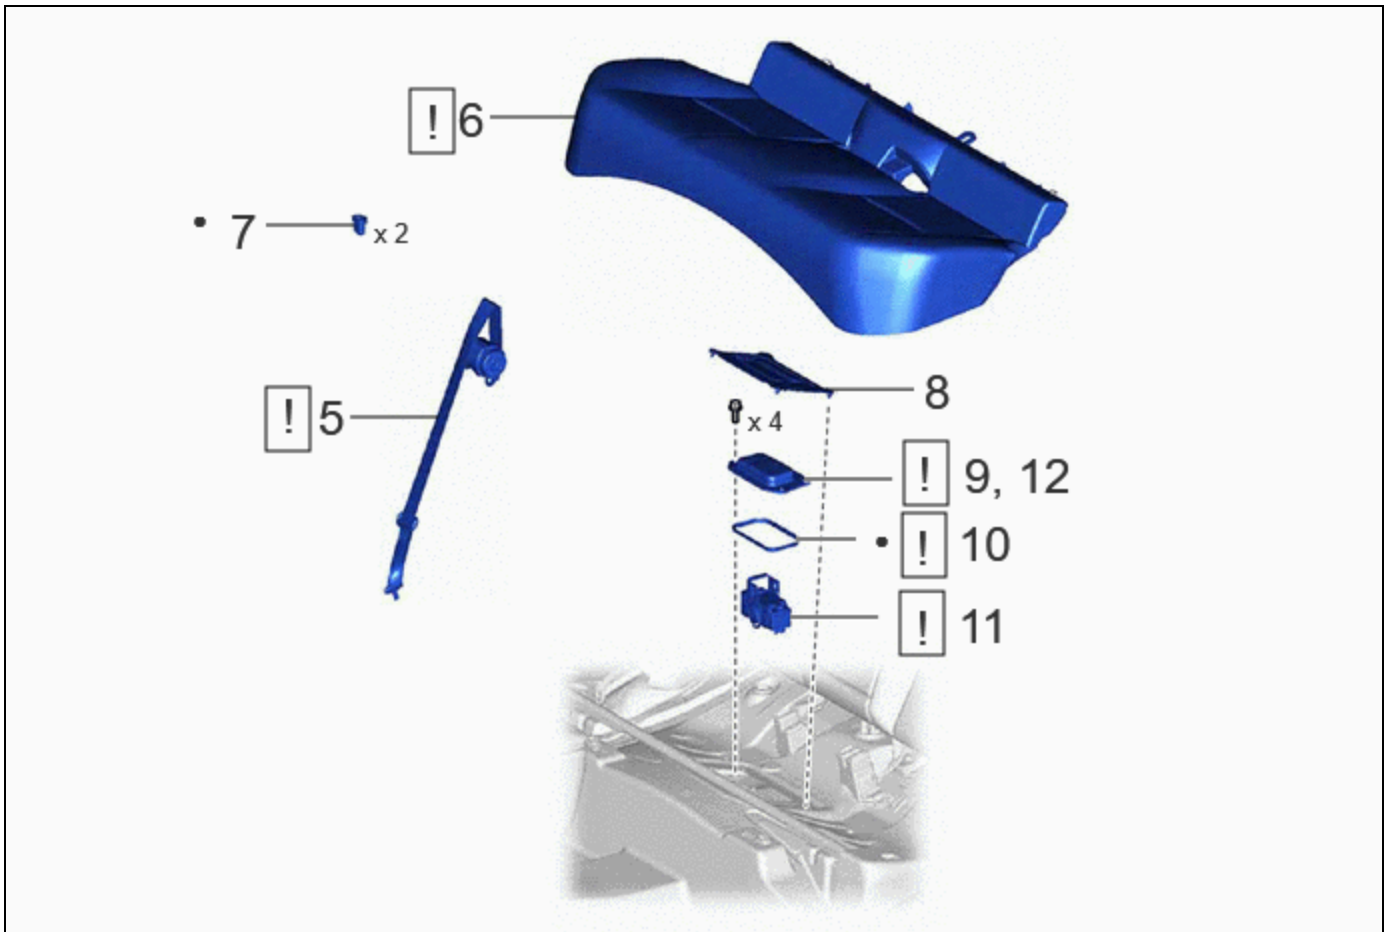
PROCEDURE		PART NAME CODE			
5	REAR CENTER SEAT OUTER BELT ASSEMBLY	73350C	<a href="#">INFO</a>	-	-
6	REAR SEAT CUSHION ASSEMBLY	-	<a href="#">INFO</a>	-	-
7	REAR SEAT CUSHION LOCK HOOK	72693	-	-	-
8	REAR FLOOR SERVICE HOLE COVER	58325E	-	-	-
9	REMOVE NO. 2 TRACTION BATTERY COVER	G9622	<a href="#">INFO</a>	-	-
10	NO. 1 HYBRID BATTERY REAR SHIELD SEAL	G92DF	<a href="#">INFO</a>	-	-
11	SERVICE PLUG GRIP	G3834	<a href="#">INFO</a>	-	-
12	TEMPORARILY INSTALL NO. 2 TRACTION BATTERY COVER	G9622	<a href="#">INFO</a>	-	-

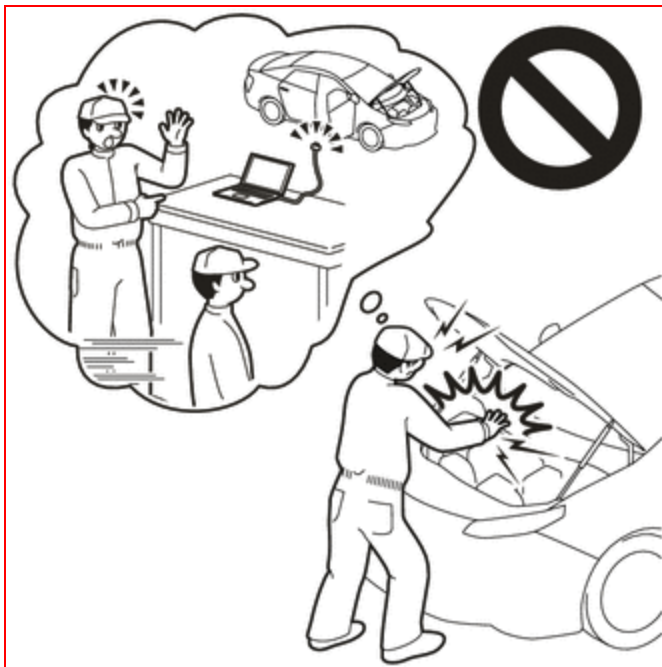
- Confirm that DTC P0AA649 (Hybrid / EV Battery Voltage System Isolation Internal Electronic Failure), P1C7C49 (Hybrid / EV Battery Voltage System Isolation (A/C Area) Internal Electronic Failure), P1C7D49 (Hybrid / EV Battery Voltage System Isolation (Hybrid/EV Battery Area) Internal Electronic Failure), P1C7E49 (Hybrid / EV Battery Voltage System Isolation (Transaxle Area) Internal Electronic Failure) or P1C7F49 (Hybrid / EV Battery Voltage System Isolation (Direct Current Area) Internal Electronic Failure), P1C8049 (Hybrid/EV Battery Voltage System Isolation (Rear Motor Area) Internal Electronic Failure, for 4WD/AWD), P1CF749 (Hybrid/EV Battery Voltage System Isolation (Charger Area) Internal Electronic Failure), P33CF49 (Hybrid/EV Battery Voltage System Isolation Internal Electronic Failure Abnormal Area Detection Failure) is not output before removing or installing the HV battery. If this DTC is output, perform troubleshooting for this DTC first.

- To reduce the risk of electric shock, do not perform troubleshooting before checking for DTCs.

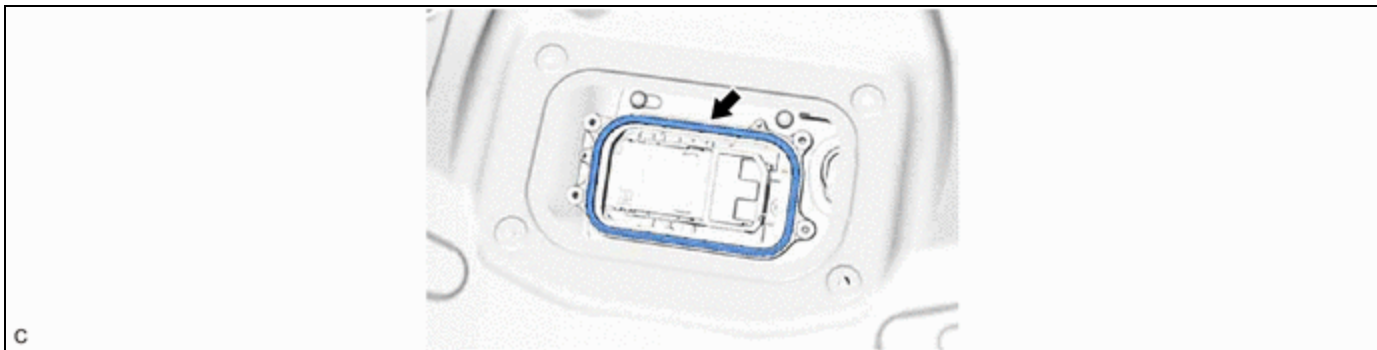
### 10. REMOVE NO. 1 HYBRID BATTERY REAR SHIELD SEAL

<b>CAUTION:</b> Be sure to wear insulated gloves.
---	--

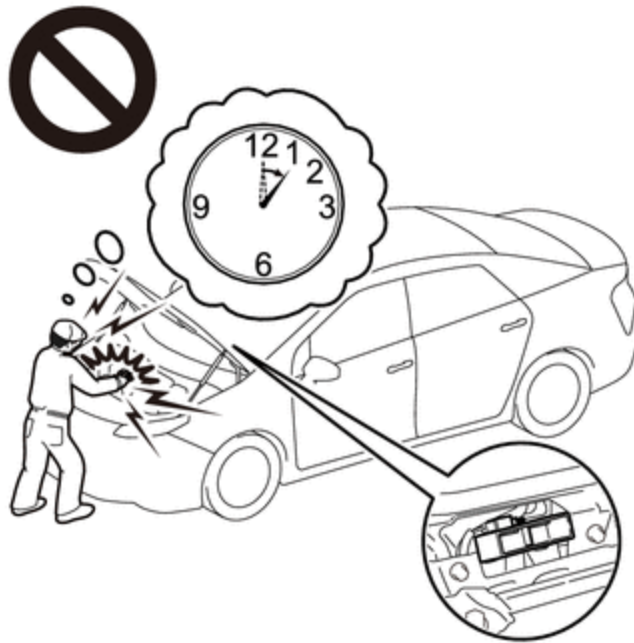
- To reduce the risk of electric shock, make sure to remove the service plug grip to cut off the high voltage circuit before servicing the vehicle.
- To reduce the risk of electric shock, make sure to wait at least 10 minutes after removing the service plug grip to fully discharge the high voltage capacitor inside the inverter with converter

assembly.

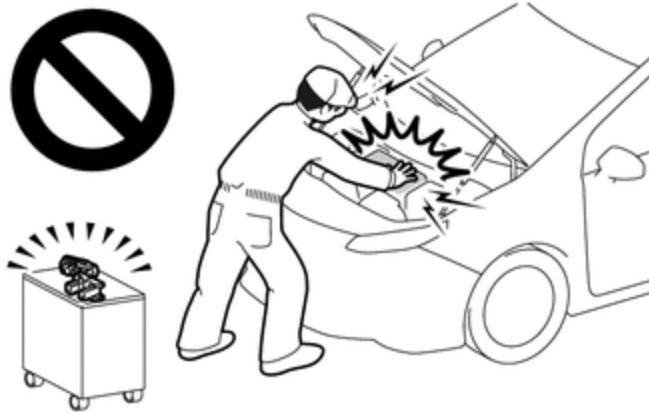
- Keep the removed service plug grip in your pocket to prevent other technicians from accidentally installing it while you are servicing the vehicle.

(1) While wearing insulated gloves, rotate the handle of the service plug grip and remove the service plug grip as indicated by the arrows, in the order shown in the illustration.
