<b>Last Modified:</b> 12-04-2024	6.11:8.1.0	<b>Doc ID:</b> RM10000002FZLJ
<b>Model Year Start:</b> 2024	<b>Model:</b> Prius Prime	<b>Prod Date Range:</b> [09/2023 - ]
<b>Title:</b> INTERIOR PANELS / TRIM: INSTRUMENT PANEL SAFETY PAD: REMOVAL; 2024 MY Prius Prius Prime [09/2023 - ]

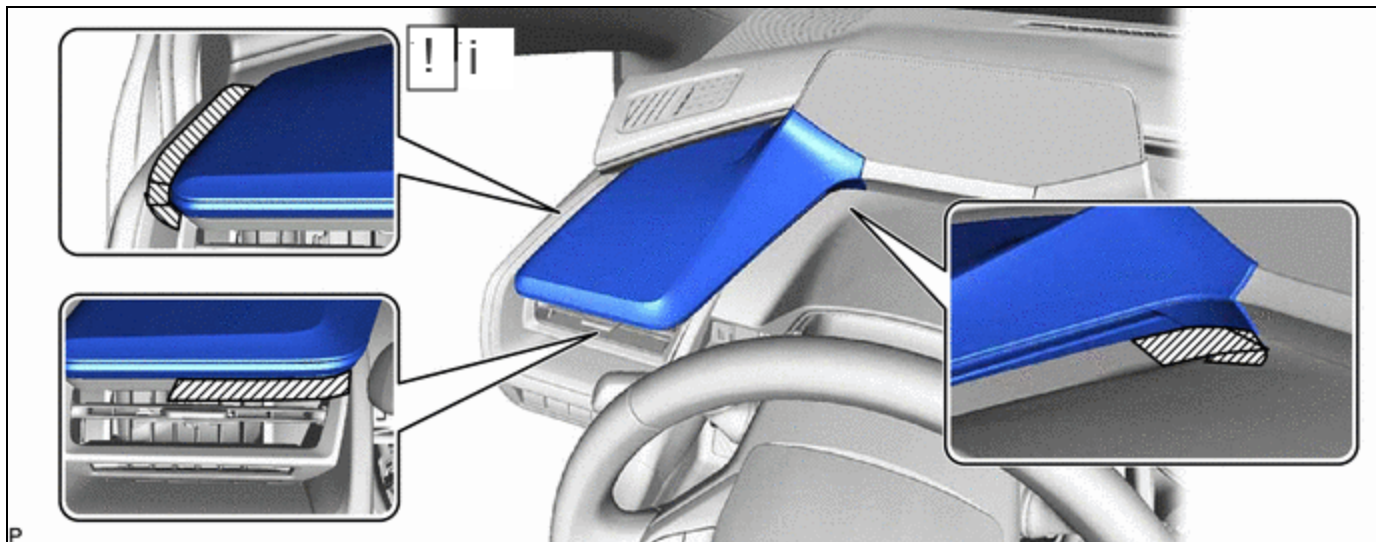
(1) Apply protective tape to the area shown in the illustration.

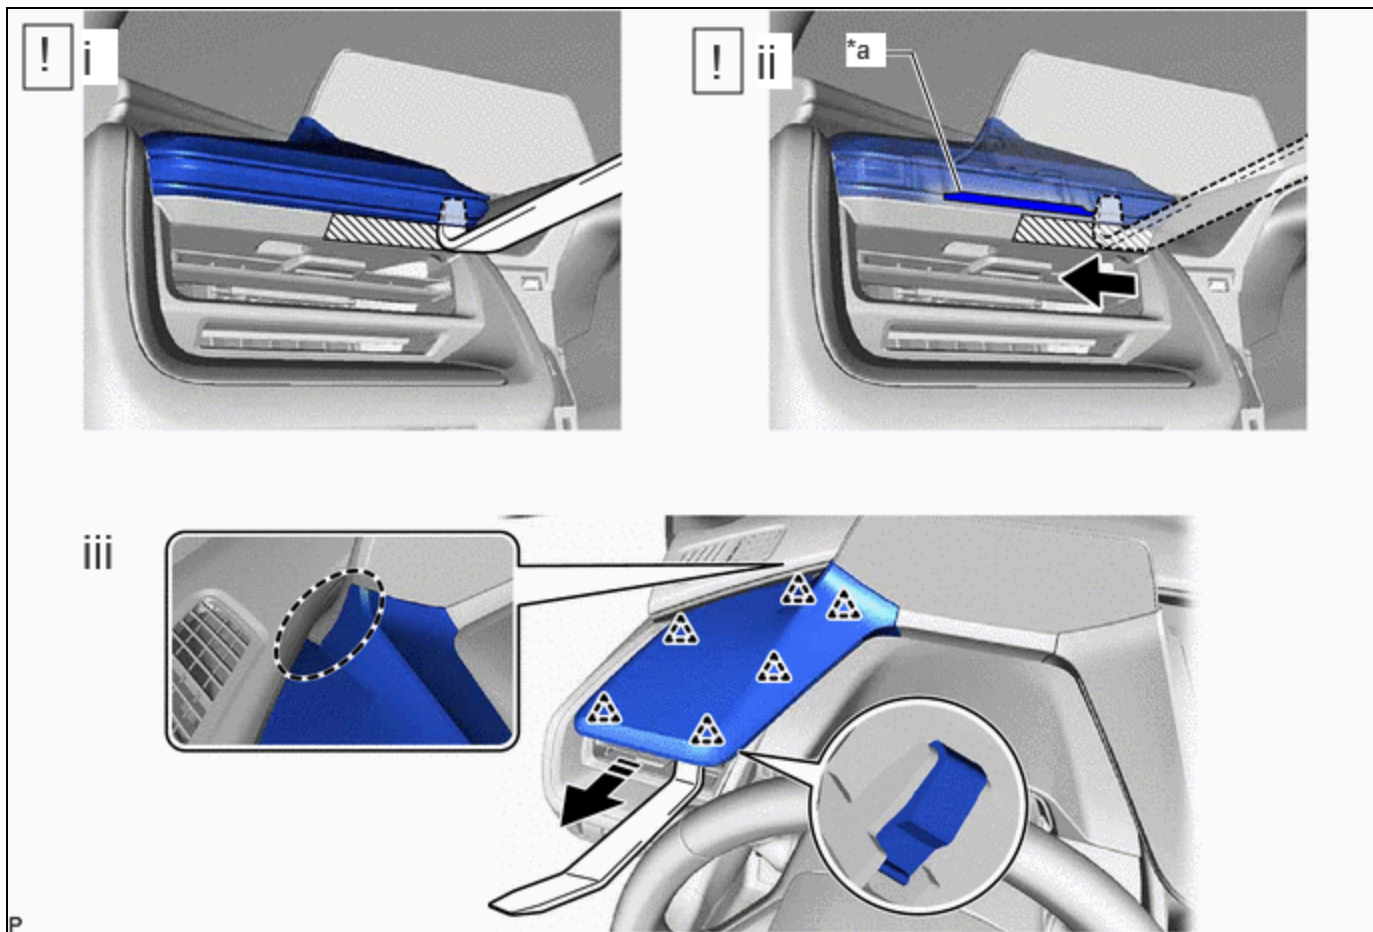
*a	Rib	-	-
	Place Hand Here		Remove in this Direction

- (1) Insert a moulding remover as shown in the illustration.
- (2) Move the moulding remover until it contacts the rib.
- (3) Disengage the 6 clips as shown in the illustration to remove the instrument cluster finish panel assembly.

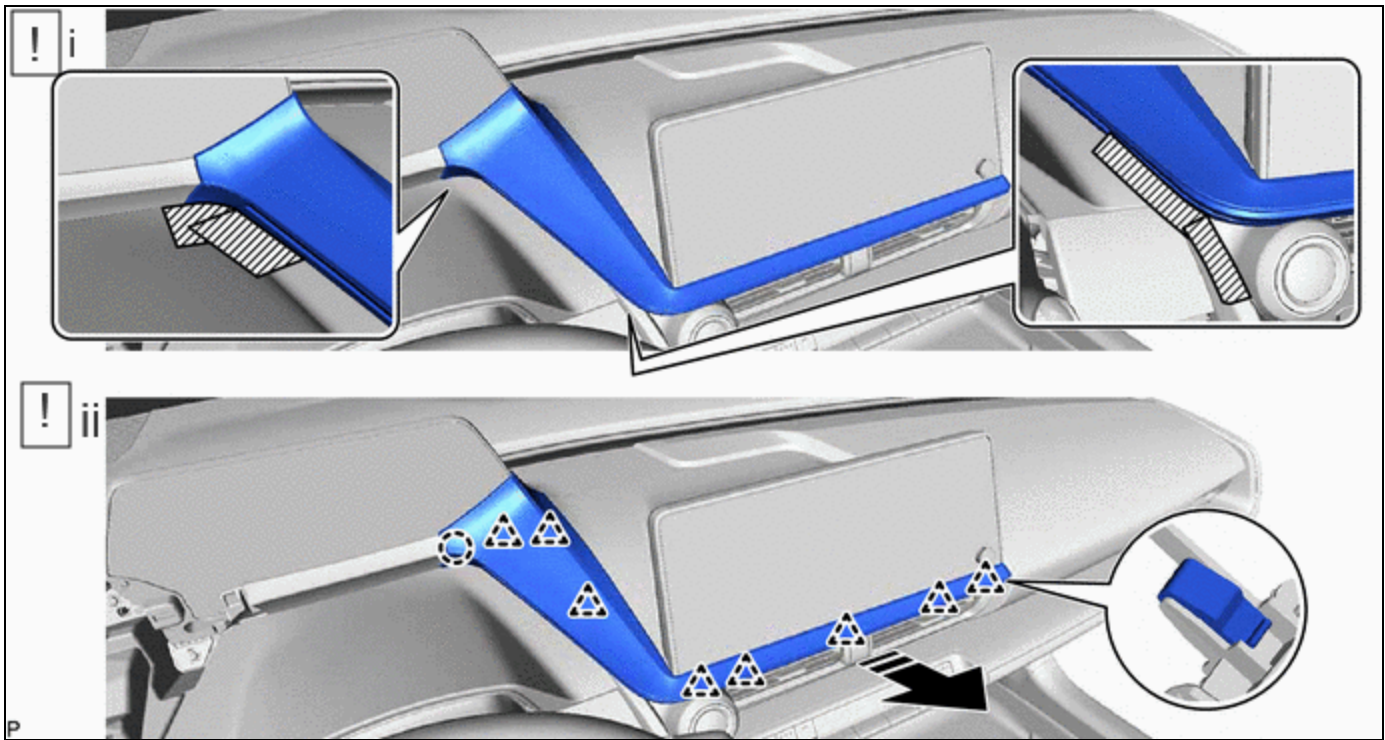
Remove in this Direction	-	-
--	--------------------------	---	---

- (1) Apply protective tape to the area shown in the illustration.
- (2) Disengage the 8 clips and claw as shown in the illustration to remove the center instrument cluster finish panel assembly.

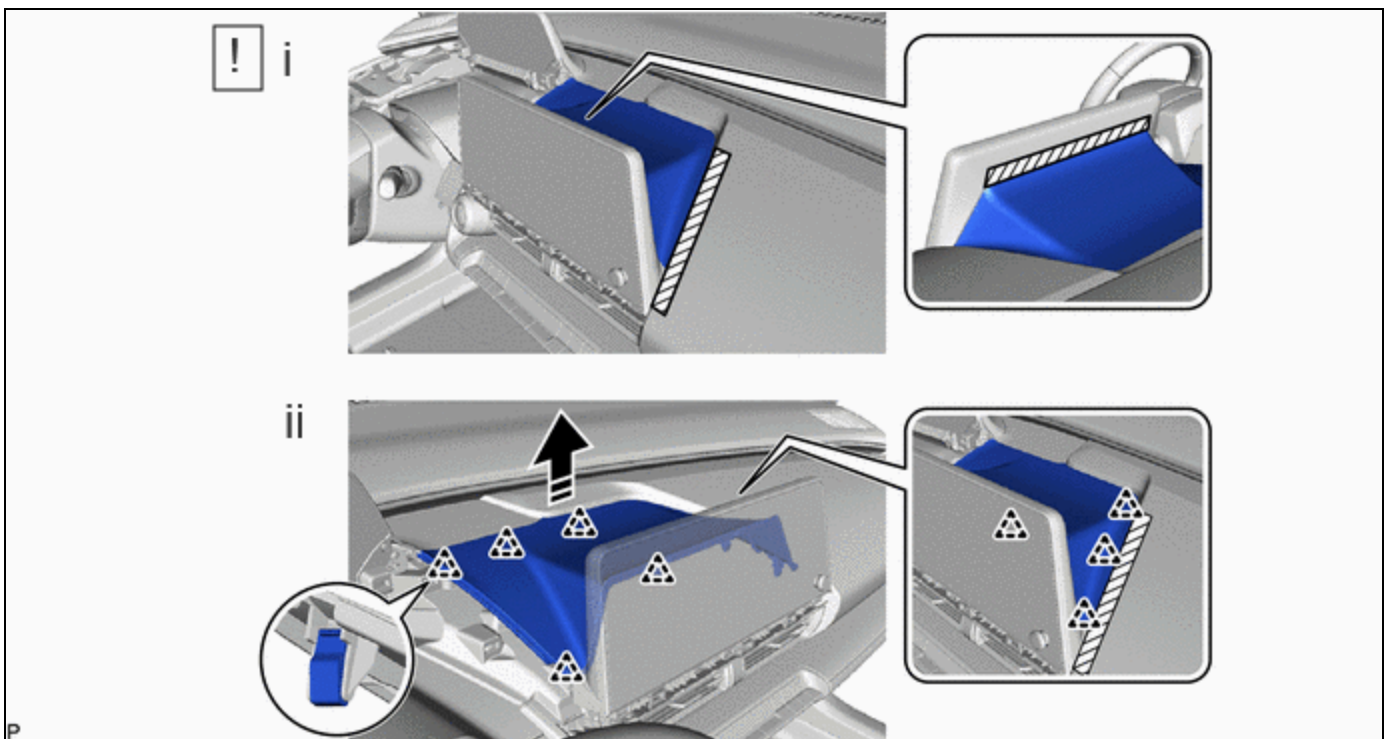
Remove in this Direction	-	-
---	--------------------------	---	---

- (1) Apply protective tape to the area shown in the illustration.
- (2) Disengage the 9 clips as shown in the illustration to remove the center upper instrument cluster finish panel.

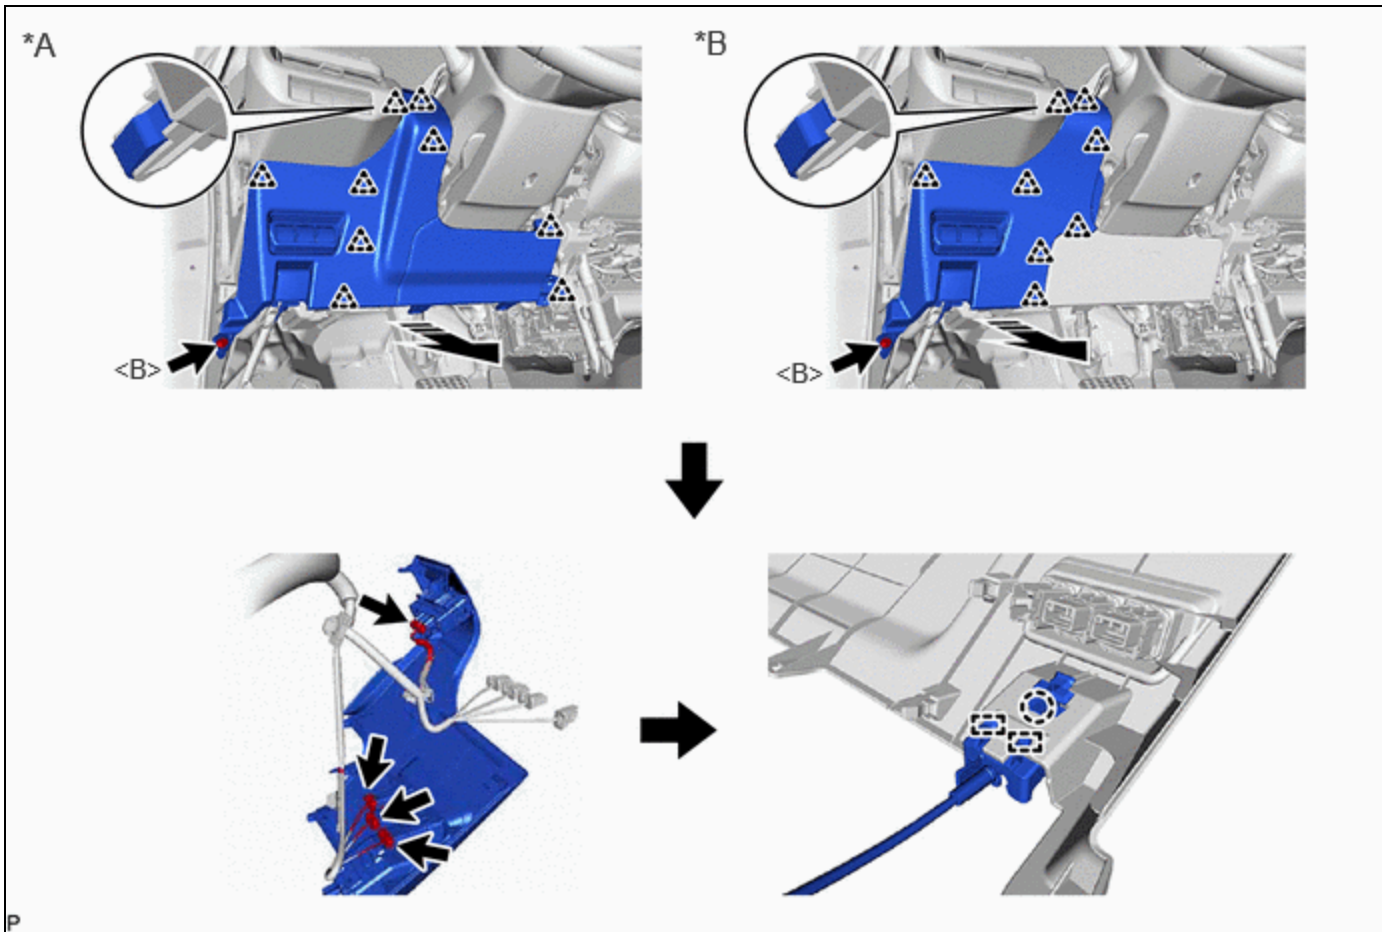
The illustration shown is an example only. The illustration may differ from the actual parts according to the model.

*A	w/o Knee Airbag	*B	w/ Knee Airbag
	Remove in this Direction	-	-

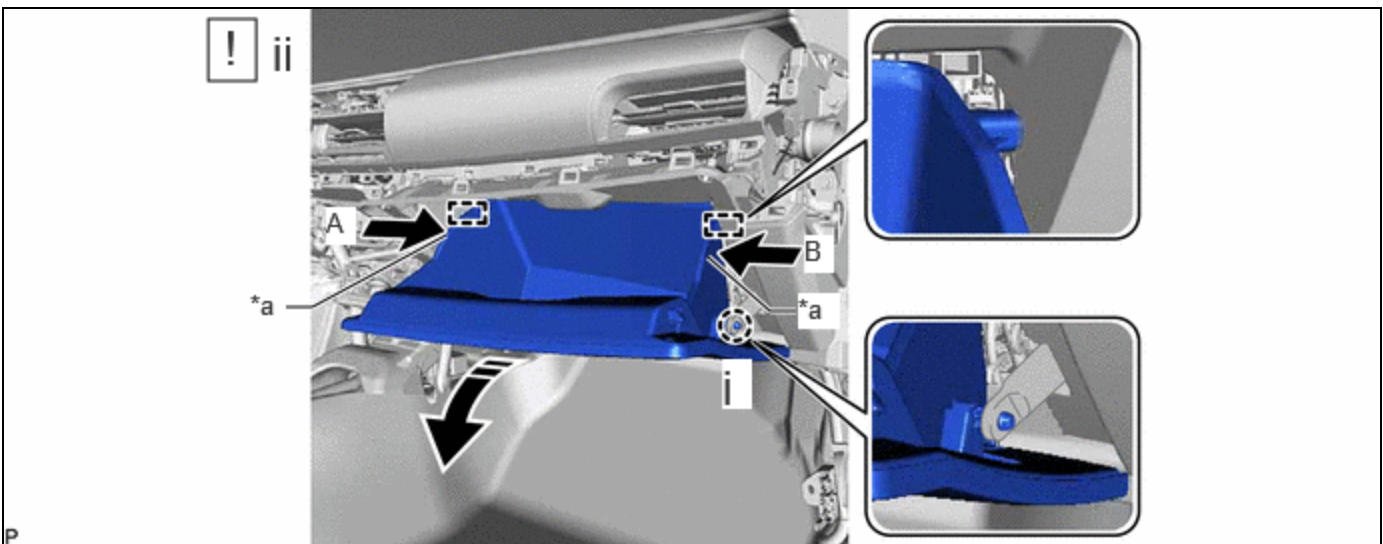
*a	Push Mark Location	-	-
	Remove in this Direction	-	-

- (1) Disengage the claw to disconnect the glove compartment door stopper sub-assembly.
- (2) Push the push mark locations (A) and (B) in the directions of the arrows shown in the illustration and pull the glove compartment door assembly until the 2 stoppers are released.

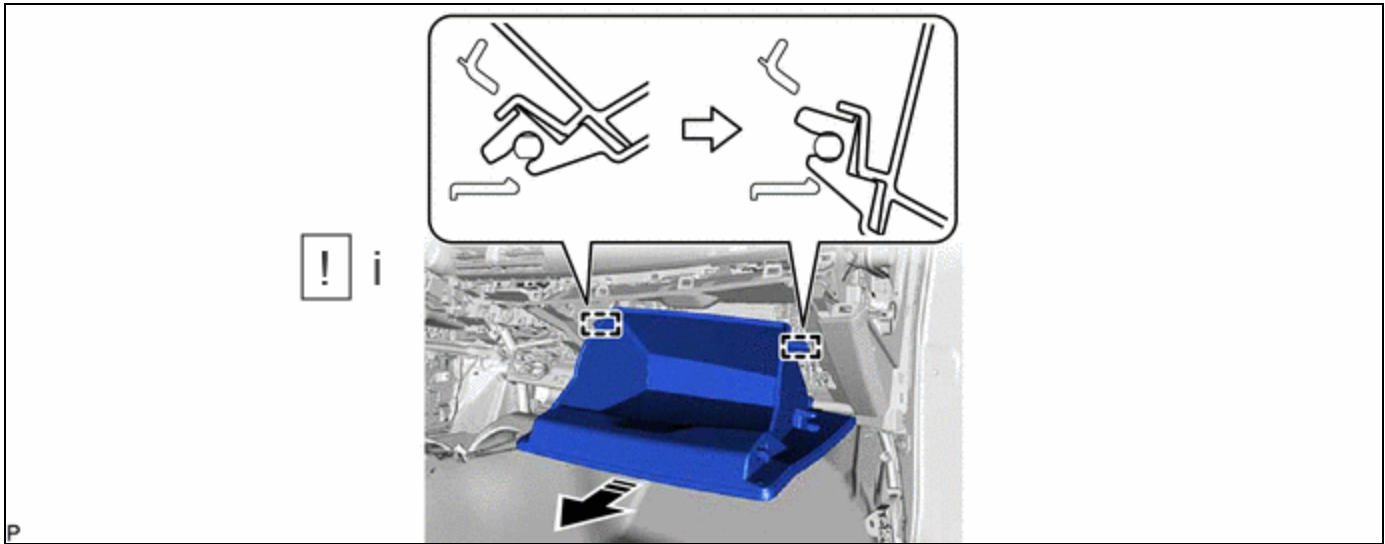
Remove in this Direction	-	-
---	--------------------------	---	---

(1) Open the glove compartment door assembly to approximately 52° from its closed position. Pull it horizontally in the direction indicated by the arrow shown in the illustration to disengage the 2 hinges and remove the glove compartment door assembly.

Pulling the glove compartment door assembly upward when removing it will cause the hinges to deform. Be sure to pull out the glove compartment door assembly horizontally.

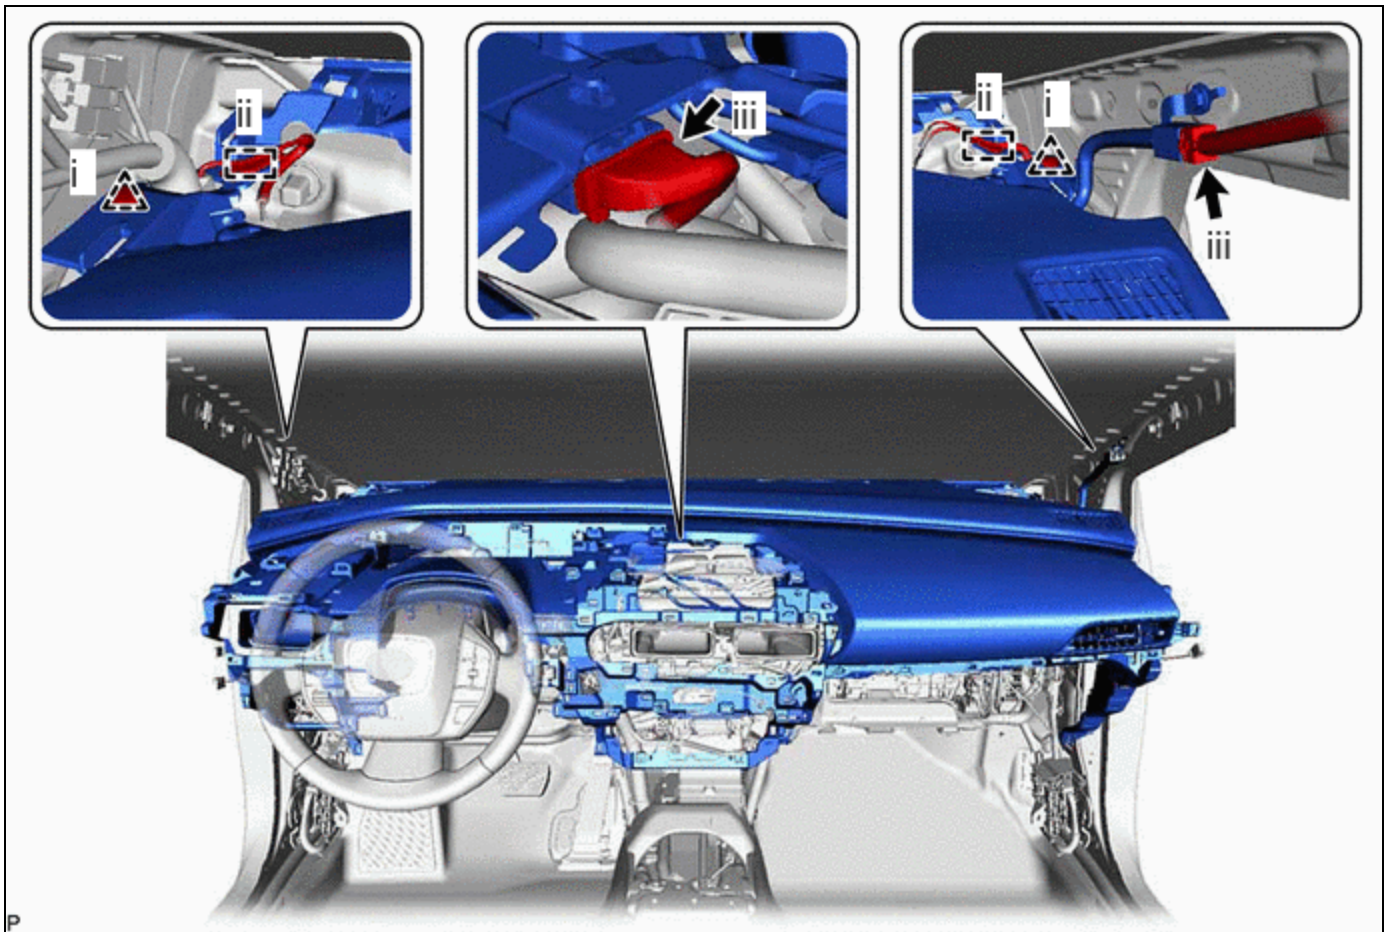
- (1) Remove the 2 clips.
- (2) Disengage the 2 clamps.
- (3) Disconnect the 2 connectors.

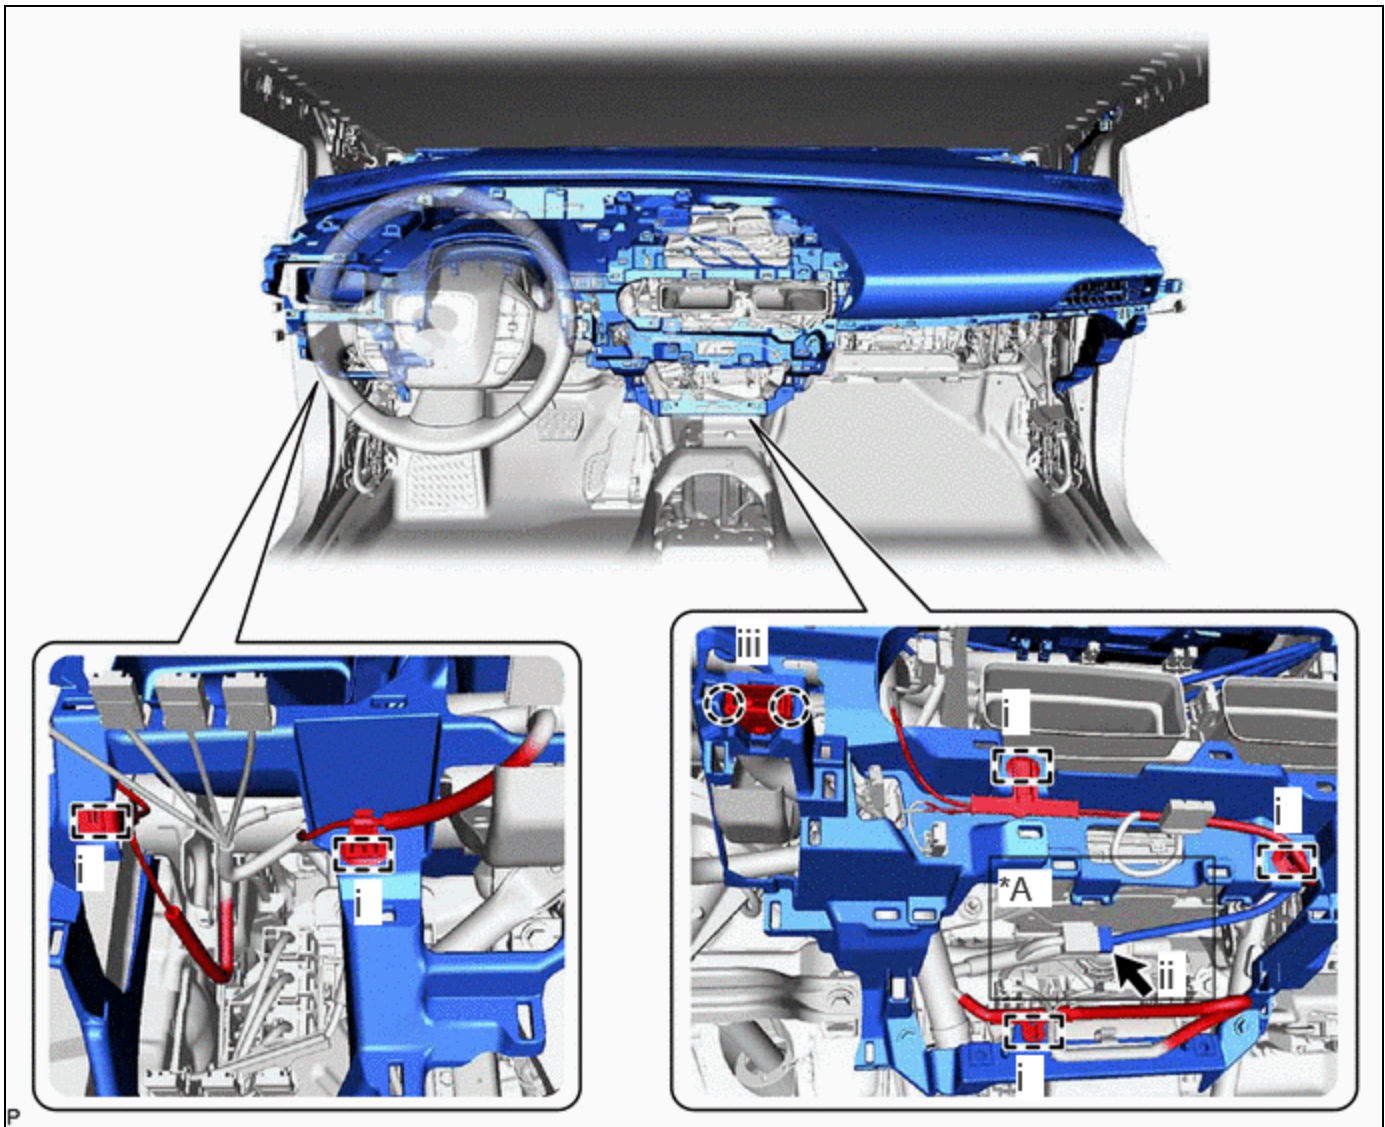
*A	w/ Telematics Transceiver	-	-
----	---------------------------	---	---

- (1) Disengage the 5 clamps.
- (2) w/ Telematics Transceiver:
  - 1. Disconnect the connector.
- (3) Disengage the 2 claws to disconnect the cooler (room temp. sensor) thermistor.

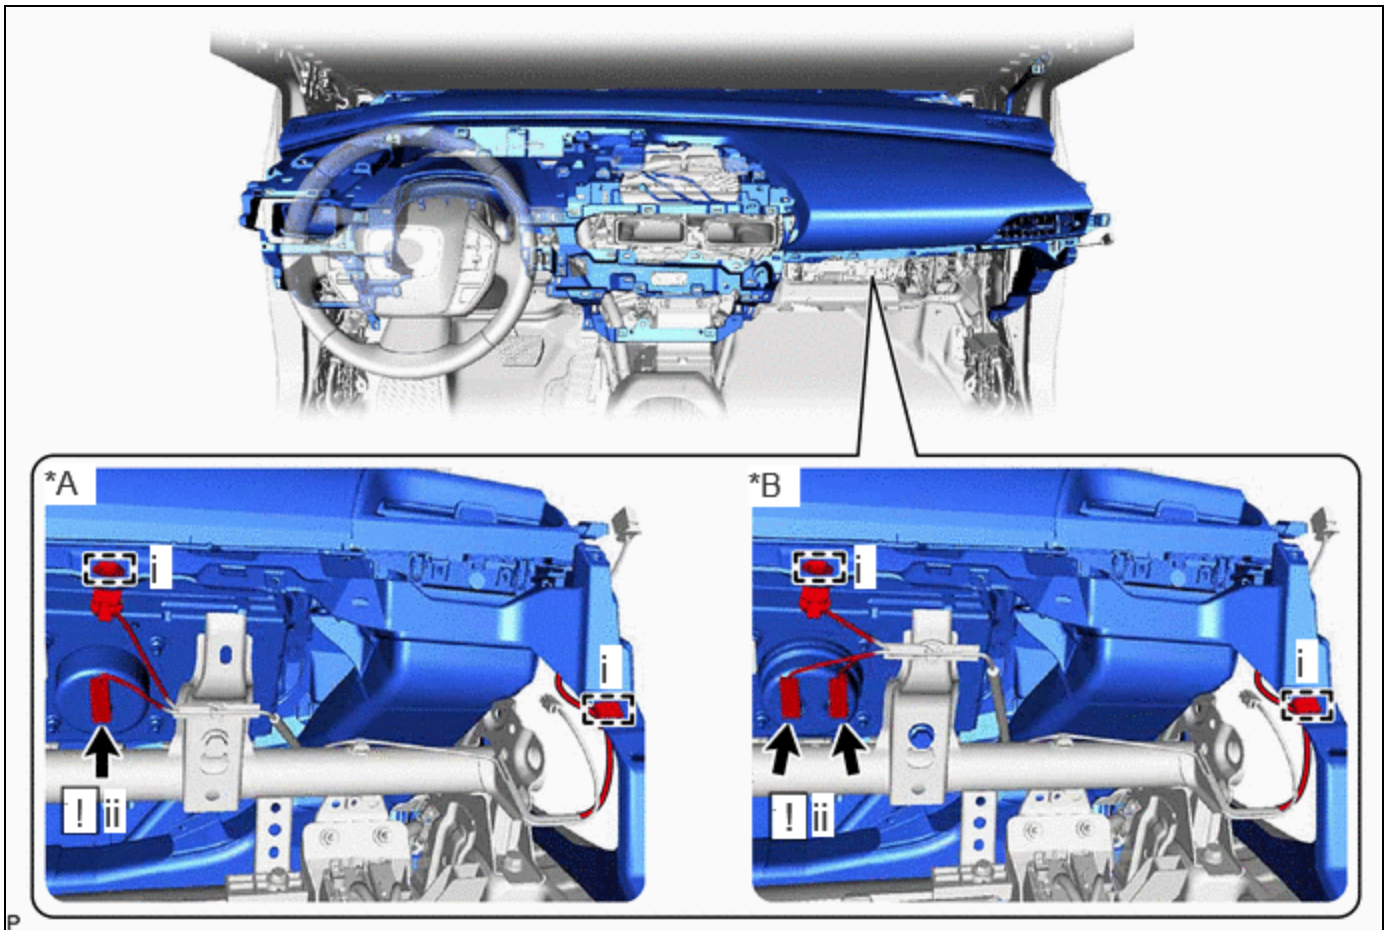
*A	for Type A	*B	for Type B
----	------------	----	------------

- (1) Disengage the 2 clamps.
- (2) Disconnect each airbag connector.

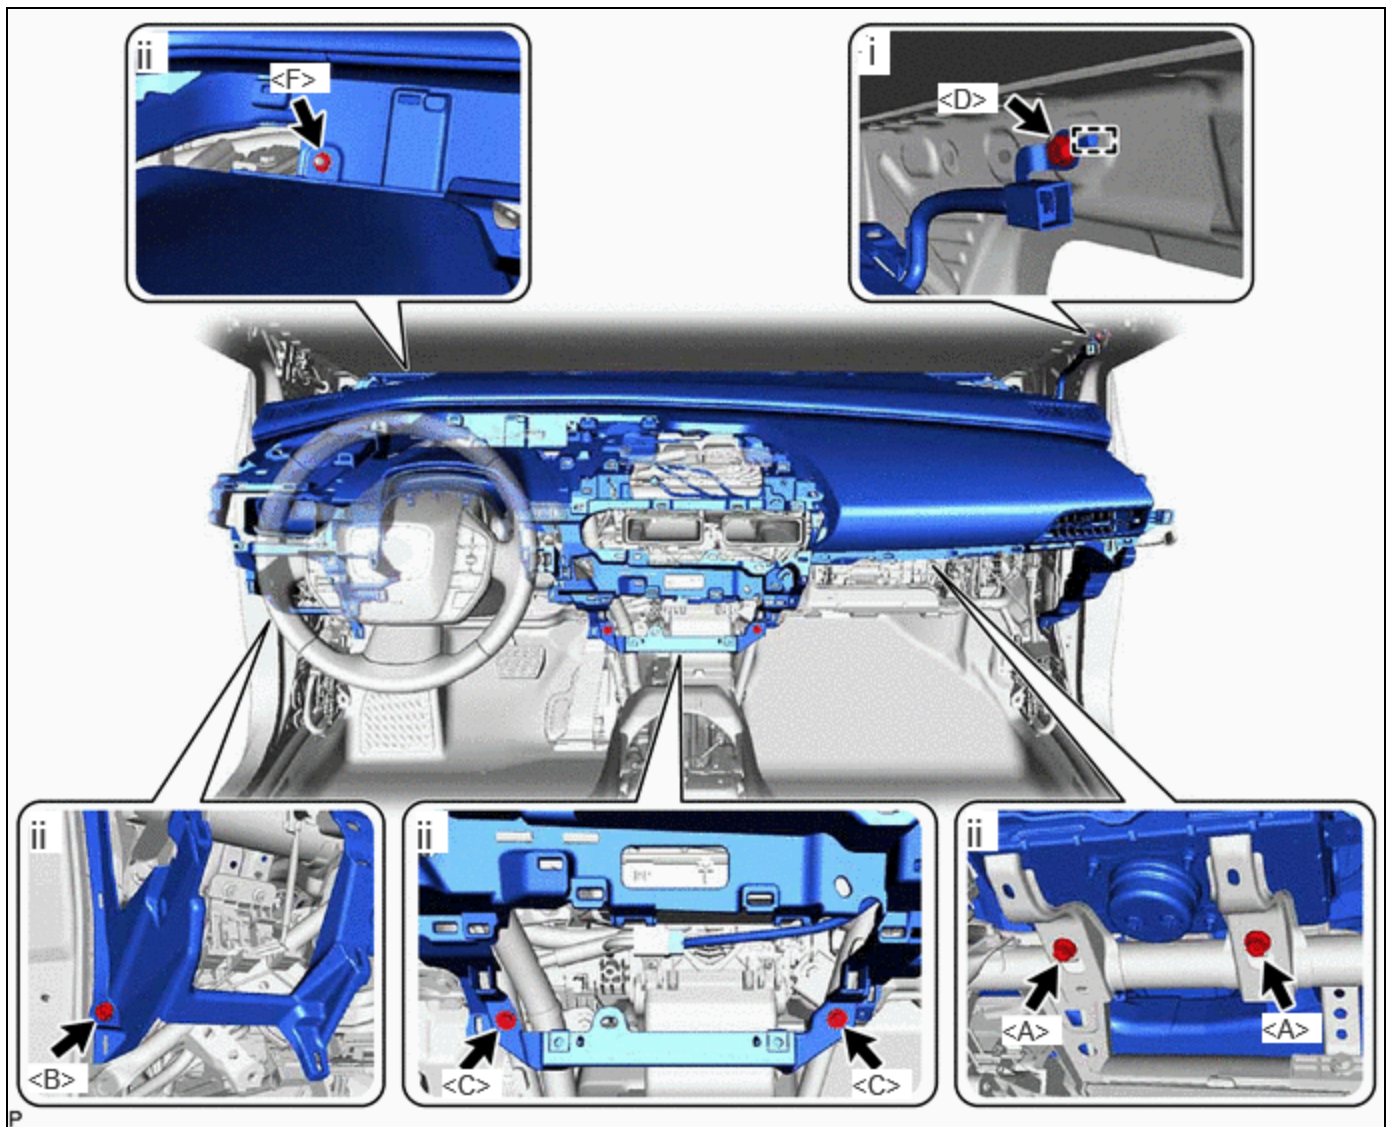
(1) Remove the bolt <D> and disengage the guide.

(2) Remove the 2 bolts <A>, bolt <B>, 2 screws <C> and nut <F>.

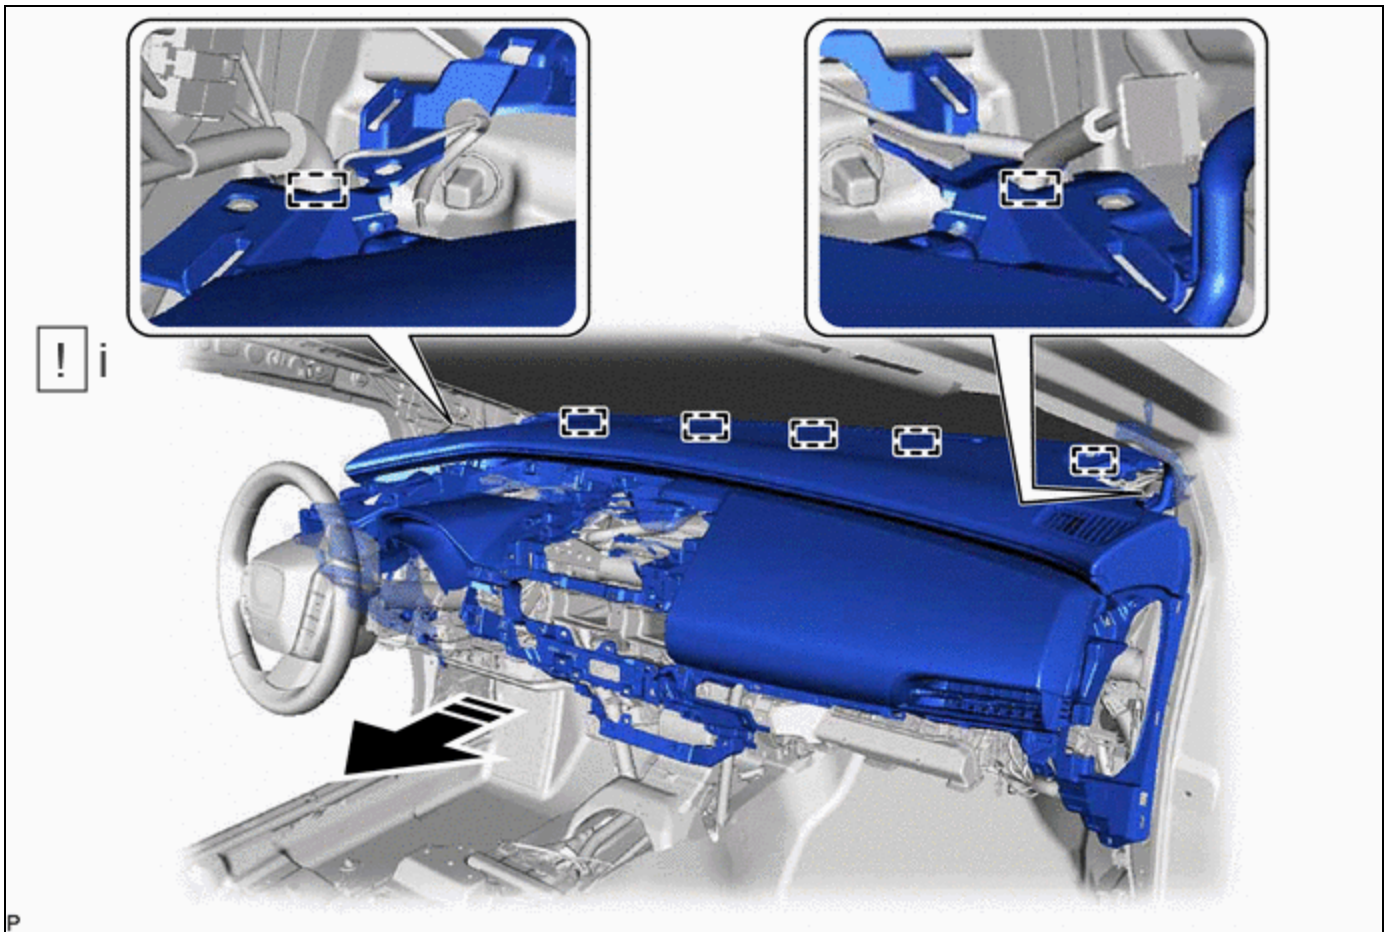
Remove in this Direction	-	-
---	--------------------------	---	---

(1) Disengage the 5 guides and 2 clamps as shown in the illustration to remove the instrument panel safety pad sub-assembly.

- Do not damage the instrument panel safety pad sub-assembly.
- Do not allow the wire harnesses to interfere with the surrounding parts.
