HONDA ServiceNews

ASN 21673 (0004)

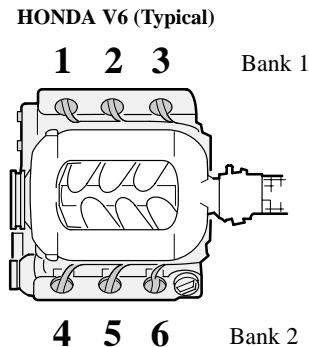
On all V6 models except Passport, the firing order is 1-4-2-5-3-6. Looking at the crankshaft pulley side of these engines, the left bank of cylinders (bank 1) is numbered 1, 2, 3, and the right bank (bank 2) is 4, 5, 6.

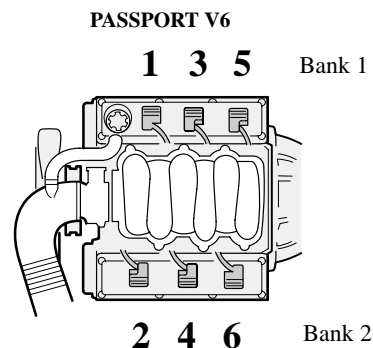
On Passports, the firing order is 1-2-3-4-5-6. From the crankshaft pulley side of the engine, the left bank of cylinders (bank 1) is numbered 1, 3, 5, and the right bank (bank 2) is 2, 4, 6.
