# Advanced Diagnostics

## DTC P1448 (63): Battery Module Overheating

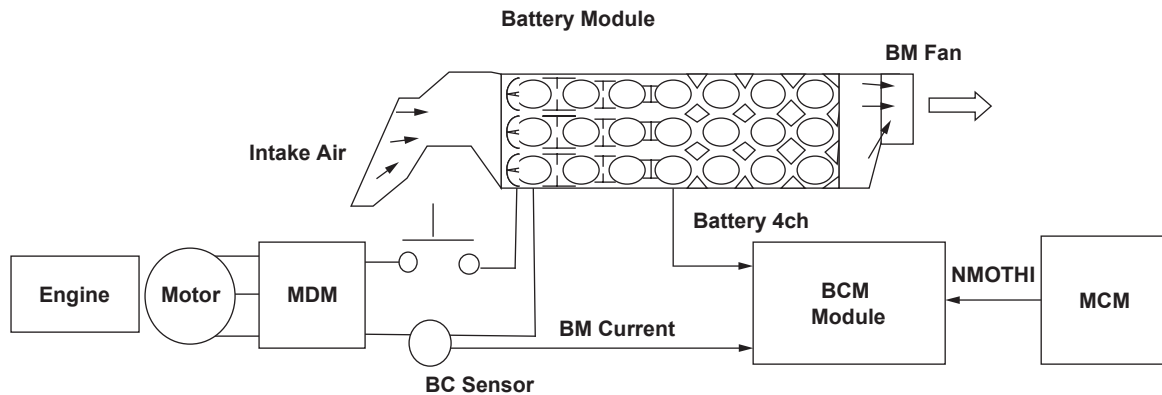
P1448-0071

To control the BM (battery module) temperature, the IMA (integrated motor assist) system is equipped with a BM fan. The motor assist stops regenerating and the IMA system is shut down by an increase in the BM temperature if the BM fan is malfunctioning. Therefore, a malfunction in the BM fan is detected to avoid problems caused by overheating. If the BM cooling system works normally when the BM temperature is high and the BM is in the power save mode, the BM temperature decreases depending on the input/output current.
