Last Modified: 12-04-2024	6.11:8.1.0	Doc ID: RM1000000289PE
Model Year Start: 2023	Model: Prius Prime	Prod Date Range: [12/2022 -]
Title: ADVANCED DRIVER ASSISTANCE SYSTEM: MILLIMETER WAVE RADAR SENSOR: TARGET ADJUSTMENT(TRIANGLE TARGET)

TARGET ADJUSTMENT(TRIANGLE TARGET)

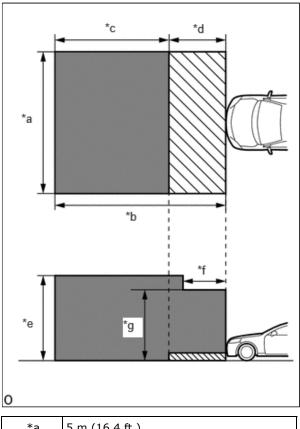
(a) Park the vehicle on a level surface where the area in front of the vehicle shown in the illustration is free of metal objects.

*a	5 m (16.4 ft.)
*b	6 m (19.7 ft.)
*c	4 m (13.1 ft.)
*d	2 m (6.56 ft.)
*e	3 m (9.84 ft.)
*f	1.5 m (4.92 ft.)
*g	2.5 m (8.2 ft.)
	*b *c *d *e *f

Do not place any metal objects in this area
Do not place metal objects with a height of more than 50 mm (1.97 in.) in this area

Metal objects that have a height of 50 mm (1.97 in.) or less do not affect adjustment within 2 m (6.56 ft.) from the front of the vehicle.

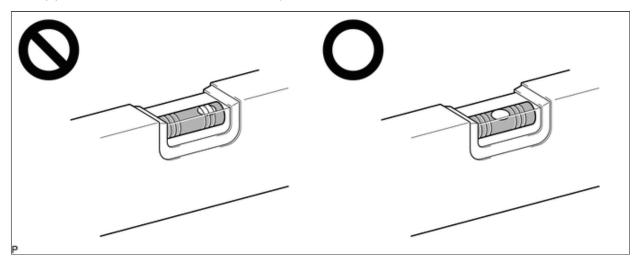
Levelness Check Point

- (b) Check the levelness of the ground.
 - (1) Check the levelness of the ground at the 3 points shown in the illustration.

(2) Place the level on each levelness check point and check that the air bubble of the level is centered.

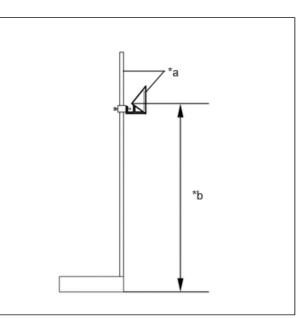
Set the reflector so that its center is 601 mm (1.97 ft.) above the

(a) Adjust SST (reflector) height.

*a	SST (reflector)
*b	601 mm (1.97 ft.)

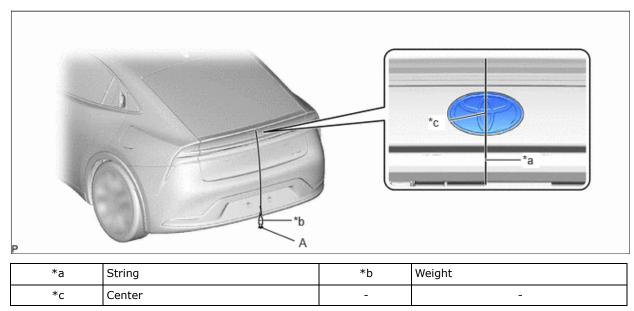
(1) Hang a weight with a pointed tip from the center of the rear emblem, and mark the rear center point of the vehicle (point A) on the ground.

12/9/24, 4:50 PM ADVANCED DRIVER ASSISTANCE SYSTEM: MILLIMETER WAVE RADAR SENSOR: TARGET ADJUSTMENT(TRIANGLE TARG... Lightly flick the string with your fingers several times to confirm that the string is perpendicular to the ground.

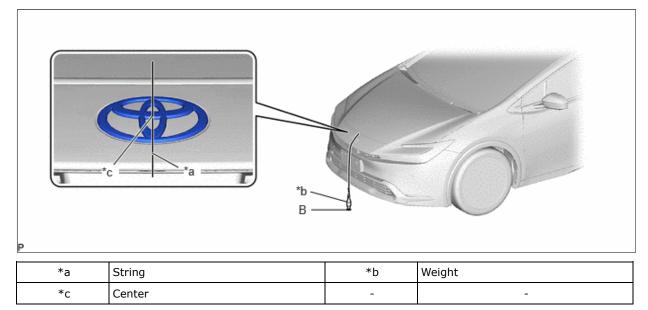
(2) Hang a weight with a pointed tip from the center of the radiator grille (or front panel) emblem, and mark the front center point of the vehicle (point B) on the ground.

Lightly flick the string with your fingers several times to confirm that the string is perpendicular to the ground.

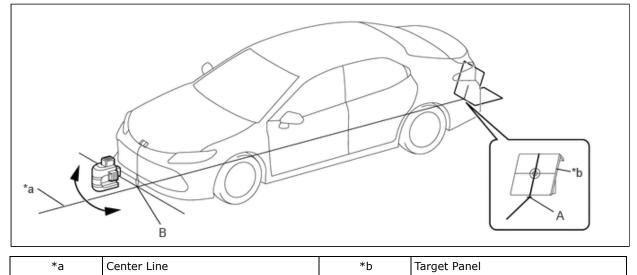
3. Align the center of the target panel with point A, and set the target panel so that it faces forward.

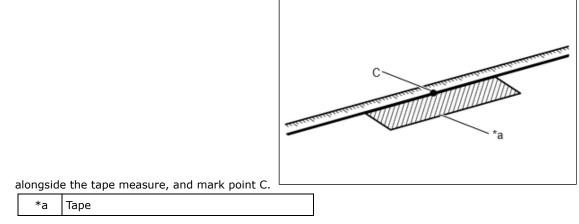
6. At a distance of 3000 mm (9.84 ft.) from point B, apply an approximately 200 mm (7.87 in.) piece of tape

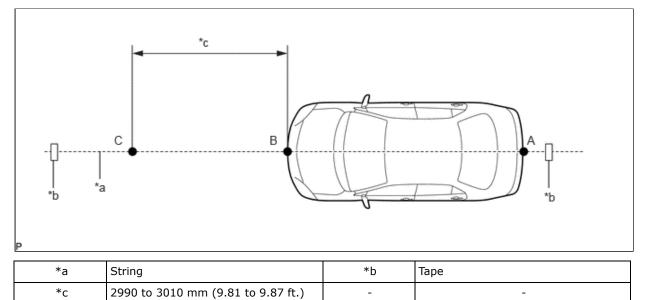
- (4) When not using a laser line marker:
 - 1. Using tape and a string, create a line that connects point B to point A and extends at least 3000 mm (9.84 ft.) beyond the front center point of the vehicle.

- Make sure the string is taut when securing it with tape.
- Lightly flick the string with your fingers several times to confirm that the string is aligned with point B.
- 2. Mark point C (SST (reflector) placement position) at a position 3000 mm (9.84 ft.) from point B.
