Last Modified: 12-04-2024	6.11:8.1.0	Doc ID: RM10000002BKE7		
Model Year Start: 2023	Model: Prius Prime	Prod Date Range: [03/2023 -]		
Title: ADVANCED DRIVER ASSISTANCE SYSTEM: FRONT CAMERA: REMOVAL; 2023 - 2024 MY Prius Prius Prime				
[03/2023 -]

REMOVAL

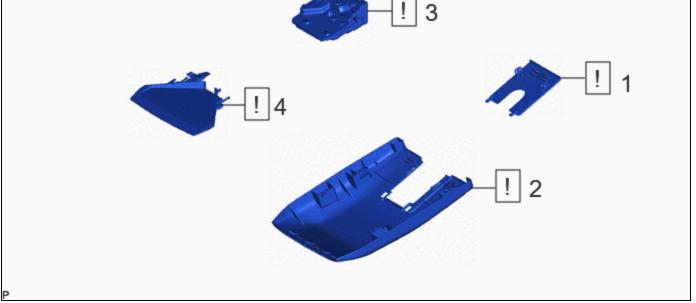
COMPONENTS (REMOVAL)

PROCEDURE	PART NAME CODE	!		Ø
1	NO. 2 FORWARD RECOGNITION COVER	86466E	INFO	-	-
2	NO. 1 FORWARD RECOGNITION COVER	86466D	INFO	-	-
3	FORWARD RECOGNITION CAMERA	8646C	INFO	-	-
4	FORWARD RECOGNITION HOOD	86461	INFO	-	-

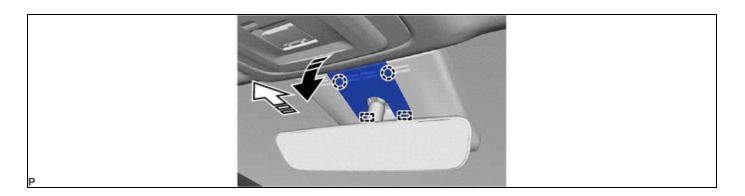
1. REMOVE NO. 2 FORWARD RECOGNITION COVER

If these claws are disengaged separately, they may break. Insert a molding remover between them and pull it down to disengage the claws simultaneously.

Remove in this Direction (1)

Remove in this Direction (2)

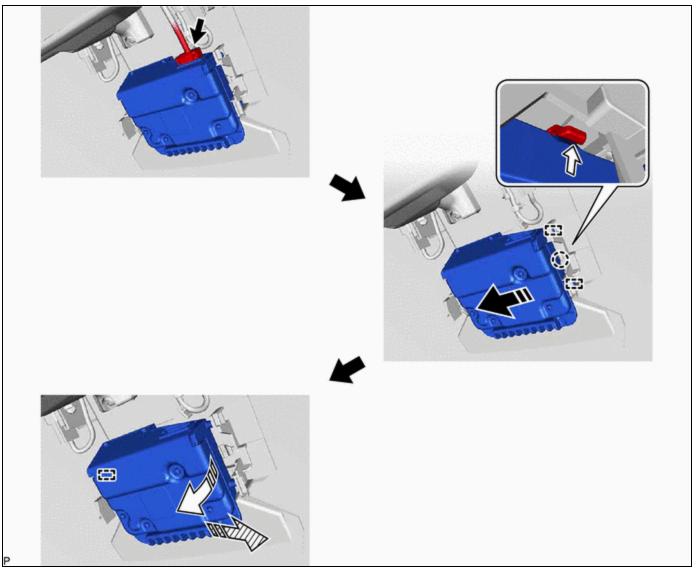
3. REMOVE FORWARD RECOGNITION CAMERA

- If the forward recognition camera has been struck or dropped, replace it with a new one.
- Do not pull the harness forcibly when disconnecting the connector.
- Do not touch the camera lens.
- If the forward recognition camera bracket is deformed or damaged, replace it together with the windshield glass.

The illustrations are representative examples, and details may differ.

•••	Remove in this Direction (1)		Remove in this Direction (2)
805	Remove in this Direction (3)	介	Push

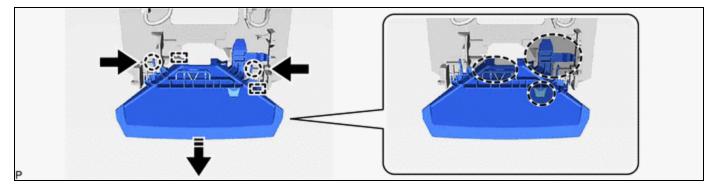
4. REMOVE FORWARD RECOGNITION HOOD

If the inner surface of the windshield glass in the area in front of the forward recognition camera is dirty, remove the forward recognition hood, clean the glass, then reinstall the forward recognition hood and forward recognition camera.

\bigcirc	Do not touch	-	Remove in this Direction
-	Push	-	-

- (1) Perform the following procedure to remove the forward recognition hood.
 - 1. Disengage the 2 claws as shown in the illustration.

Do not touch the areas shown in the illustration as application of load may cause bending.
