Last Modified: 12-04-2024	6.11:8.1.0	Doc ID: RM10000000289LY
Model Year Start: 2023	Model: Prius Prime	Prod Date Range: [12/2022 -]
Title: ADVANCED DRIVER ASSISTANCE SYSTEM: FRONT CAMERA SYSTEM: C00CA15; Camera "A" Heater Control Circuit Short to Battery or Open; 2023 - 2024 MY Prius Prius Prime [12/2022 -]

DTC	C00CA15	Camera "A" Heater Control Circuit Short to Battery or Open
------------	----------------	---

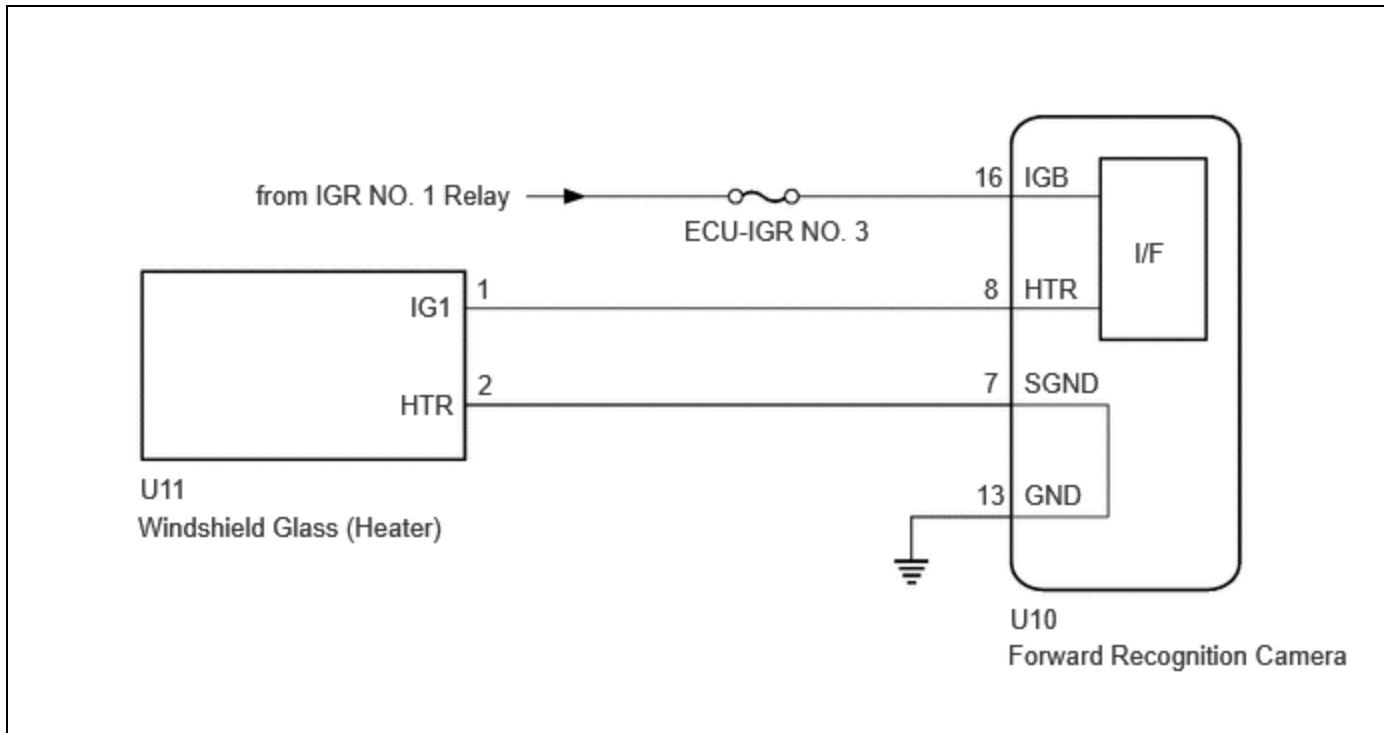
WIRING DIAGRAM

Forward recognition camera controls the current to the windshield glass (heater). Forward recognition camera stores DTC C00CA15 when it detects a malfunction in the drive circuit of the windshield glass (heater).
