Last Modified: 12-04-2024	6.11:8.1.0	Doc ID: RM1000000289M8
Model Year Start: 2023	Model: Prius Prime	Prod Date Range: [12/2022 -]
Title: ADVANCED DRIVER ASSISTANCE SYSTEM: FRONT CAMERA SYSTEM: U023587; Lost Communication with Cruise Control Front Distance Range Sensor Single Sensor or Center Missing Message; 2023 - 2024 MY Prius Prius Prime [12/2022 -]

DTC	U023587	Lost Communication with Cruise Control Front Distance Range Sensor Single Sensor or Center Missing Message
------------	----------------	---

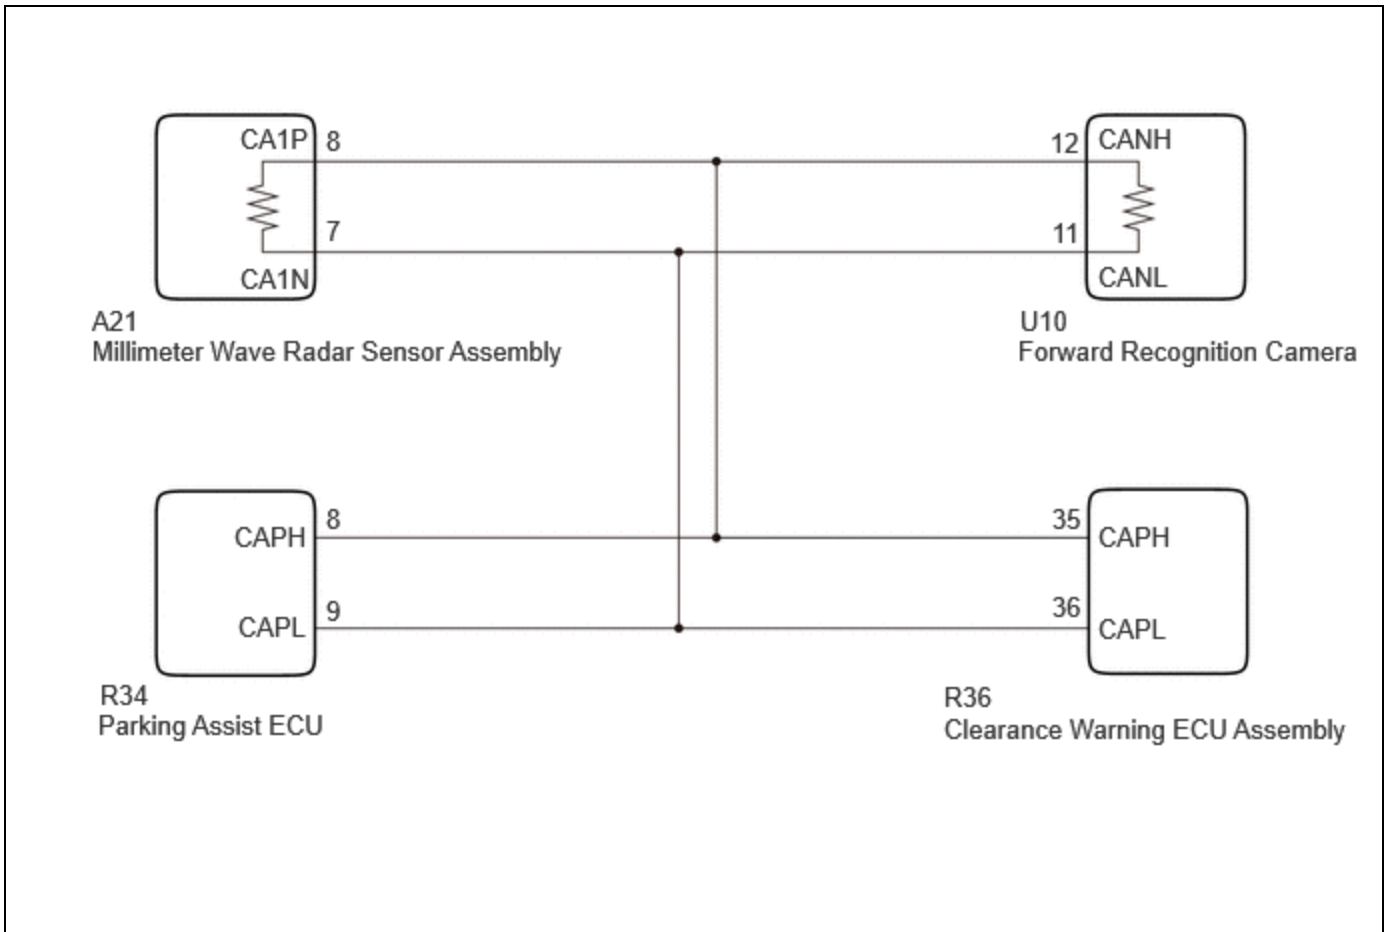
w/ Advanced Park

The forward recognition camera communicates with the millimeter wave radar sensor assembly via CAN communication line. If communication with the millimeter wave radar sensor assembly stops, the forward recognition camera stores DTC U023587.

WIRING DIAGRAM
