Last Modified: 12-04-2024	6.11:8.1.0	Doc ID: RM100000028U14
Model Year Start: 2023	Model: Prius Prime	Prod Date Range: [12/2022 -]
Title: CELLULAR COMMUNICATION: SAFETY CONNECT SYSTEM: B157213; Microphone Circuit Open; 2023 - 2024 MY Prius Prius Prime [12/2022 -]

DTC	B157213	Microphone Circuit Open
------------	----------------	--------------------------------

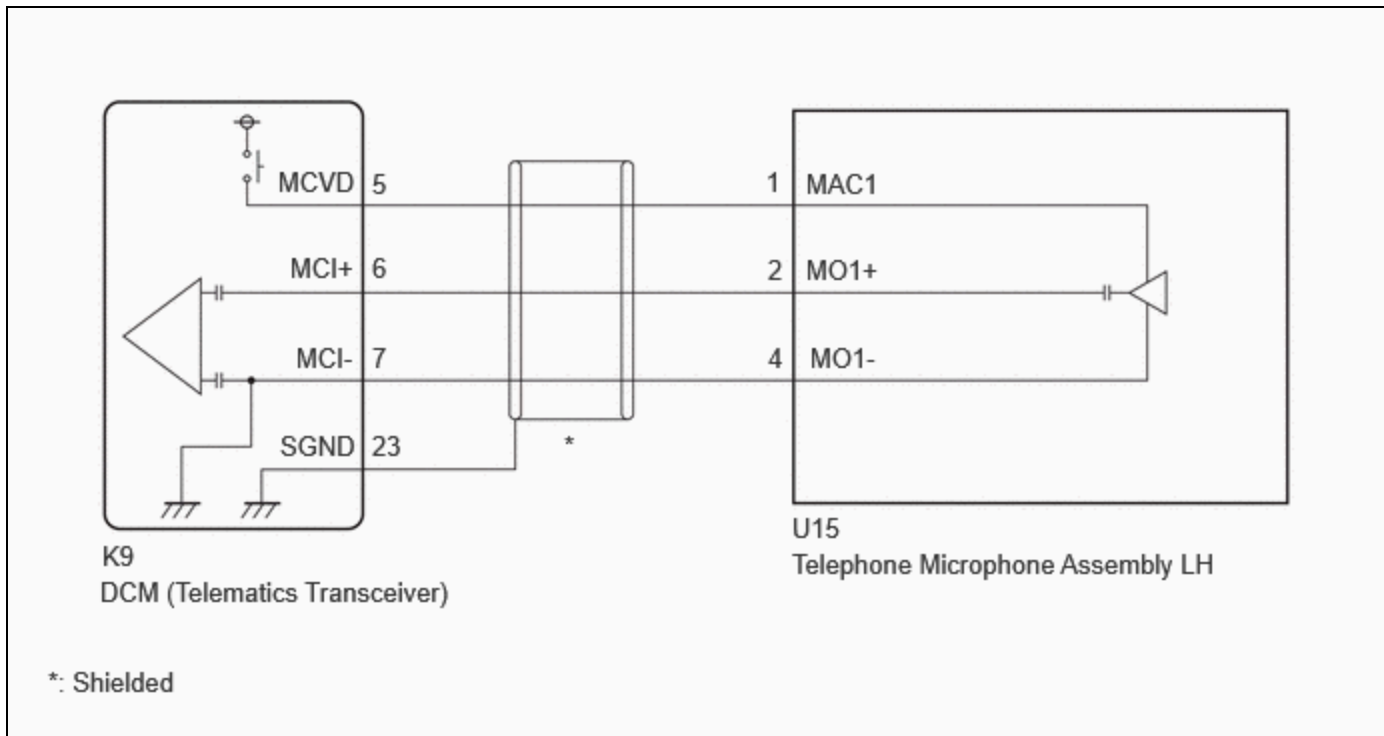
WIRING DIAGRAM

This DTC is stored when the DCM (telematics transceiver) detects a malfunction in the telephone microphone assembly circuit.

DTC NO.	DETECTION ITEM	DTC DETECTION CONDITION	TROUBLE AREA	DTC OUTPUT FROM	PRIORITY
B157213	Microphone Circuit Open	Current at terminal MCVD is lower than the malfunction threshold for 10 seconds or more while the ignition switch is ON	<ul style="list-style-type: none"> DCM (telematics transceiver) Telephone microphone assembly LH Harness or connector 	Telematics	A

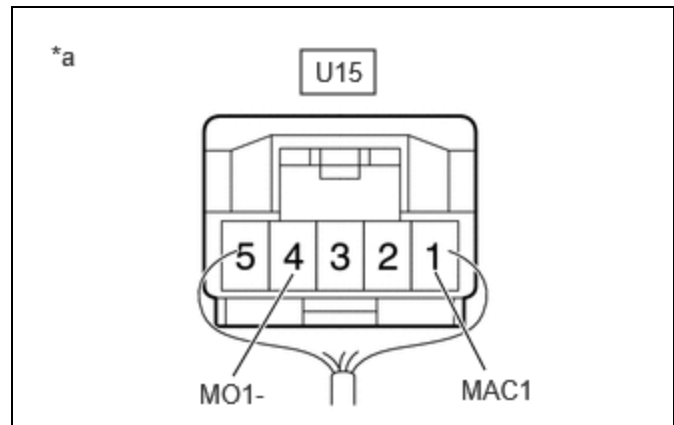
TESTER CONNECTION	SWITCH CONDITION	SPECIFIED CONDITION	RESULT
U15-1 (MAC1) - Body ground	Ignition switch ON	7.5 to 8.5 V	V

TESTER CONNECTION	CONDITION	SPECIFIED CONDITION	RESULT
U15-4 (MO1-) - Body ground	Always	Below 1 Ω	Ω

*a Component with harness connected (Telephone Microphone Assembly LH)

(b) Measure the voltage and resistance according to the value(s) in the table below.
