Last Modified: 12-04-2024	6.11:8.1.0	Doc ID: RM10000002918F
Model Year Start: 2023	Model: Prius Prime	Prod Date Range: [12/2022 -]
Title: PARK ASSIST / MONITORING: PANORAMIC VIEW MONITOR SYSTEM: U11B687; Lost Communication with Clearance Sonar Module (ch2) Missing Message; 2023 - 2024 MY Prius Prius Prime [12/2022 -]

DTC	U11B687	Lost Communication with Clearance Sonar Module (ch2) Missing Message
------------	----------------	---

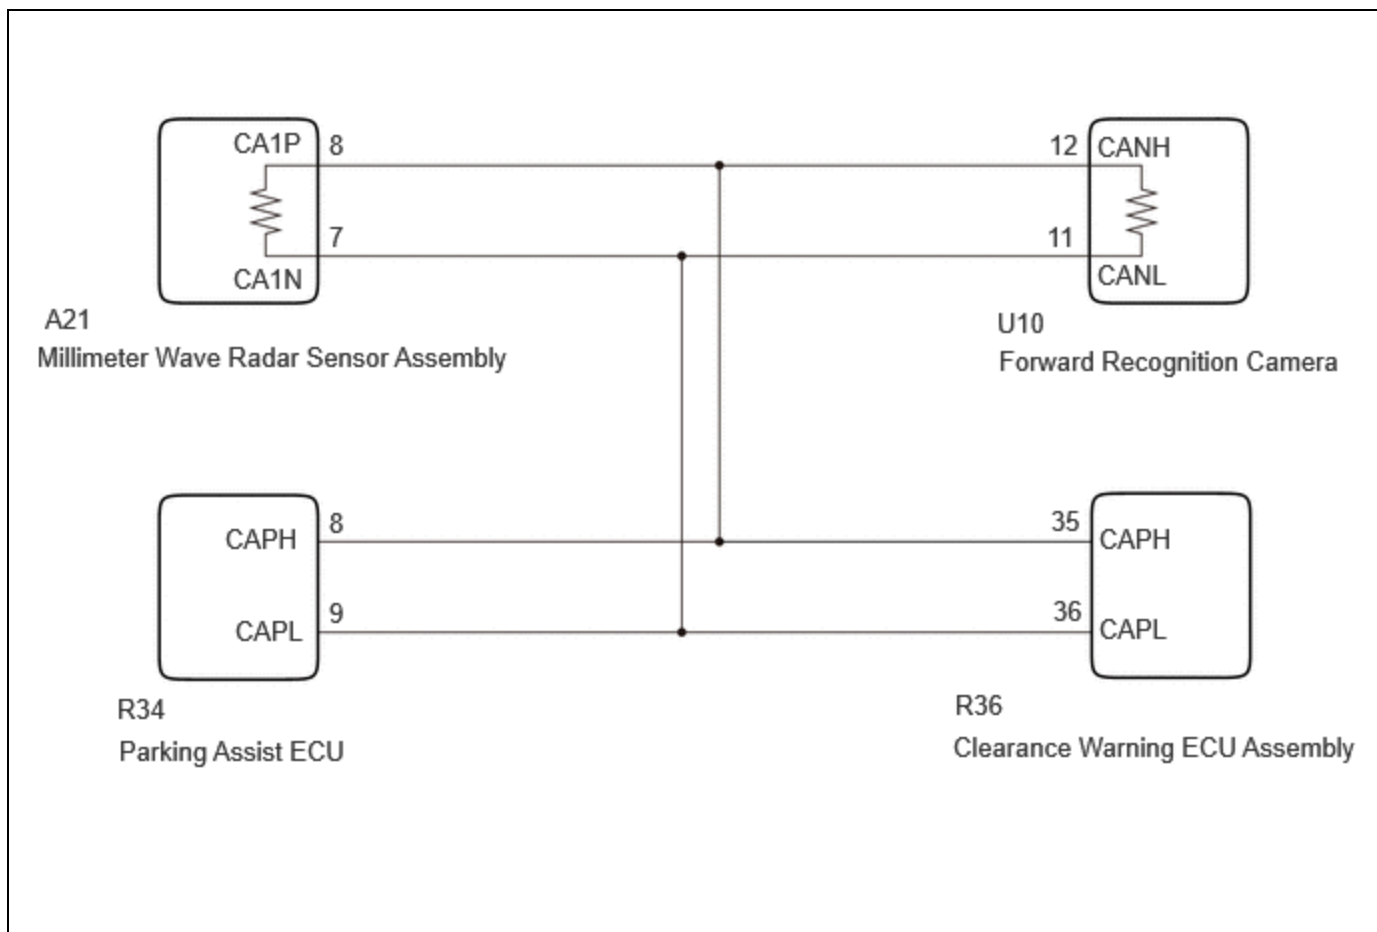
WIRING DIAGRAM

This DTC is output when the parking assist ECU detects lost communication with the clearance warning ECU assembly.
