Last Modified: 12-04-2024	6.11:8.1.0	Doc ID: RM100000002AZY
Model Year Start: 2023	Model: Prius Prime	Prod Date Range: [03/2023 -]
Title: M20A-FXS (EMISSION CONTROL): CANISTER (for PHEV Model): INSPECTION; 2023 - 2024 MY Prius Prime [03/2023 -]

1. INSPECT CANISTER (CHARCOAL CANISTER ASSEMBLY) (VISUALLY CHECK)

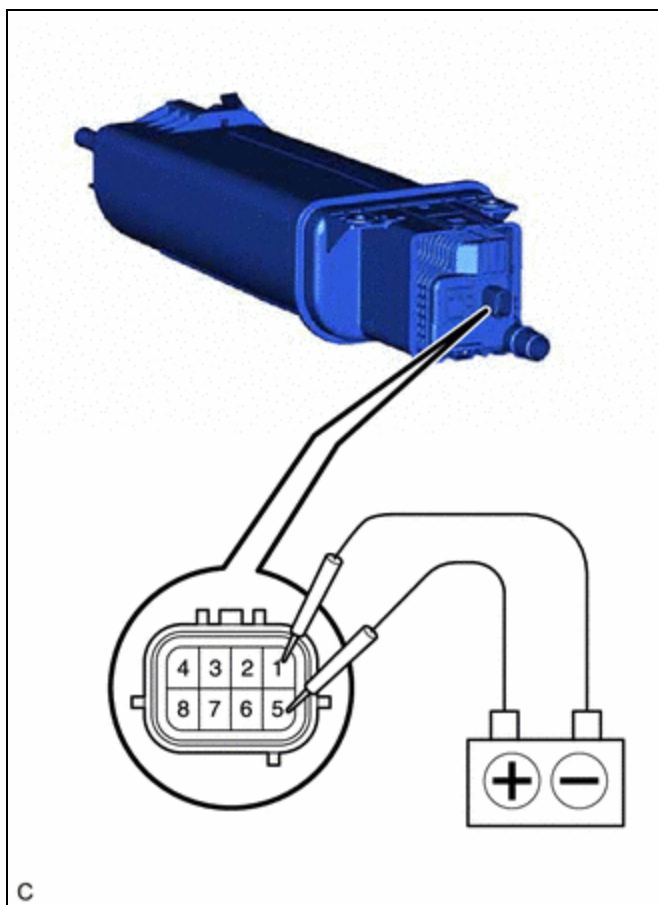
- (a) Connect a positive (+) auxiliary battery lead to terminal 5 and a negative (-) auxiliary battery lead to terminal 1.

- (b) Check that a clicking sound is heard from the leak detection pump sub-assembly.
